Detection of gully erosion using Global Navigation Satellite Systems in Myjava – Turá Lúka

MICHAELA DANÁČOVÁ, MILICA ALEKSIĆ, MATÚŠ TOMAŠČÍK, ANNA LIOVÁ, ROMAN VÝLETA

Keywords: gully erosion – monitoring – Global Navigation Satellite Systems (GNSS)

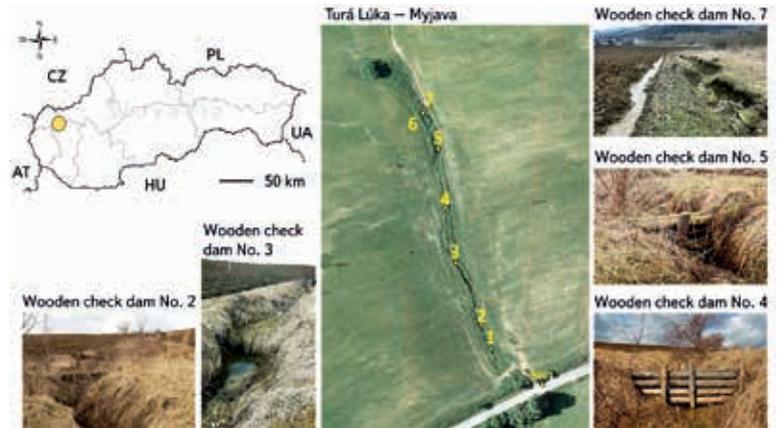
Due to the occurrence of muddy floods after torrential summer rains and during spring snowmelt, when extreme surface runoff along with eroded material caused siltation of roads and residences, the erosion gully was included in the project "Landscape Revitalization and Integrated Watershed Management Programme of the Slovak Republic" in 2010. Within this project's implementation, seven small wooden check dams were constructed in the gully as a form of anti-erosion and stabilisation measures (Fig. 1).

Fig. 1. Location of the study region of the erosion gully with 7 small wooden check dams

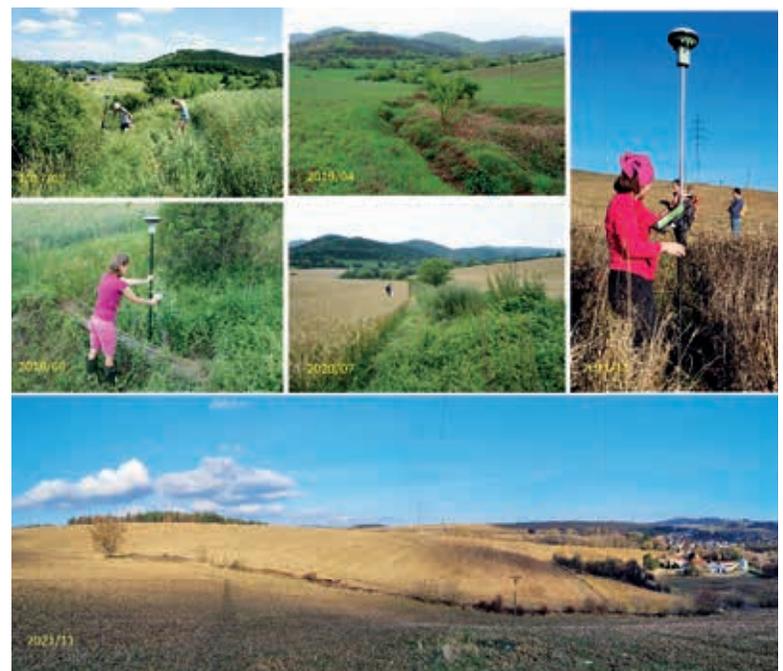
Fig. 2. The photo documentation of the erosion gully using GNSS technology from 2017–2021

The use of modern surveying technologies to monitor erosion features in the landscape requires that the land surface be largely cleared of extensive vegetation (e. g., grassland, shrubs, and self-seeded trees), which is labour and time intensive. That is why, since 2017, the erosion gully has been monitored only using GNSS technology, i. e., a Leica System GS15 GNSS with a connection to the Slovak Real-Time Positioning Service (SKPOS, generating so-called network corrections of geodetic coordinates in real time), because of the presence of full-grown vegetation in the gully. This technology is easy to process the measured data, but data collection requires creation of a point field, i. e., a density of points, where each point has a precise horizontal and vertical position. Fig. 2 shows the state of vegetation when changes were measured in the erosion gully in 2017–2021.

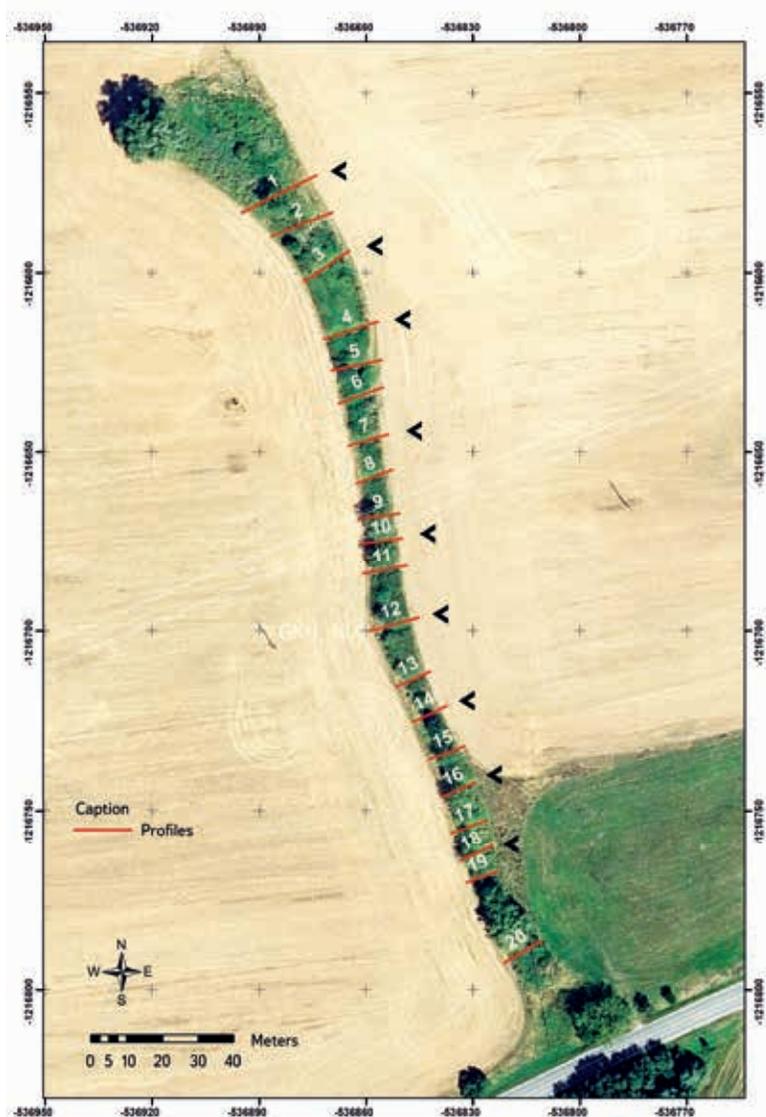
Fig. 3. Location of the 20 transverse profiles in the gully erosion: the black arrow shows 9 selected profiles (base map: GKÚ Bratislava, NLC, 2019)

of 20 transverse profiles are being measured using the Leica System GS15 GNSS, but only 18 profiles have been measured in the last 2 years (year 2020–2021). Profiles 19 and 20 have been excluded from monitoring due to their complete siltation by transported sediment and due to the increasing density of vegetation and trees. The problem is access to the site of measurement and shading of the vegetation itself, as in most cases the satellite signal is lost, thus significantly increasing measurement inaccuracy. In such a case, the possibility remains to measure these transverse profiles using a total station. However, this measurement method has not been applied.

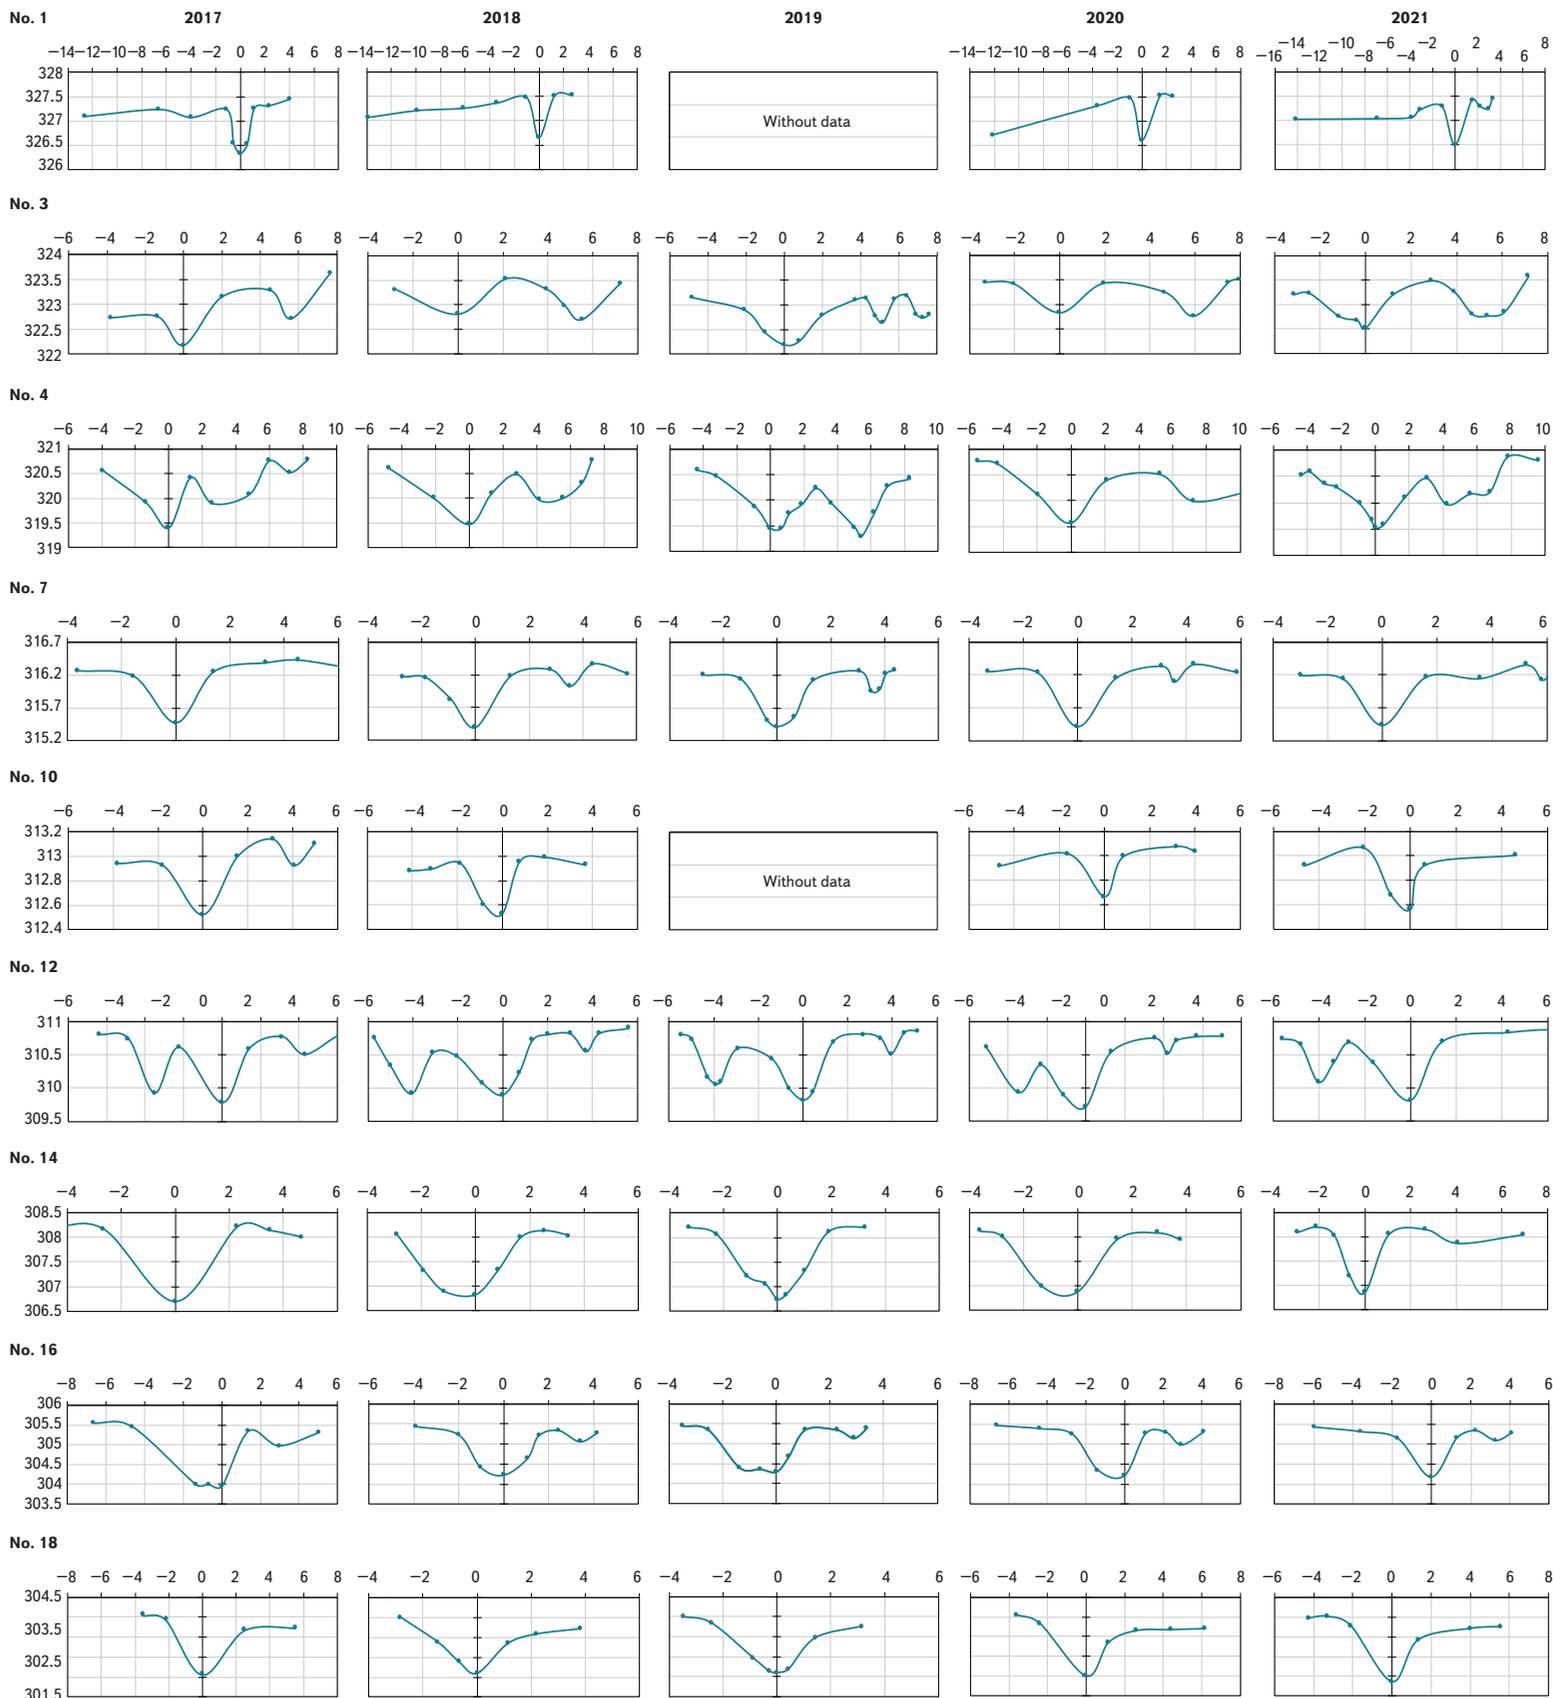
For the purposes of evaluating the erosion gully's condition, 9 transverse profiles were selected, namely profiles 1, 3, 4, 7, 10, 12, 14, 16, and 18 (Fig. 3). Their graphic representation is presented in Fig. 4. Profiles 1 and 10 (for 2019, marked as NO DATA) are not shown in the results and comparisons because they were not measured due to unfavourable weather and bad access to the site of measurement, or loss of satellite signal.

Some profiles could not be included because their lines of measurement were not completely identical in each year. They were therefore excluded due to the impaired possibility of correct evaluation of the development of change in the erosion gully's morphology. It was possible to conclude by visual assessment that expected minor changes had become evident in the head, i. e. the uppermost part of the gully. In this widest part of the gully, there are relatively small depths and several small rills alongside. The minor changes are also caused by a lower slope and a smaller drainage area in this part of the gully. Above the head of the gully, water appears on the ground surface throughout the year. The gully already reaches a depth of more than 1 m approximately 80 m from the head of the erosion gully, i. e. from profile 4. It is seen from the graphic representation of the transverse profile measured in 2019 that it has a different course. This is caused by the fact that the direction of the line of points measured in profile 4 was not maintained as it had been in the other years. Consequently, this year was excluded from the overall comparison of the gully's shape and parameters in this profile. In the central part of the gully (profiles 7 to 14), in a 100–190 m long section, there was no change of the deepest part, i. e. the axis of the main gully. It varies between 1.5–2 m, but the change in shape, or the formation of secondary ephemeral (temporary) rills, was only apparent in profile 12. This section has the highest slope conditions, with slopes of up to 20%. Siltation by transported particles can be observed in the lower part of the erosion gully (comparison of profiles 16 to 18). A more detailed analysis of gully erosion in this location would require repeated measurements using modern technology (UAV or TLS), as was done in 2014–2016, or using GNSS technology with a much higher number of point measurements, which is significantly more time consuming.

Fig. 4. Selected transverse profiles of erosion gully measured using GNSS technology from 2017–2021

Evaluation of the results of field measurements confirmed that the upper part of the erosion gully has a more complex shape, but no significant change occurs in its depth or shape due to the presence of abundant vegetation. In the middle part, slight changes in both horizontal and vertical direction were observed, with the most significant changes occurring in the profiles located in the lower part of the erosion gully, where siltation was expected. It is possible on the basis of long-term monitoring of the erosion gully to review current stabilisation measures as well as the possibility of implementing further protection and stabilisation measures to reduce erosion-transport and runoff processes in the area. Monitoring of the erosion gully is therefore justified and should be continued in the following period, also considering the possible impact of climate change in the form of more extreme torrential rainfall events. A more detailed measurement (e. g. by UAV or TLS technology) would be appropriate every 2–3 years in the spring period due to still undeveloped extensive vegetation, as was the case in 2014–2016. This would ensure evaluation of the position of bed line (the gully's axis), the gully's length, and its volume. Point measurements in the profiles in front of the wooden check dams and selected transverse profiles are sufficient once a year. On the other hand, there are several possibilities for field surveying, and it cannot be disregarded that spatial data obtained from Light Detection and Ranging (LIDAR), the Geodesy, Cartography and Cadastre Authority of the Slovak Republic (ÚGKK SR), are now publicly available, too. Data from this source could also be used for this type of task in the future, and it would be interesting to compare them with field measurements.
