# Impact of Teplice restoration on river basin runoff – preliminary results

ADAM BERAN

**Keywords:** catchment hydrology – restoration – evaporation – monitoring

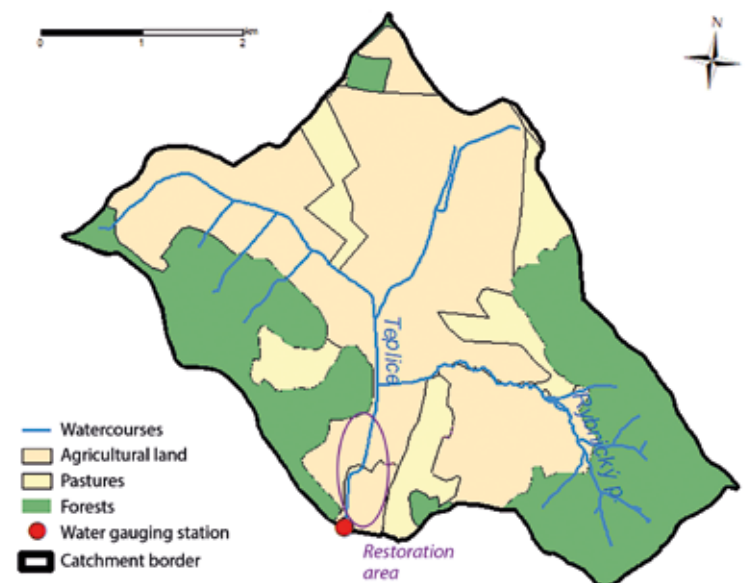
Fig. 1. Teplice catchment

The area of interest of the Teplice catchment (*Fig. 1*) is located in the White Carpathians PLA in the South Moravian region, in the eastern part of the Hodonín district. The closing profile with the water gauging station is located in Slovakia, 100 m from the state border with the Czech Republic. The altitude of the basin ranges from 340 to 631 m above sea level. Teplice springs south of the village of Kuželov near the Czech-Slovak state border. The two more significant left-hand tributaries in the basin are Javornický potok and Rybnický potok. Teplice, as Teplica, flows further through the territory of Slovakia and flows into the Myjava river near the village of Senica. It then

The area of the Teplice basin to the closing profile of the water gauging station is 17.57 km<sup>2</sup>. There are forests (6.05 km<sup>2</sup>), agricultural land (9.39 km<sup>2</sup>) and pastures (2.13 km<sup>2</sup>) in the catchment area.

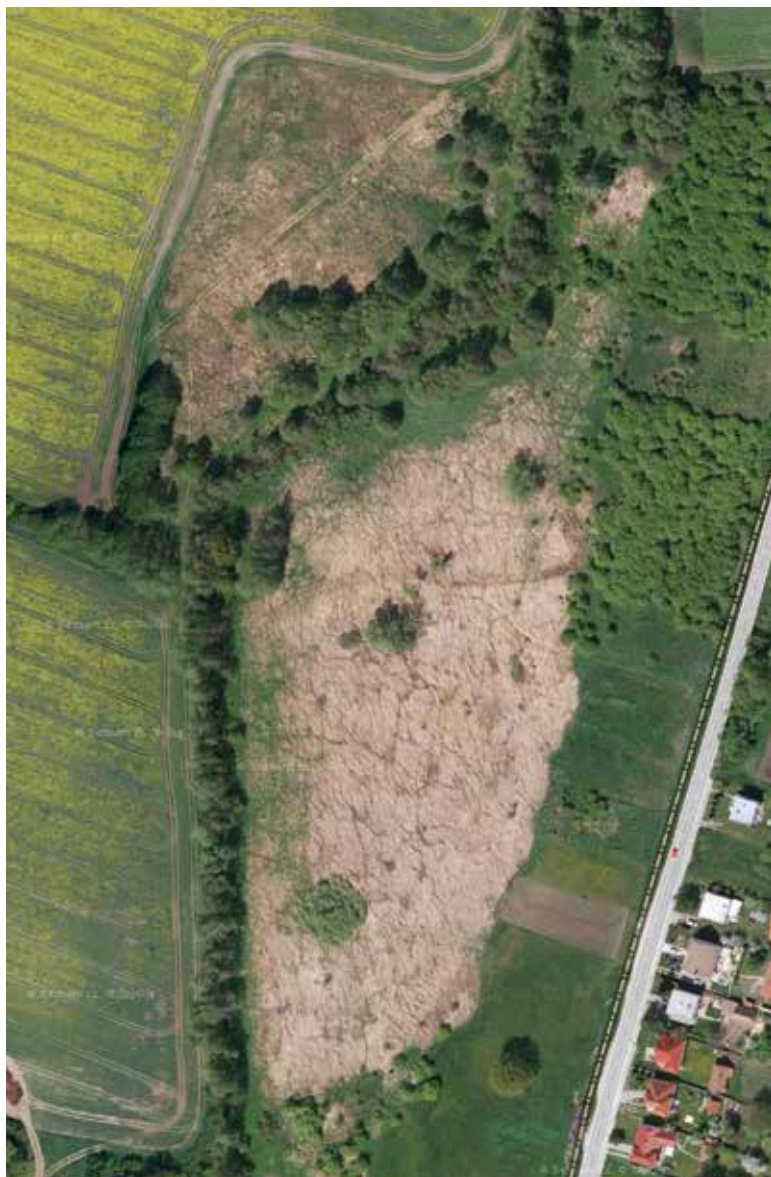
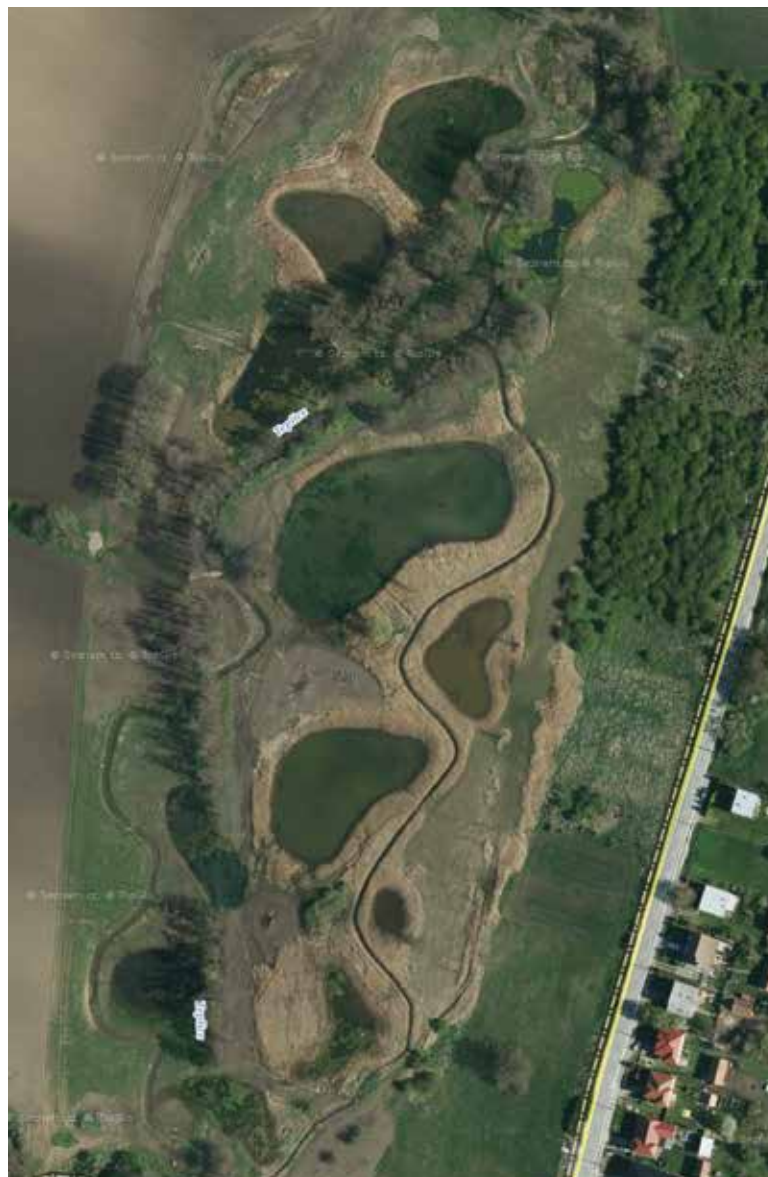
Fig 2. In the left is the area of interest before the implementation of the measure (2018), in the right after the completed revitalization ([www.mapy.cz](http://www.mapy.cz))

Fig. 2 shows a comparison of the morphology of the watercourse on ortho-photo maps from 2018 with the Teplice channel still straight, and from 2021, where the completed reopening of the Teplice channel in the landscape is supplemented by newly established water bodies. The photo in Fig. 3 comes from the time of implementation, while Fig. 4 documents the state after the completion of the restoration works..

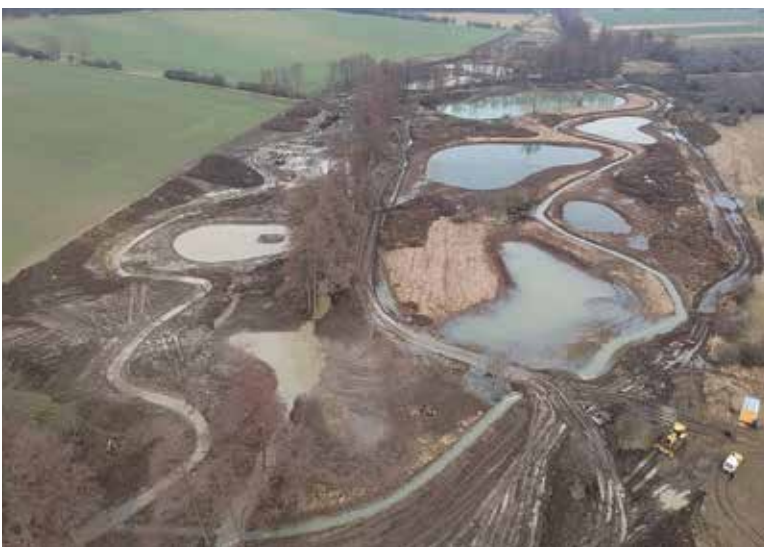
Fig. 3. Implementation of measures, 2020

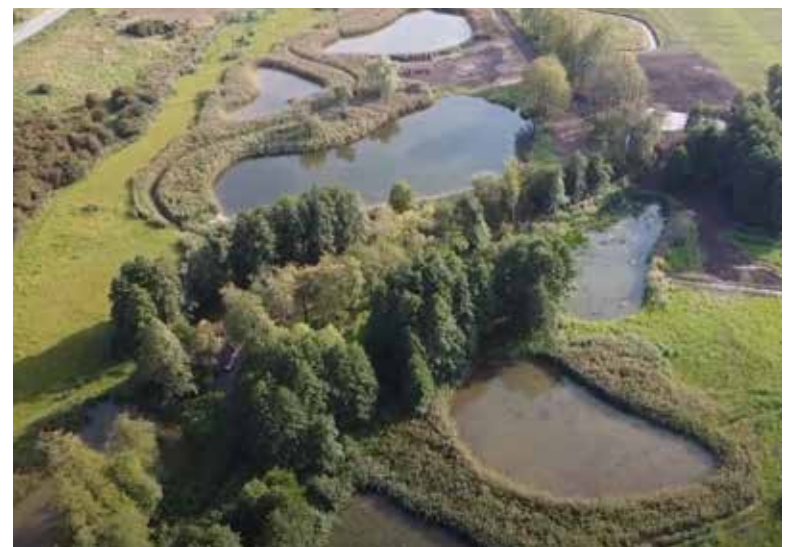
Fig. 4. Completed revitalization, 2021

The reopening of the watercourse took place on a 1.5 km long section of the previously straight channel, the length of which was extended to 2.6 km. The result of the restoration was pools with a surface area of approximately 25,000 m<sup>2</sup>. At an average air temperature of 21 °C in the summer months, about 140 m<sup>3</sup> of water evaporates from this area per day, which when converted corresponds to a flow rate of 1.6 l/s. However, this water loss is twice as high due to plant transpiration. It can therefore be said that the loss of water through evaporation from water bodies amounts to approximately 3 l/s on warm days. Due to the increase in the groundwater level in the restored section, it can be assumed that the entire area of the restored section (i.e., not only the water surface), and the extended channel of the watercourse can be included in the evaporation area. Based on the monitoring, an increase

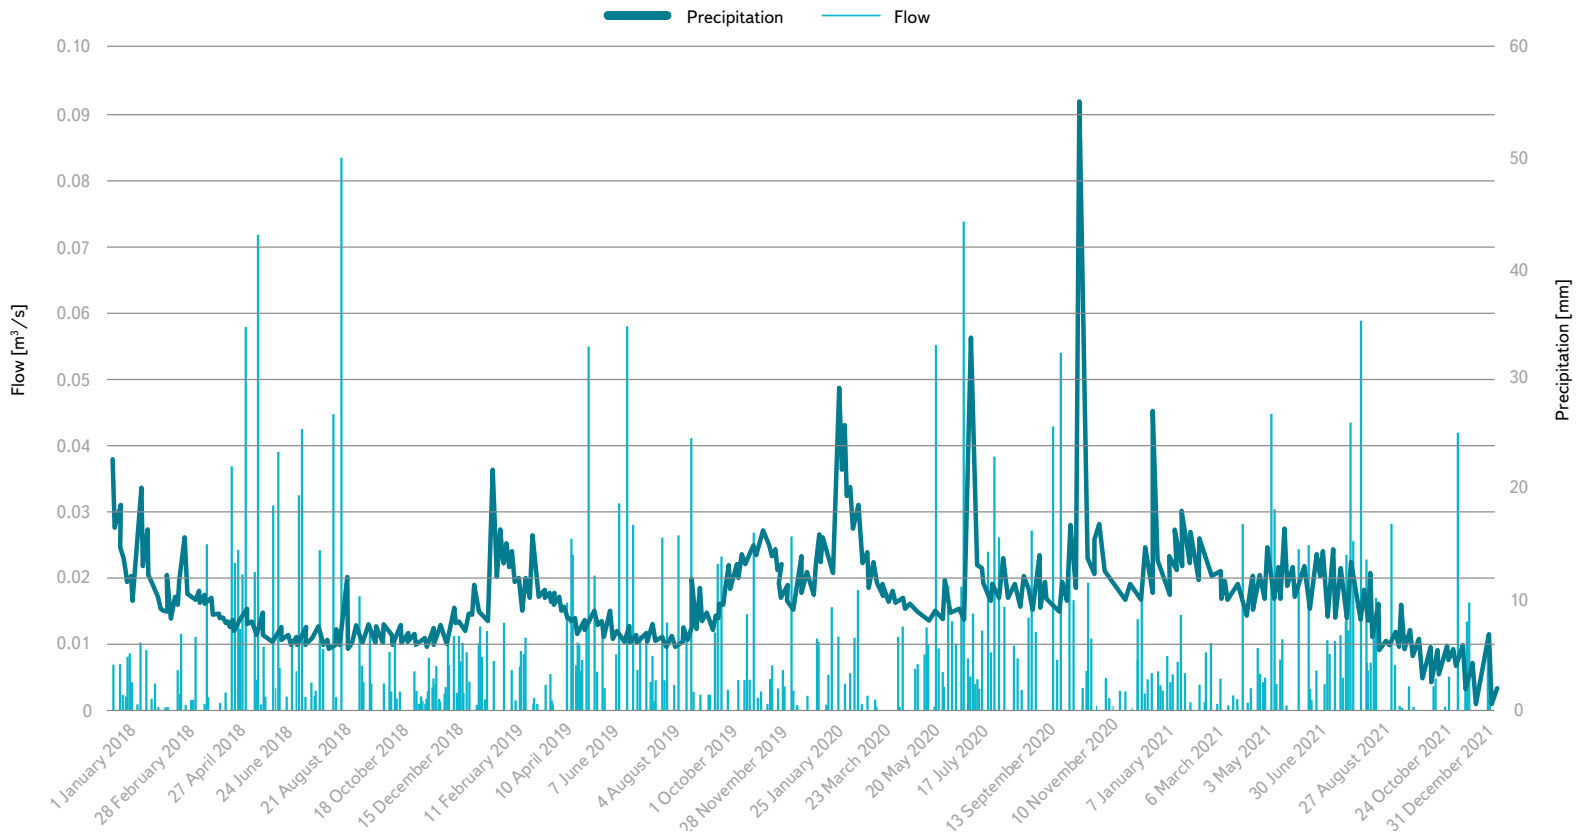
Fig. 5. Runoff and precipitation from 1 January 2018 to 31 December 2021

Fig. 5 shows a graph with the daily course of flows and precipitation totals from 1st January 2018 to 31st December 2021. Hydrological characteristics for the monitored period are shown in Tab. 1. The long-term mean precipitation total in 1961–1990 was 750 mm [6]. In 2018 and 2019, there was below-average precipitation of 612.8 mm and 661.9, respectively. 2020 was above average with 838.8 mm, while in 2021 the precipitation total was only 547.2 mm. The mean air temperature for the reference period 1961–1990 was 7.5 °C. In the monitored period, it was 11.24 °C (2018), 10.98 °C (2019), 10.52 °C (2020), and 9.68 °C (2021), with an average flow in the closing profile of 16, 4 l/s, and then 13.4 l/s in 2018, 115.4 l/s in 2019, and 19.3 in 2020. After the restoration, in 2021, the average annual flow in the closing profile reached a value of only 13.9 l/s.

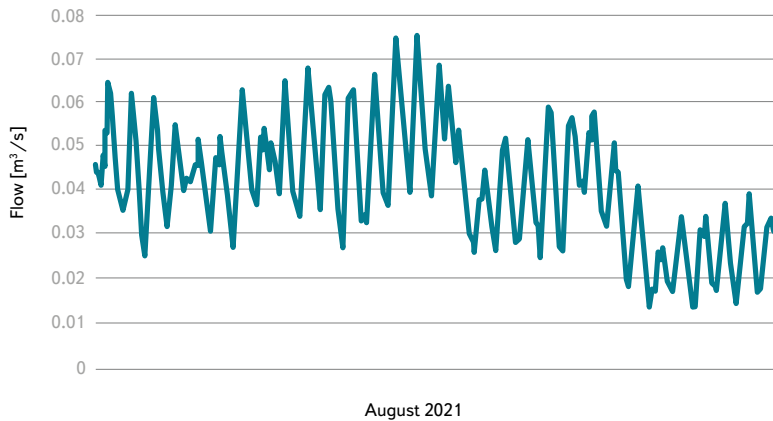
Fig. 6. Flow fluctuations after implementation of revitalization (sample data August 2021)

A detailed look at the daily course of the water flow through the closing profile (Fig. 6 and 7) shows a significant fluctuation during the day, which began to appear after the completion of the restoration. The highest flows occur

in the afternoon between 12:00 and 18:00 and the lowest in the morning between 2:00 and 8:00. These intraday differences amount to a maximum of 30 to 40 l/s.

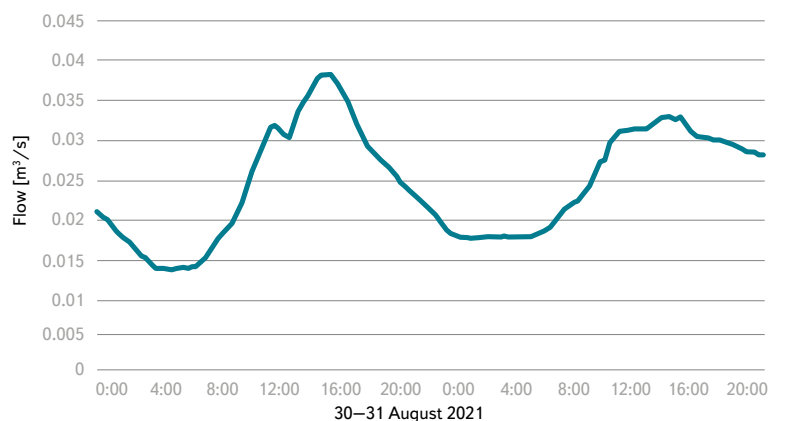
Fig. 7. Daily course of runoff (sample data – 30 August and 31 August 2021)
