Disappeared pond system in the lower Doubrava river

PAVEL RICHTER

ABSTRACT

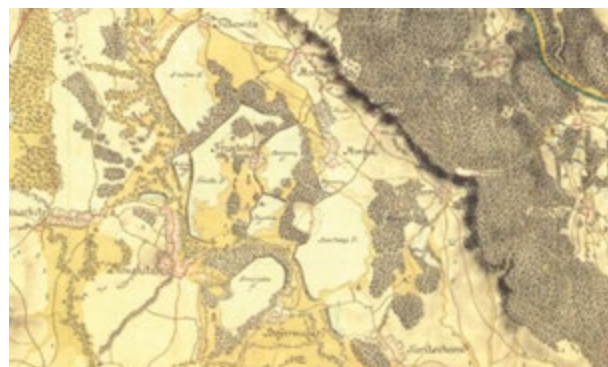
Fig. 1. Pond system in the lower Doubrava river, 1st military mapping

The pond system on the lower Doubrava river lay on the Čertovka watercourse and was fed by a system of canals from the Doubrava river. This system was recorded during the 1st military mapping, including the pond names. There were Bojmanský, Podolský, Bramborský, Horecký, Dvorský, Borecký, Taušek, Světlov, Babický, and Kmotrov ponds. There were also smaller ponds drawn without specifying their names: Koukalecký, and a pond in the village of Horka. On the left bank of the Doubrava river, there were Kravinec and Šibeniční ponds as well as a small pond near Žehušice chateau (Figs. 1 and 4).

mapping. Koukalecký pond is currently a rainwater pond and has no inflow or outflow, although the 1st military mapping shows an inflow and outflow into Podolský pond. The situation recorded in the 2nd military mapping shows Koukalecký pond as it is today, i.e. a rainwater pond (Figs. 1–4). Other water bodies in the studied area are not ponds; they have been created by sand mining or has concreted bottom.

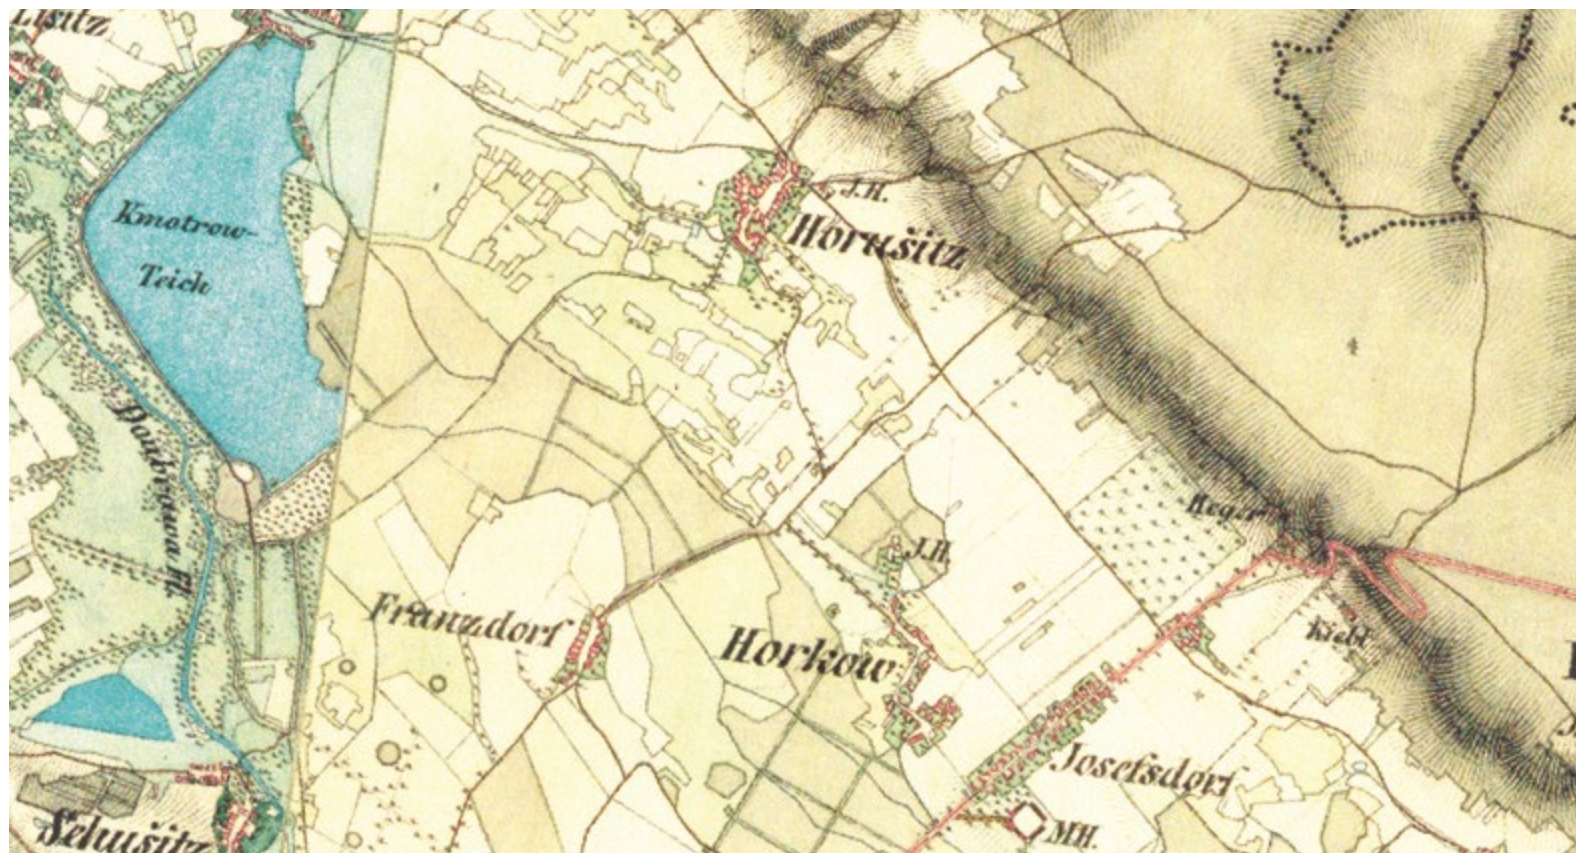
Fig. 2. Kmotrov and Šibeniční ponds in the area of the disappeared pond system on the lower Doubrava river, 2nd military mapping

On the map of the 2nd military mapping, only Kmotrov pond, Koukalecký pond and the pond in the village of Horka were shown in the pond system. On the left bank of the Doubrava river, Šibeniční pond remained on a significantly larger area, and the pond near Žehušice chateau (Figs. 2 and 4).

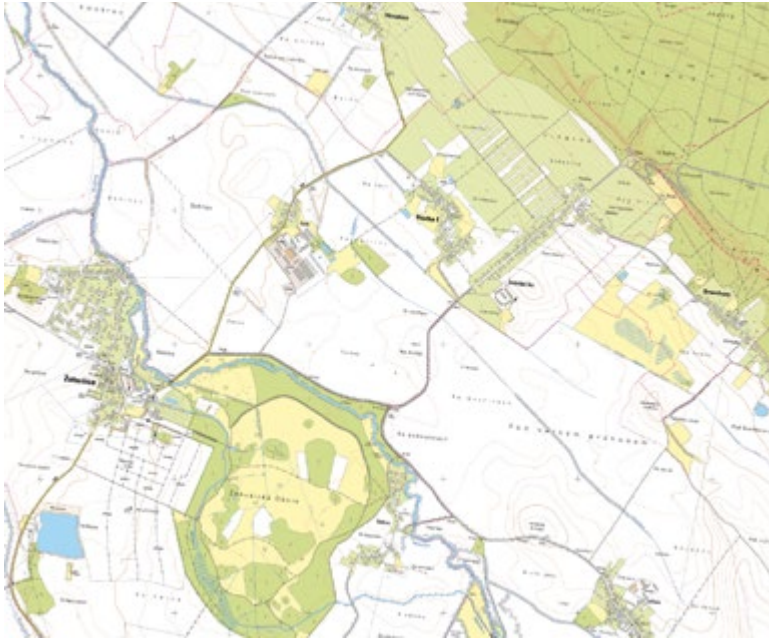
Fig. 3. Current state of the landscape around the disappeared pond system in the lower Doubrava river, current BM 10

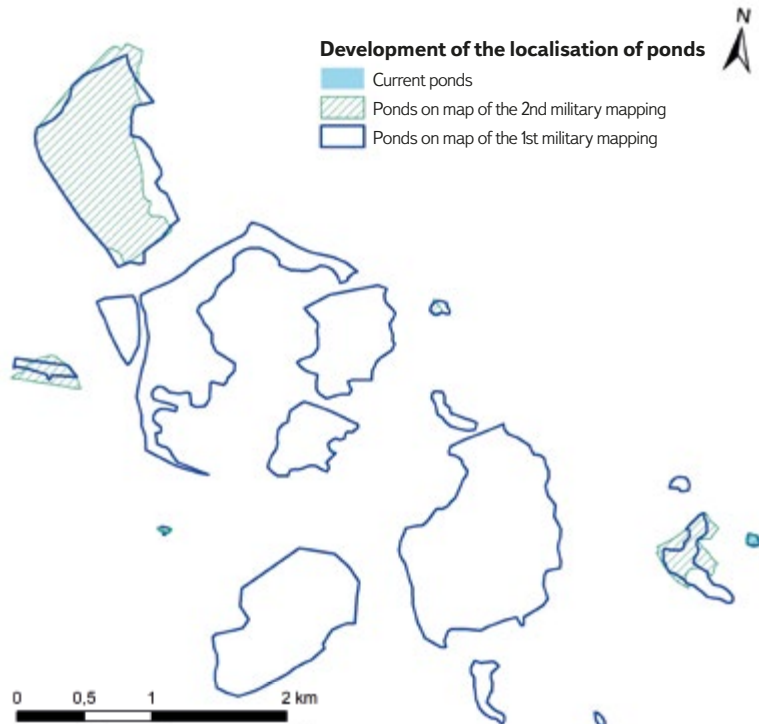
Fig. 4. Changes in the ponds on the lower Doubrava river, from 1st military mapping to the present

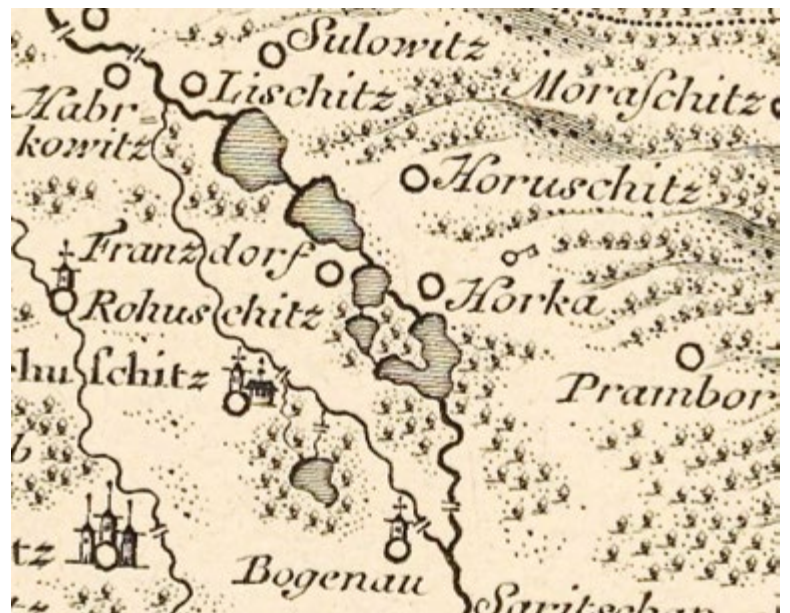
Fig. 5. Pond system on the lower Doubrava river, Müller's map of Bohemia

Müller's map of Bohemia shows a system of five ponds on the Čertovka. These are the Horecký, Borecký, Taušek, Světlov, and Kmotrov ponds. However, the situation on this map is different from the one from the 1st military mapping; the shape of Světlov and Horecký ponds is very different, and the location is not completely accurate. Also, the Čertovka watercourse is not recorded in full, but only the part located beyond the confluence with the channel that feeds the pond system. This part – including the canal – is drawn as the main watercourse and the Doubrava river is drawn with a faint line. On the left bank of the Doubrava river is shown Kravinec pond (Fig. 5).

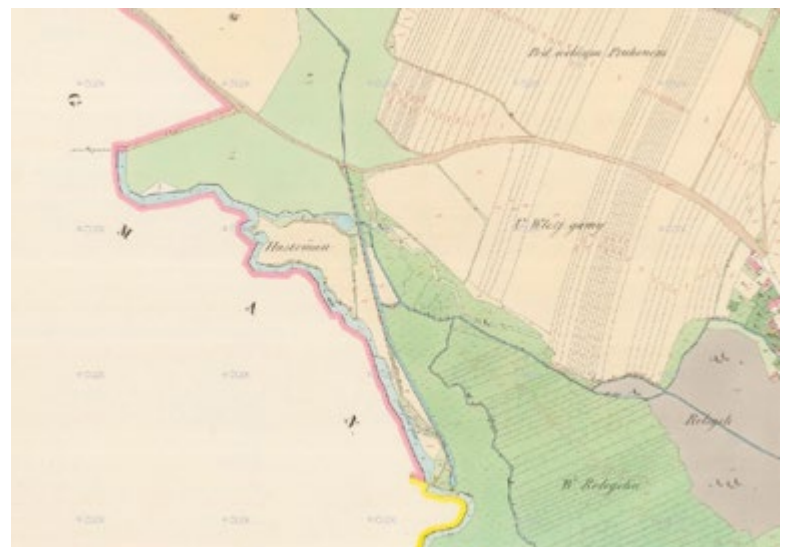
Fig. 6. The Hastman site on a Imperial Inprint of the Stable Cadastre

Figs. 6 and 7 compare the current and historical conditions in the Hastrman site behind Bojmaný weir, where the canal began which was used to supply the disappeared pond system, and now returns to the Doubrava river behind the weir. The Imperial Imprint of the Stable Cadastre still show a functional system of canals, although only Kmotrov and Horecký ponds were the only ponds preserved from the pond system shown on the 1st military mapping. Figs. 8 and 9 show the current state in this site, both the overflow for the canal in front of Bojmany weir and the preserved section of the canal for feeding the disappeared pond system, which flows into Starkočský stream.

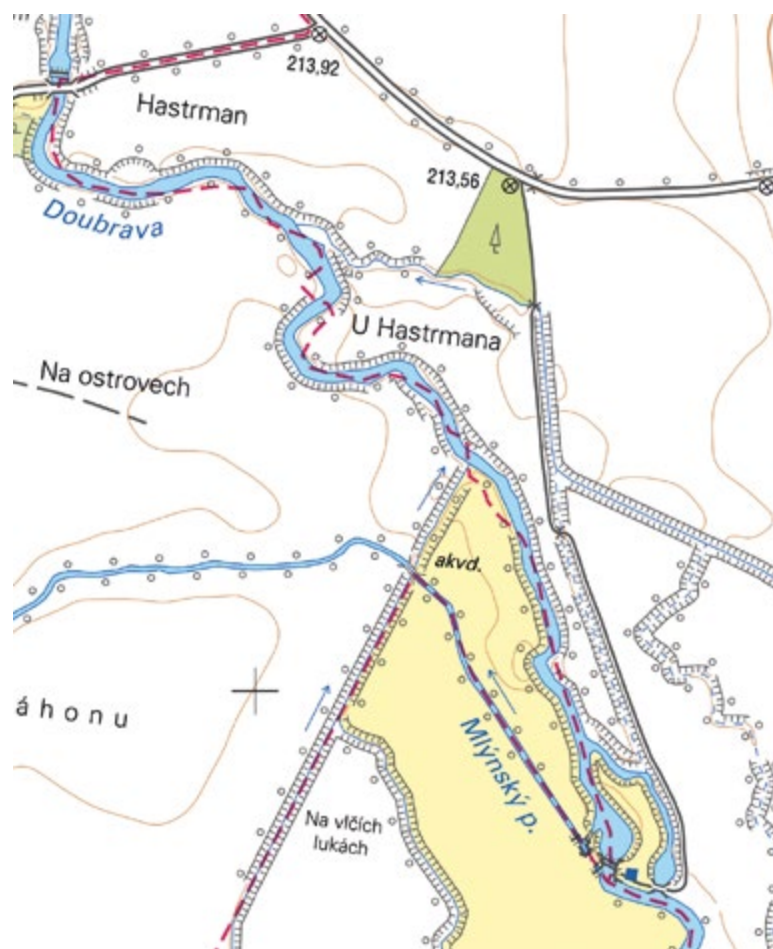
Fig. 7. The Hastrman site on current BM 10

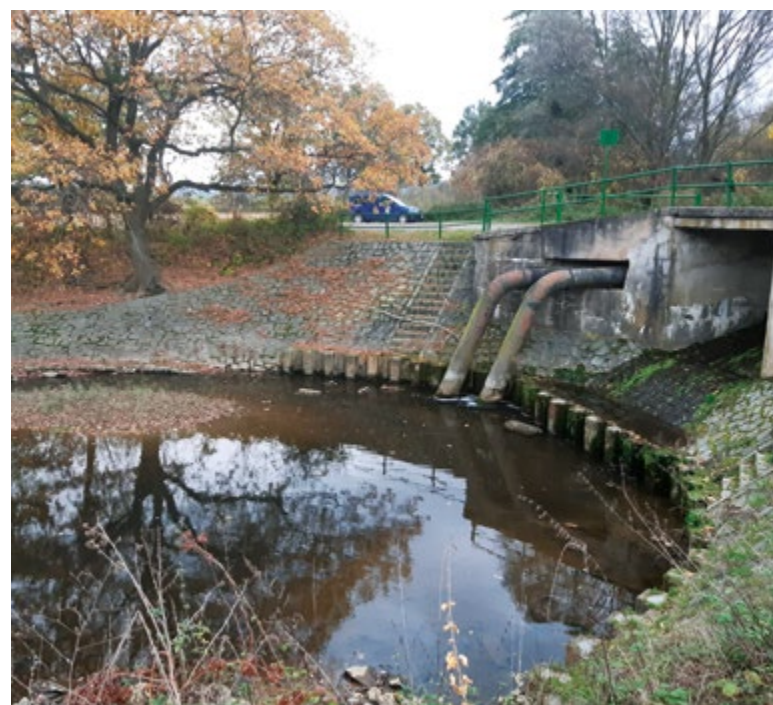
Fig. 8. Current situation below Bojmany weir at the spillway for the riverbed, which was used to supply the disappeared pond system and now returns behind the weir to the Doubrava river (November 2023)

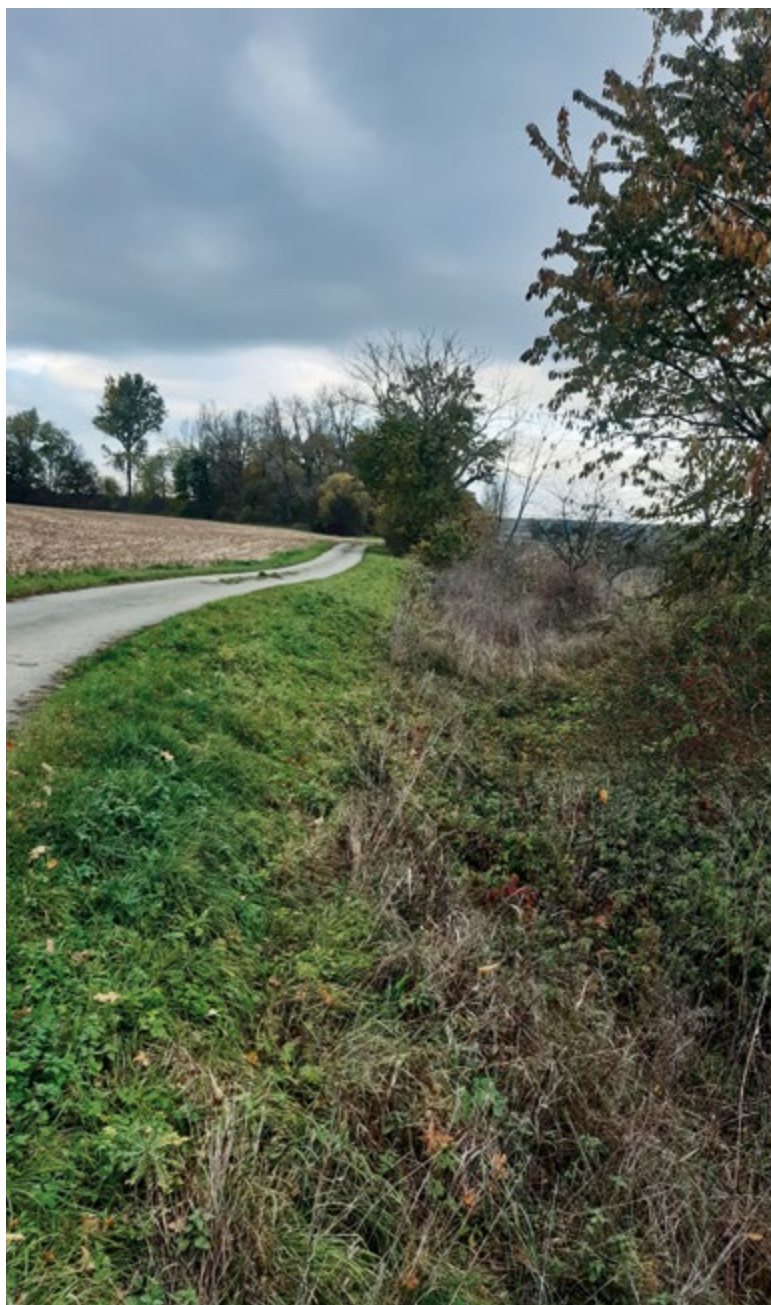
Fig. 9. A preserved riverbed section for the water supply of the disappeared pond system (November 2023), marked as an occasional flow on BM 10

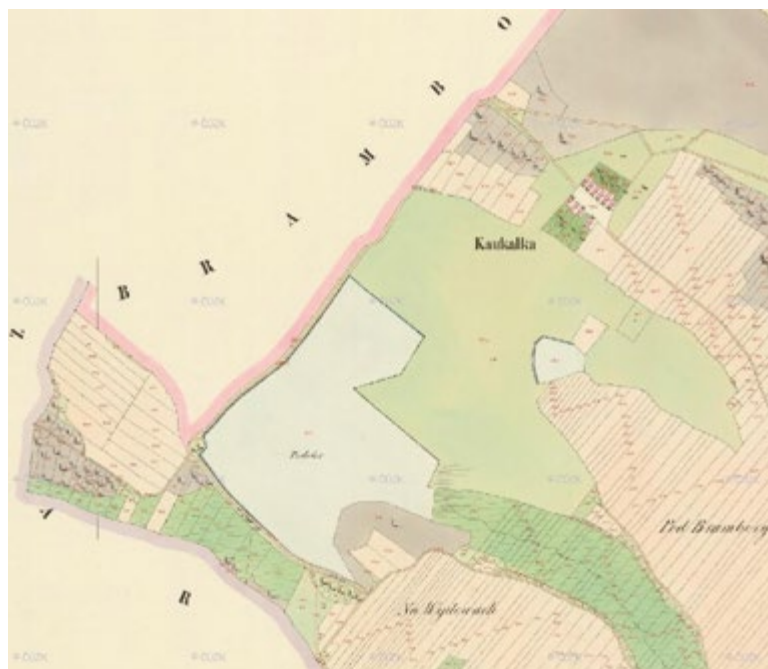
Fig. 10. Podolský and Koukalecký ponds on a Imperial Imprint of the Stable Cadastre

Fig. 10 shows the condition of Podolský and Koukalecký ponds, where it is already evident that Koukalecký pond has no inflow and outflow. The current state of Koukalecký pond is shown in Fig. 11. Furthermore, the current landscape in the site of the disappeared Horecký (Fig. 12) and Bramborský ponds (Fig. 13) is shown with successional vegetation including mature trees and reeds. A general view of the current landscape around Koukalecký pond and the disappeared Bramborský and Horecký ponds on the Orthophoto map of the Czech Republic reveals a waterlogged site at the area of the disappeared Horecký pond, and also wetland habitats near both disappeared ponds (Fig. 14).

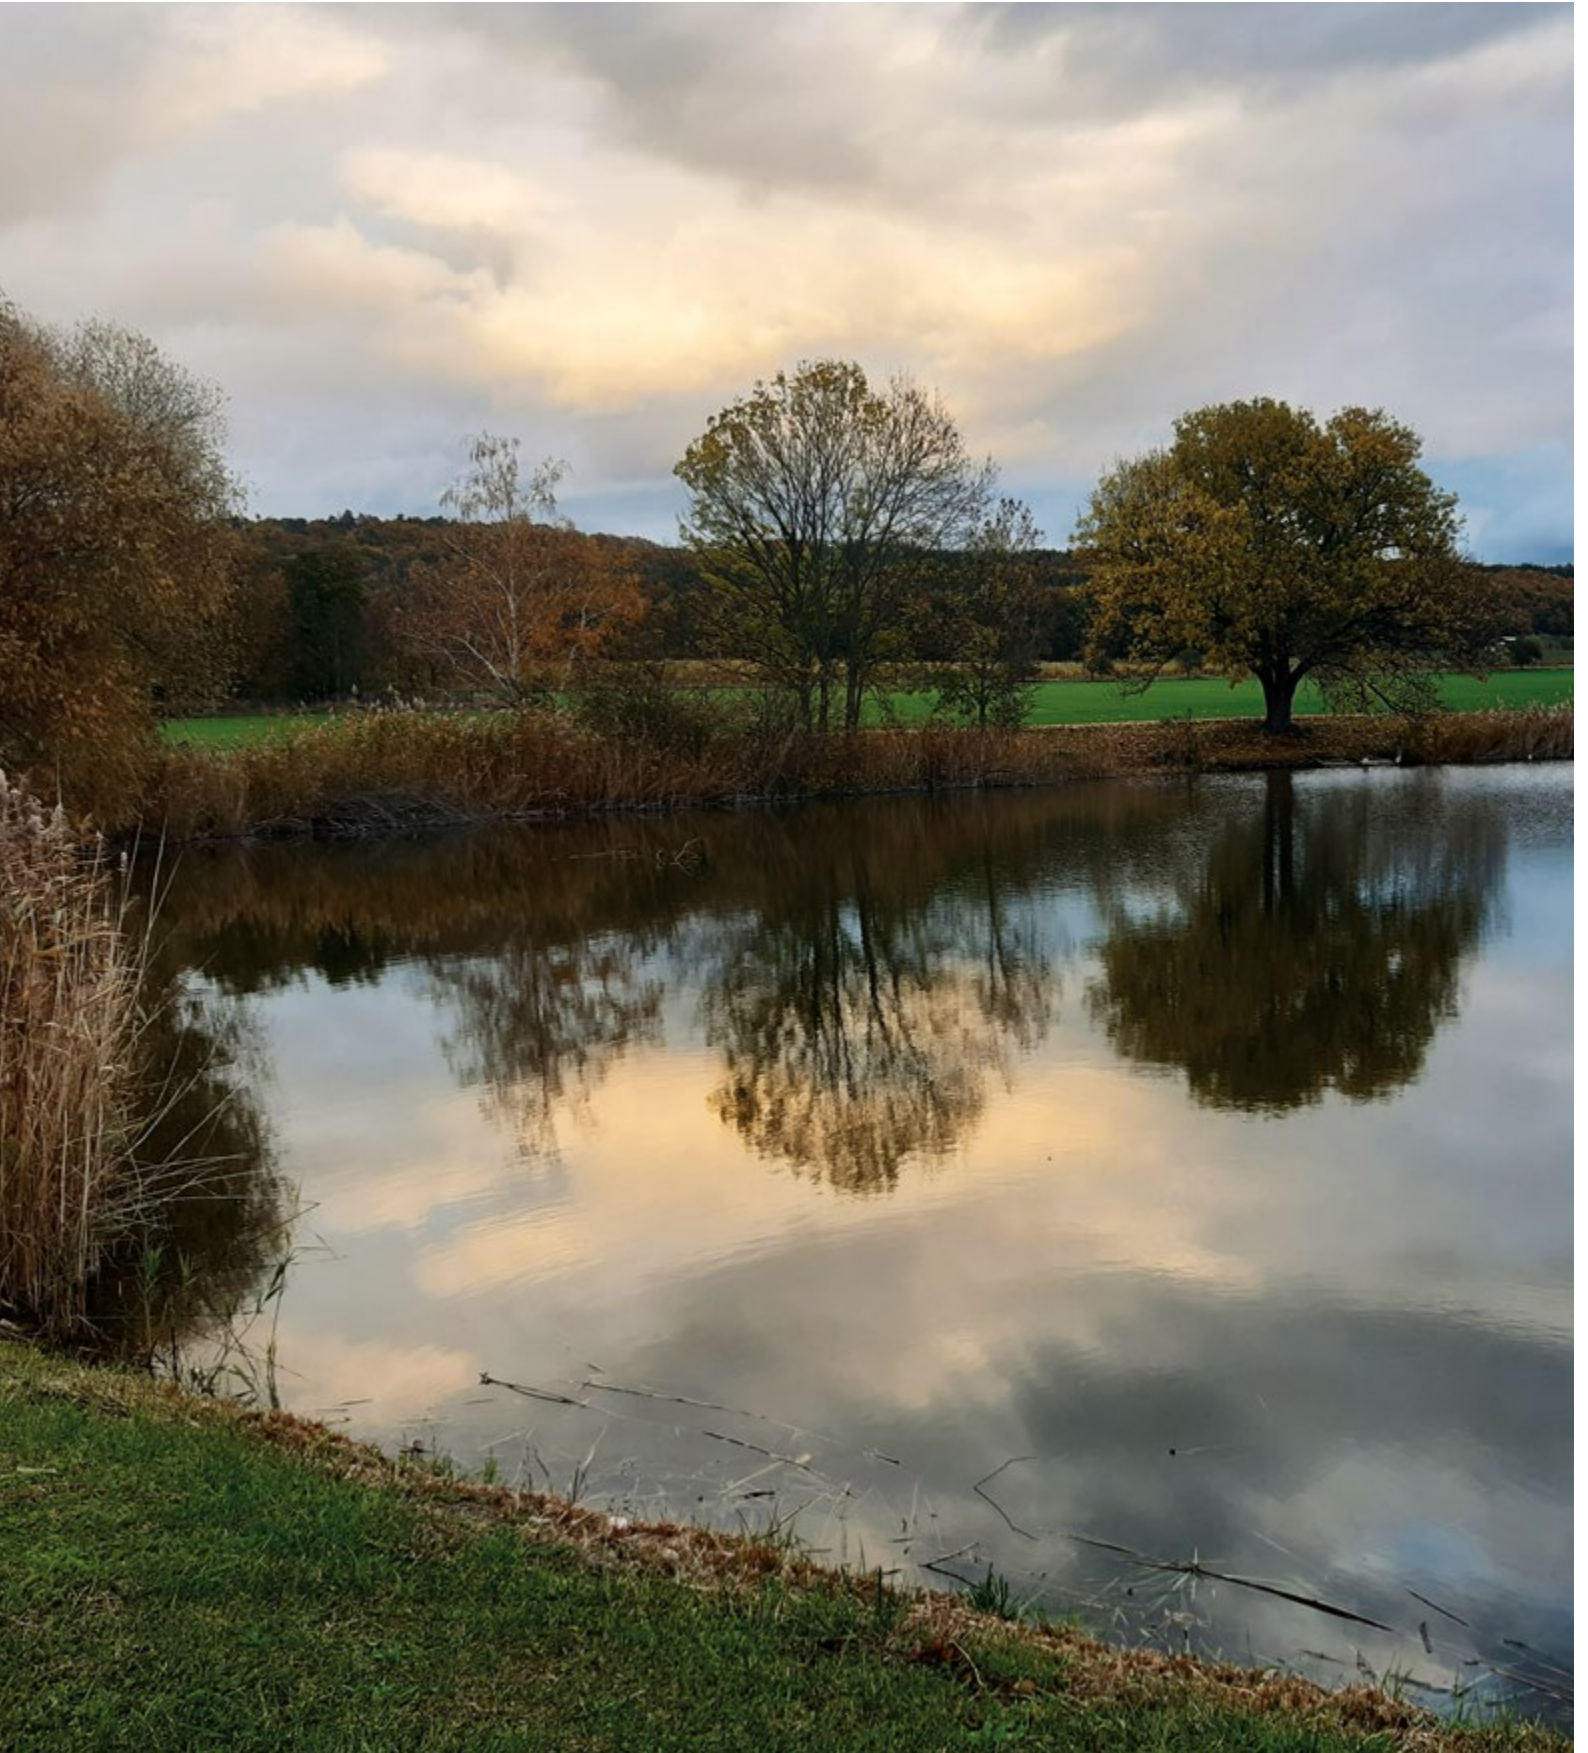
Fig. 11. Current state of Koukalecký pond (November 2023)

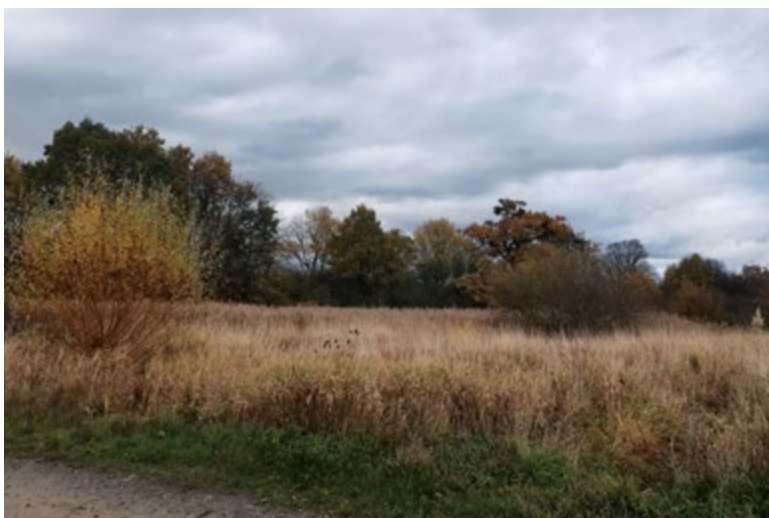
Fig. 12. Current state of the landscape at the site of the disappeared Horecký pond (November 2023)

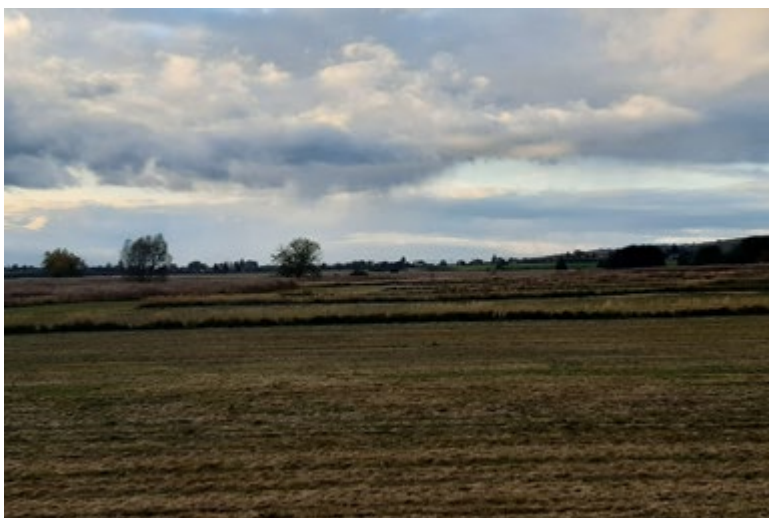
Fig. 13. Current state of the landscape at the site of the disappeared Bramborský pond (November 2023)

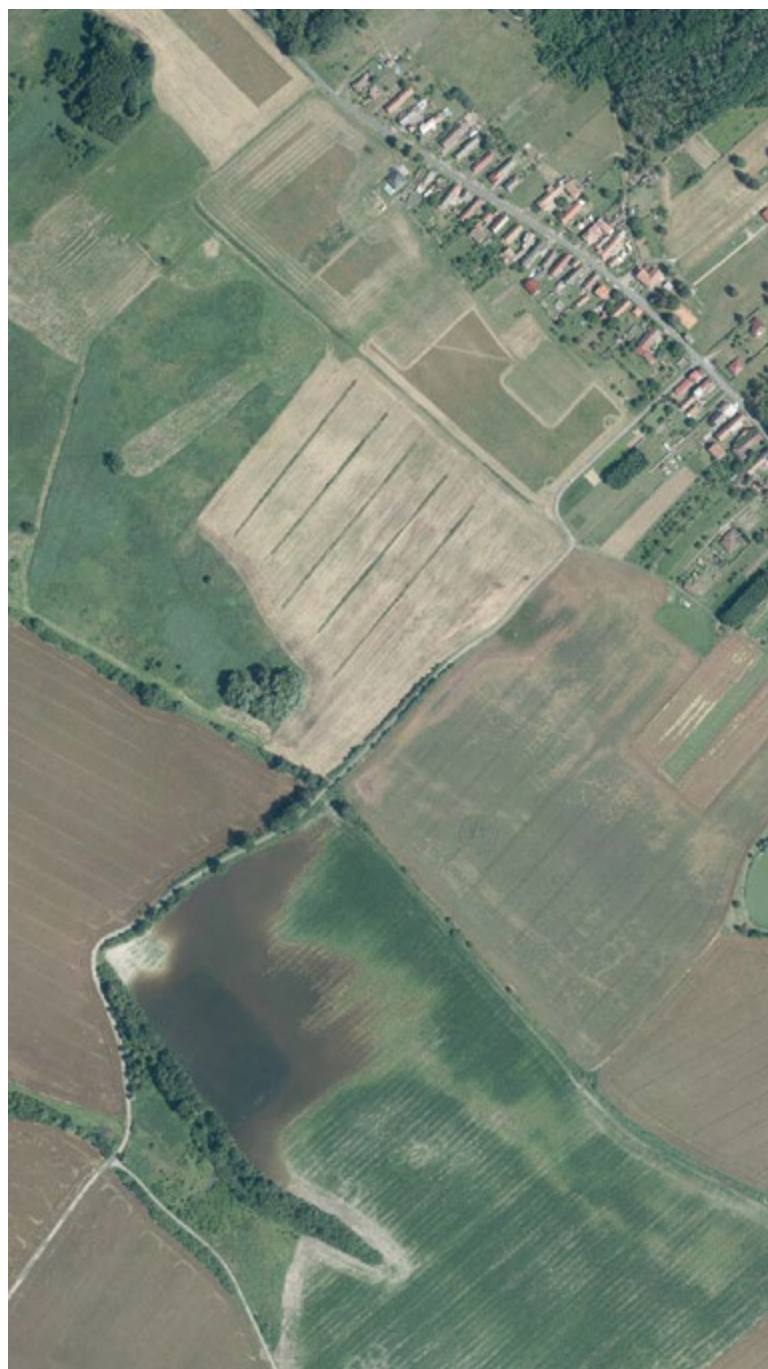
Fig. 14. Current state of the landscape at the site of Koukalecký pond and the disappeared Bramborský and Horecký ponds (waterlogged location in the lower part of the image), current Orthophoto map of the Czech Republic

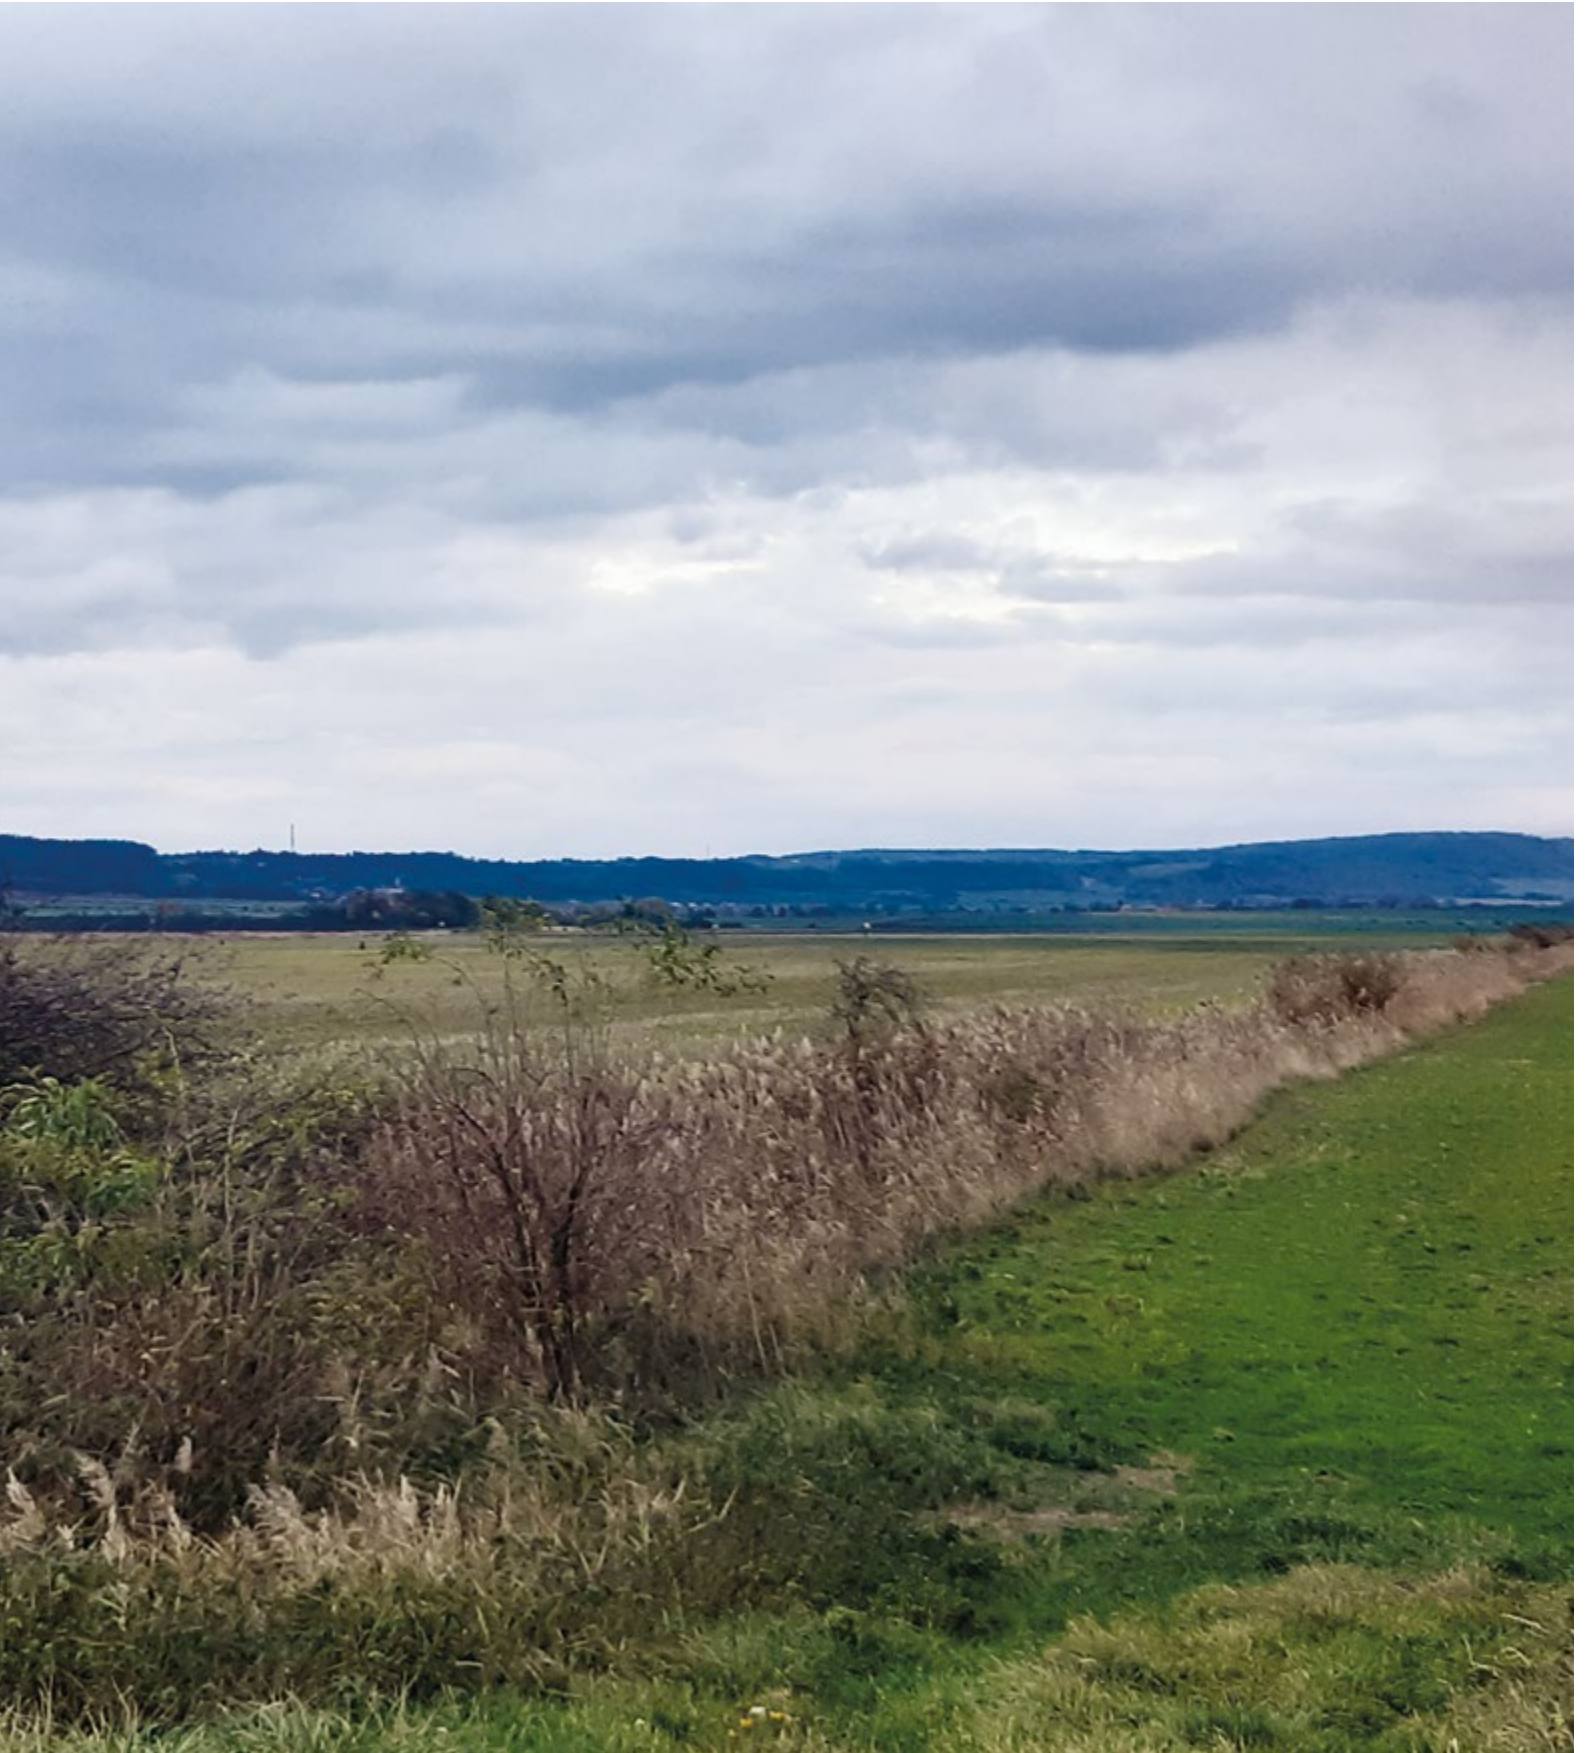
Fig. 15. Current state of the landscape including the Čertovka watercourse at the site of the disappeared Borecký pond (November 2023)

Fig. 15 shows the current state at the site of the disappeared Borecký pond, including the canalized watercourse Čertovka.
