Historical water reservoirs – splash dams in the Low Tatras (Slovakia)

JAKUB CIMBALA, PAVEL HRONČEK, BOHUSLAVA HRONČEKOVÁ GREGOROVÁ

Keywords: splash dams – historical water reservoirs – timber floating – 2nd Military Mapping – GIS analysis – Low Tatras

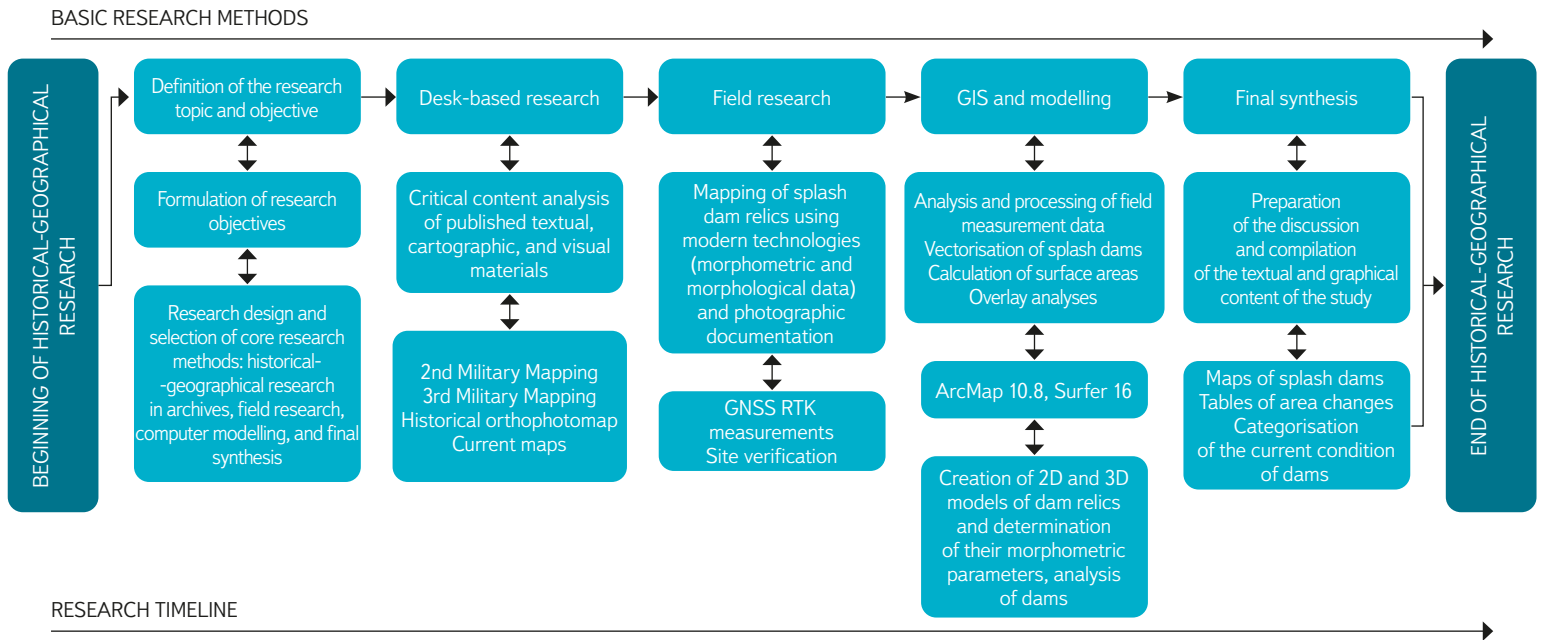
Fig. 1. Research workflow and data processing

The entire methodological procedure, the sequence of individual research steps and the methods used are shown in Fig. 1.

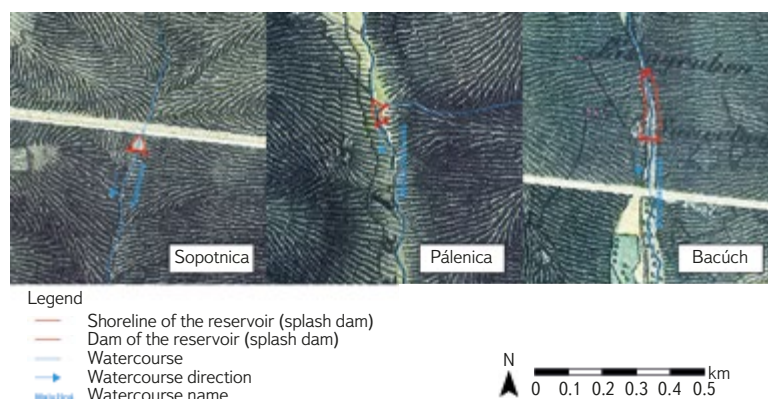
Fig. 4. Example of historical splash dams shown on the map of the 2nd Military Mapping in the Low Tatras (southern part) (1 : 10,000)

Georeferencing of maps and the determination of the “precise” location of splash dam embankments in maps also enables accurate location of their relics in the field. Through the analysis of map sheets of the 2nd Military Mapping, 13 historical water reservoirs were identified in the studied area of the Low Tatras (a 14th splash dam, Kremeniny, was verified on the basis of written sources), situated predominantly in the upper parts of mountain valleys on smaller watercourses. Their spatial distribution shows a clear association with areas of intensive historical timber extraction and favourable geomorphological conditions for damming watercourses (Figs. 3, 4).

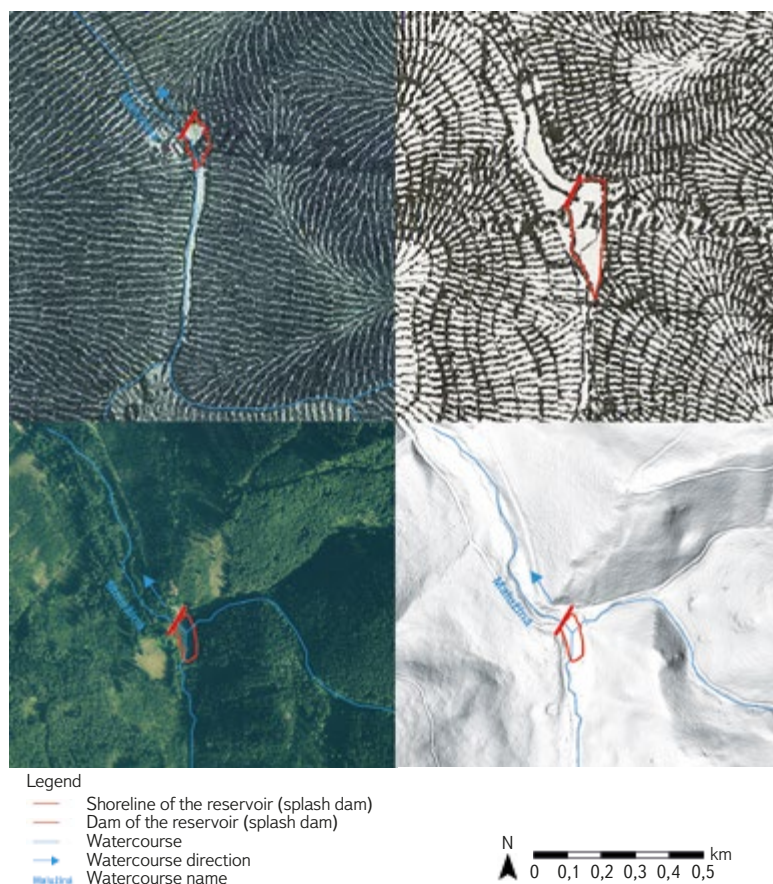
Fig. 5. Preserved water surface of the historical Malužiná splash dam in the northern Low Tatras (1 : 10,000)

Given the absence of textual archival sources, historical maps (Fig. 5) represent the primary relevant source for reconstructing the history of the Malužiná splash dam. The earliest record, noted with a delay of more than 130 years in the chronicle of the village of Malužiná, states that the splash dam was constructed in 1801. It was a wooden log dam built of spruce timber, as also documented by sources held in the Forestry and Timber Museum in Zvolen. An already existing splash dam is depicted on a map stored in the Hungarian National Archives in Budapest (S 11 – No. 636) from 1804, where a blue-coloured reservoir with a dam is shown without a name. The map of the 2nd Military Mapping from 1839 depicts the splash dam reservoir in blue and labels the site as *Na Teichu*. On the map of the 3rd Military Mapping from 1876, the site is labelled as *Klausa* and depicts a dam with a reservoir. It is highly probable that

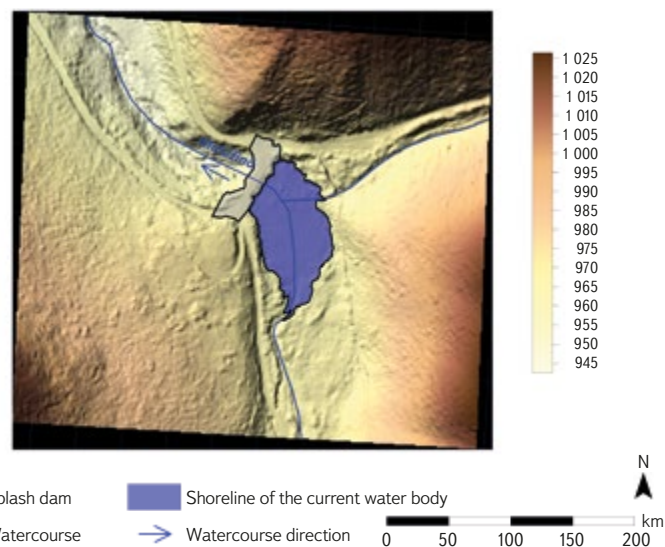
Fig. 6. Computer model of Malužiná splash dam based on field measurements

Based on additional field measurements and 3D modelling, the basic parameters of the relic of the original splash dam embankment are as follows. The width of the dam base is approximately 30 m, the maximum height reaches 8 m, and the crest length is 67.45 m. The volume of the reservoir could not be calculated due to its inundated state; its current surface area was estimated at approximately 0.25 ha, whereas according to the map of the 3rd Military Mapping, its area in the 1880s was 1.93 ha. The present surface area is determined by a temporary, rehabilitated spillway, as the original one is in a critical condition and non-functional. The original outlet adit, constructed in the centre of the earthfill dam from precisely worked travertine blocks and vaulted with a barrel vault, was approximately 22.5 m long (measurable part), 2.6 m wide and 2.5 m high.

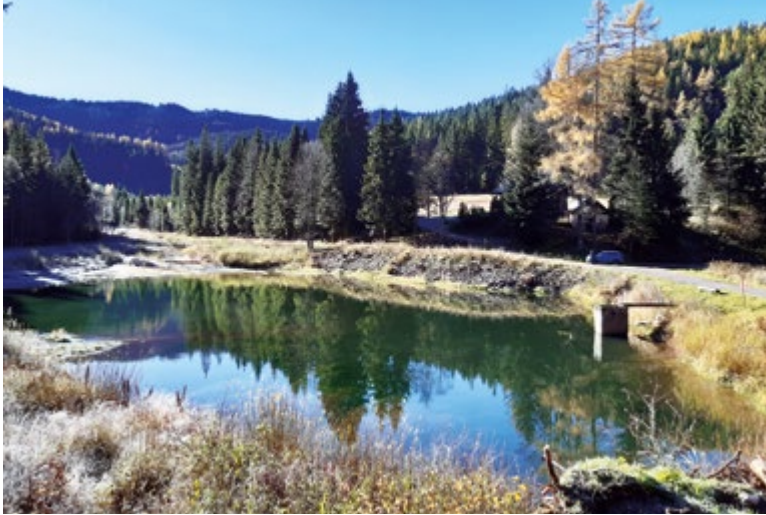
Fig. 7. Malužiná splash dam (right) and reservoir (view from the east), November 2025

The embankment of the **Malužiná splash dam** (Figs. 5–9) is located at river kilometre 8.06 of the Malužinský stream, in the headwaters of the valley of the same name on the northern slopes of the Low Tatras (cadastral area of Malužiná, Liptovský Mikuláš District). The Malužinský stream, which rises on the south-eastern slopes of Vrbovica (1,393.8 m a.s.l.) at an elevation of approximately 1,195 m a.s.l., is a fourth-order stream that flows into the Boca stream from the right at Malužiná at an elevation of approximately 738 m a.s.l. (the Boca stream flows from the left into the Váh river, which is a left-bank tributary of the Danube). The Malužinský stream has a snow–rain runoff regime and drains a catchment area of 4,465.9 ha.

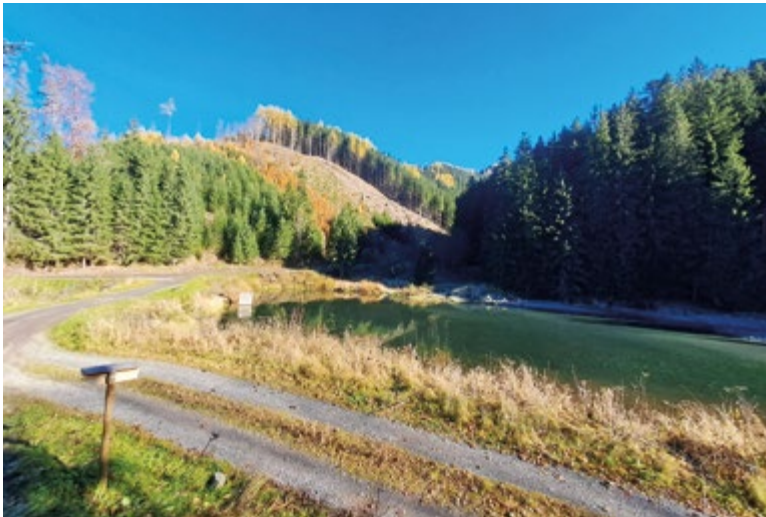
Fig. 8. Malužiná splash dam (left) and reservoir (view from the west), November 2025

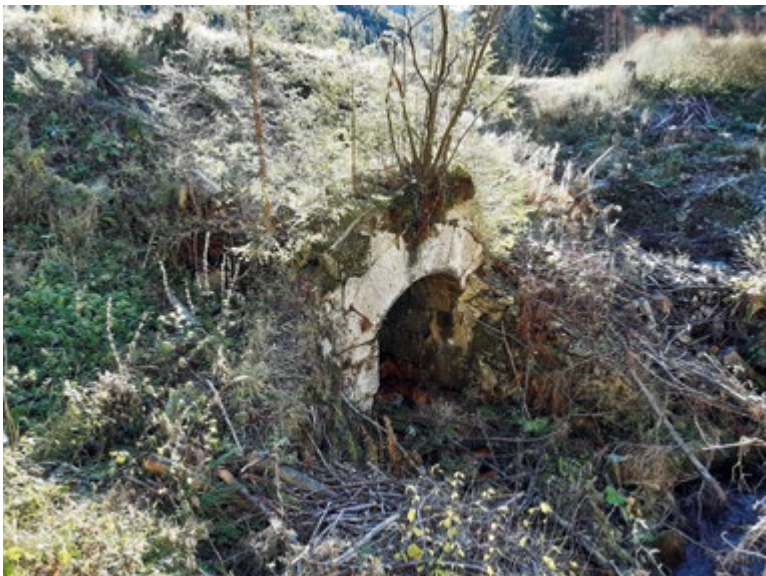
Fig. 9. Portal of a disused outlet gallery preserved in the embankment of Malužiná splash dam, November 2025

the original wooden dam was rebuilt and maintained several times until 1923, when it was reconstructed into an earthfill stone–earth dam, the relic of which is present in the landscape today. The maximum volume of the reservoir of the new splash dam, prior to sediment infilling, was 45,000 m³. The dam was constructed from material extracted in a quarry approximately 50 m in extent, opened directly near the dam crest on its right side. It ceased to serve its original purpose in 1930, when a forest railway was put into operation in the Malužinský stream valley.

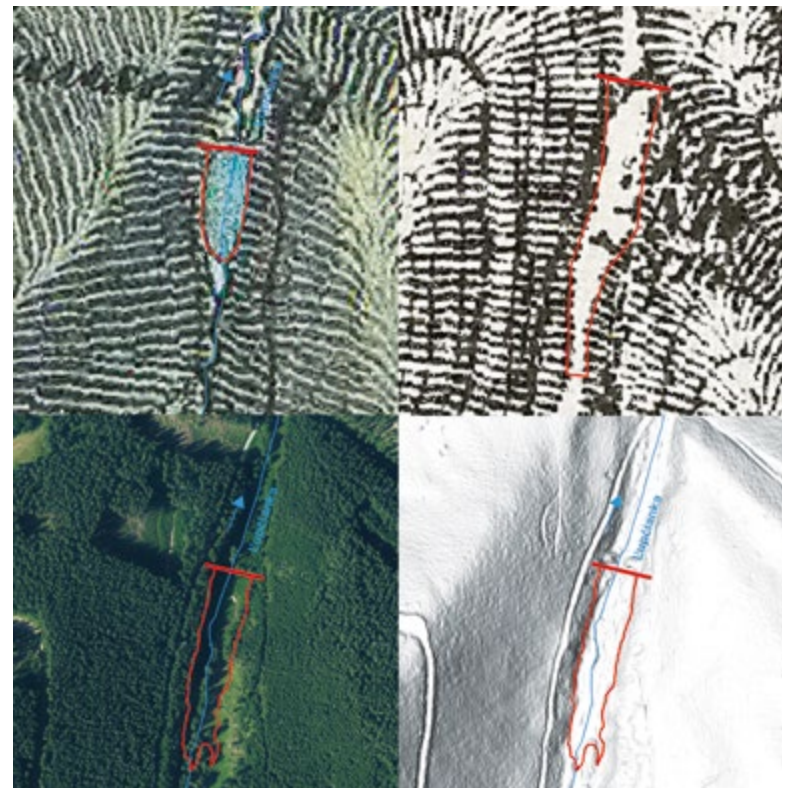
Fig. 10. Indications of the historical Magurka splash dam, still identifiable despite the disappearance of the reservoir (1 : 5,000)

Just like in the previous splash dam, the main historical sources for the study of the Magurka splash dam are historical maps. Written sources document the construction of a wooden–earth dam as late as 1819, intended for the annual floating of timber to Partizánska Ľupča. Relics have been preserved approximately 5 m below the existing stone dam on both sides of the wooden chute. The original log structure had a base thickness of approximately 20 m, a length of about 45 m, and its height can be estimated at around 8 m. This reservoir is first depicted on the analysed maps of the 2nd Military Mapping from 1845, where it is shown as a blue-coloured lake and labelled *Klause*. On the map of the 3rd Military Mapping from 1876, the site is depicted and labelled *Klause*, and the site in which it is situated is named *Na Teichu*. The splash dam was maintained and probably served its purpose until the beginning of the 20th century, as in 1911 the Forest Cooperative in Nemecká (now Partizánska) Ľupča constructed the present dam. By 1938, historical maps already depict the site without a reservoir and refer to it using *Tajch* Slovak nomenclature. That the splash dam was most likely no longer in operation at the turn of the 1930s and 1940s is also evidenced by a record in the municipal chronicle of Partizánska Ľupča, which states that timber from the Teich was already being transported by horse-drawn wagons. On maps produced after 1955, only the dam is shown, without a reservoir.

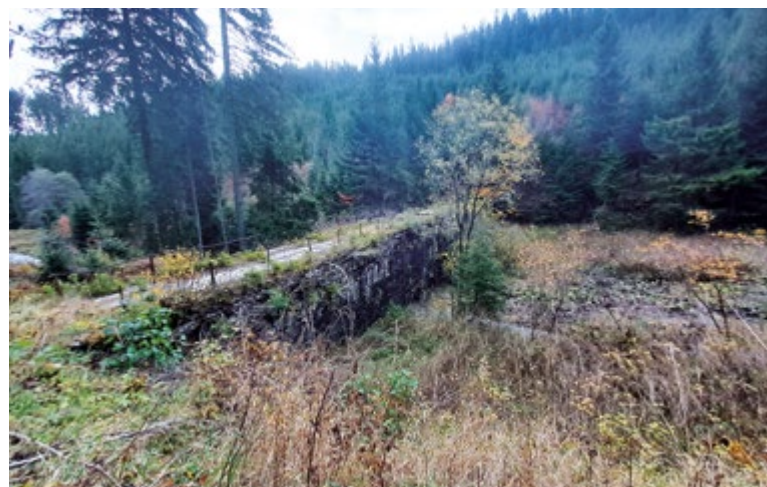
Fig. 13. Upstream slope of Magurka splash dam, November 2025

Based on field measurements and 3D modelling, the basic parameters of the relic of the dam and the original splash dam are as follows. The width of the dam base is 11.27 m, the height 9.9 m, and the length 54.3562 m. The volume of the reservoir was 38,833.3 m³ and its surface area 10,743 m². According to the map of the 2nd Military Mapping from the mid-19th century, its area was 0.72 ha, and according to the 3rd Military Mapping from the 1880s, 1.87 ha. The dam wall is constructed of quarry stone, with the crest reinforced by a concrete slab. In its lower central part, the dam contains two outlet openings vaulted with segmental arches, while in the central upper part there is a spillway. To prevent back erosion below the outlet openings, the stream bed is lined with wooden beams and its banks are reinforced with retaining walls over a length of approximately 30 m. In the centre of the dam, there was a wooden shelter housing the technical equipment used for opening the outlet gates.

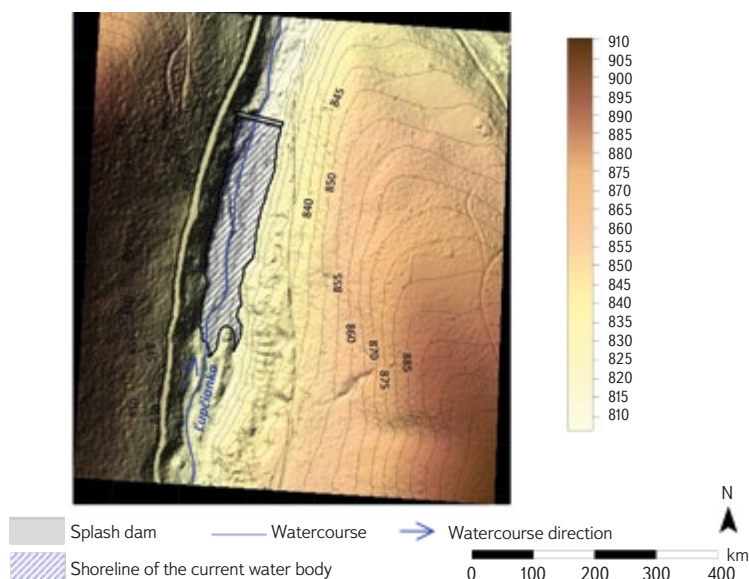
Fig. 11. Computer model of Magurka splash dam based on field measurements

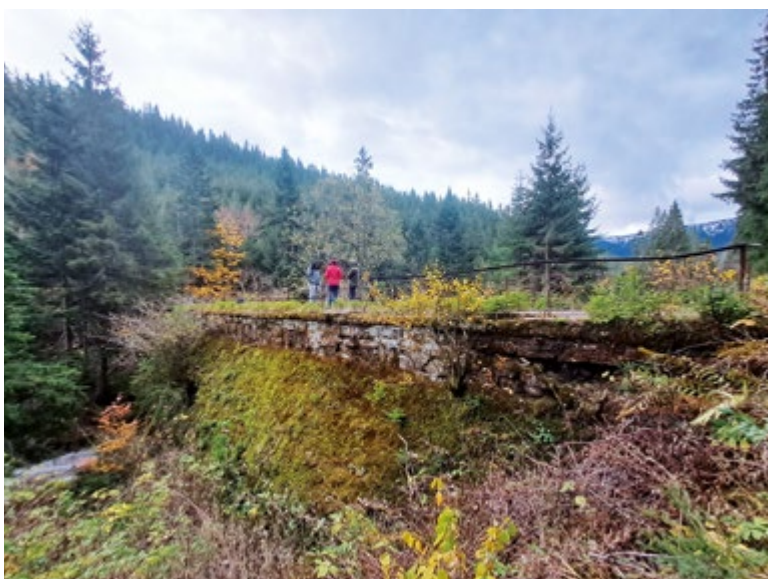
Fig. 12. Downstream slope of Magurka splash dam, November 2025

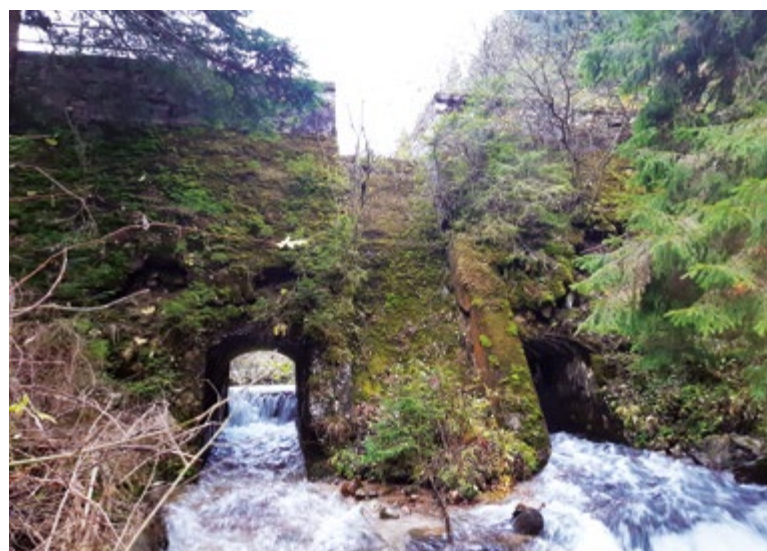
Fig. 14. Relics of outlet galleries of Magurka splash dam, November 2025
