Landscape changes in the upper part of the Výrovka river basin from a water management perspective

PAVEL RICHTER

ABSTRACT

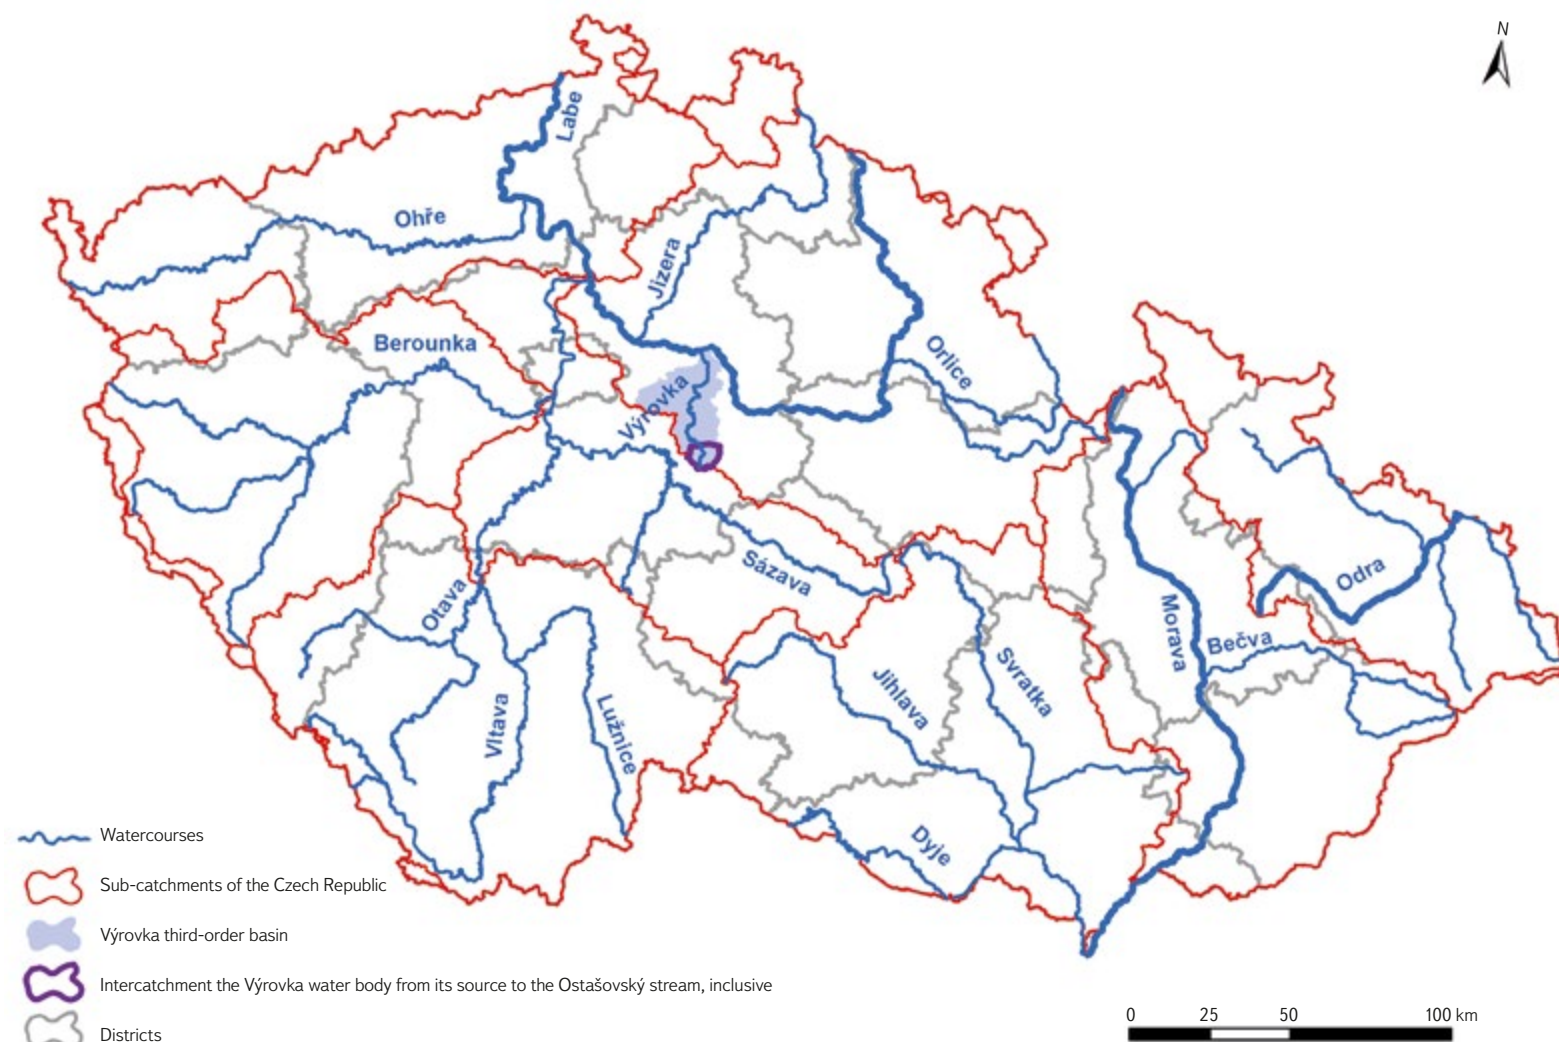
Fig. 1. The study area in the context of hydrological and administrative divisions

From an administrative perspective, the intercatchment of the water body is located in Central Bohemian Region (*Fig. 1*) predominantly within Kutná Hora District (cadastral areas Bláto, Chmeliště, Janovická Lhota, Jindice, Kochánov u Mitrova, Křečovice u Onomyšle, Mančice u Rašovic, Miletín u Onomyšle, Mitrov u Uhlířských Janovic, Nepoměřice, Onomyšl, Opatovice II, Rašovice u Uhlířských Janovic, Rozkoš u Onomyšle, Staňkovice u Uhlířských Janovic, Sudějov, Uhlířské Janovice, Vavřínek, Žandov, Žišov, and tiny parts of cadastral areas Smilovice u Staňkovic and Staré Nespěřice), and to a small extent in Kolín District (cadastral areas Církvice u Kolína, and Skvrňov) [2, 3]. The water body itself flows through cadastral areas Kochánov u Mitrova, Janovická Lhota, Uhlířské Janovice, Chmeliště, Žišov, and Vavřínek (*Figs. 2 and 3*).

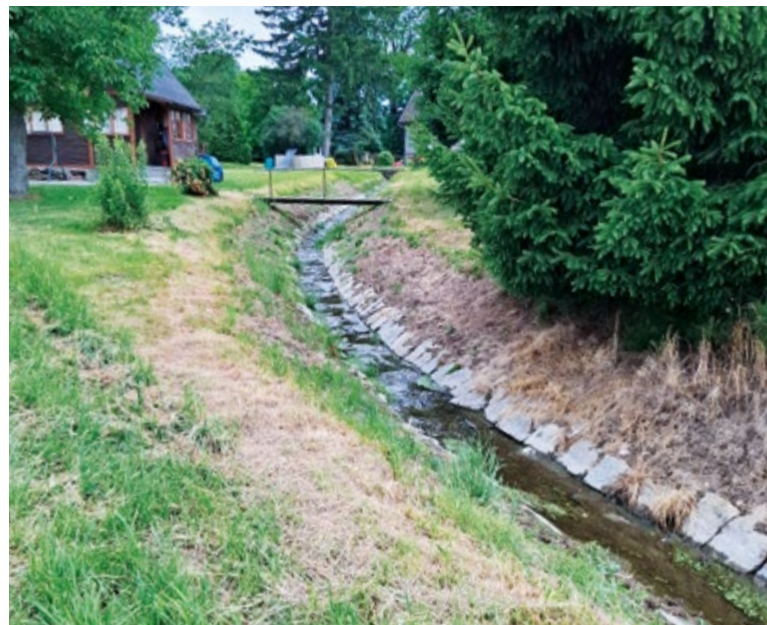
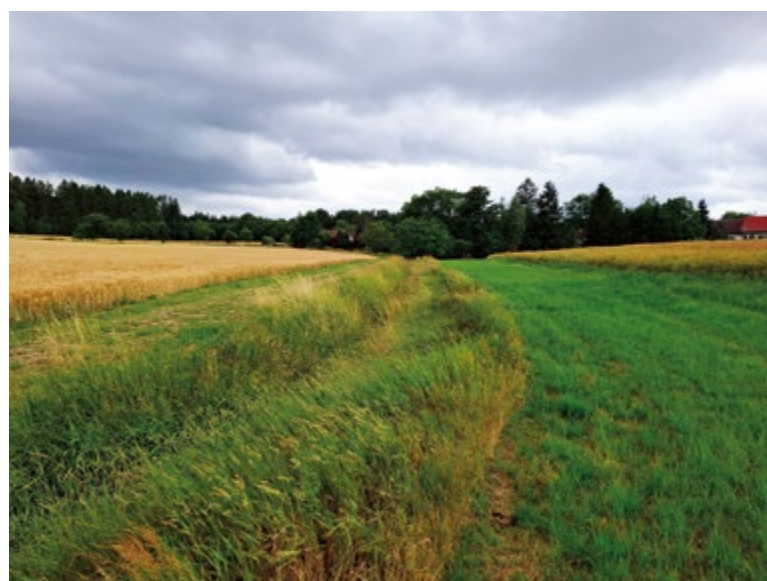
Fig. 5a, b. Current state of the landscape in the Východní ústí Vávřínský náhon spring area (July 2025)

Fig. 4 shows the development of the landscape in the Výrovka source area from the mid-nineteenth century through the 1950s to the present. In the source area at Kochánov, a small water reservoir is currently designated as the source, from which the Výrovka flows out through a paved channel (Fig. 5a, b). The watercourse then continues in a straightened, overgrown channel through three smaller ponds (Figs. 3 and 6), the last of which (Bohr pond) has a dam located 2 km downstream from the Výrovka source. Fig. 7 documents the current state of the landscape in this area.

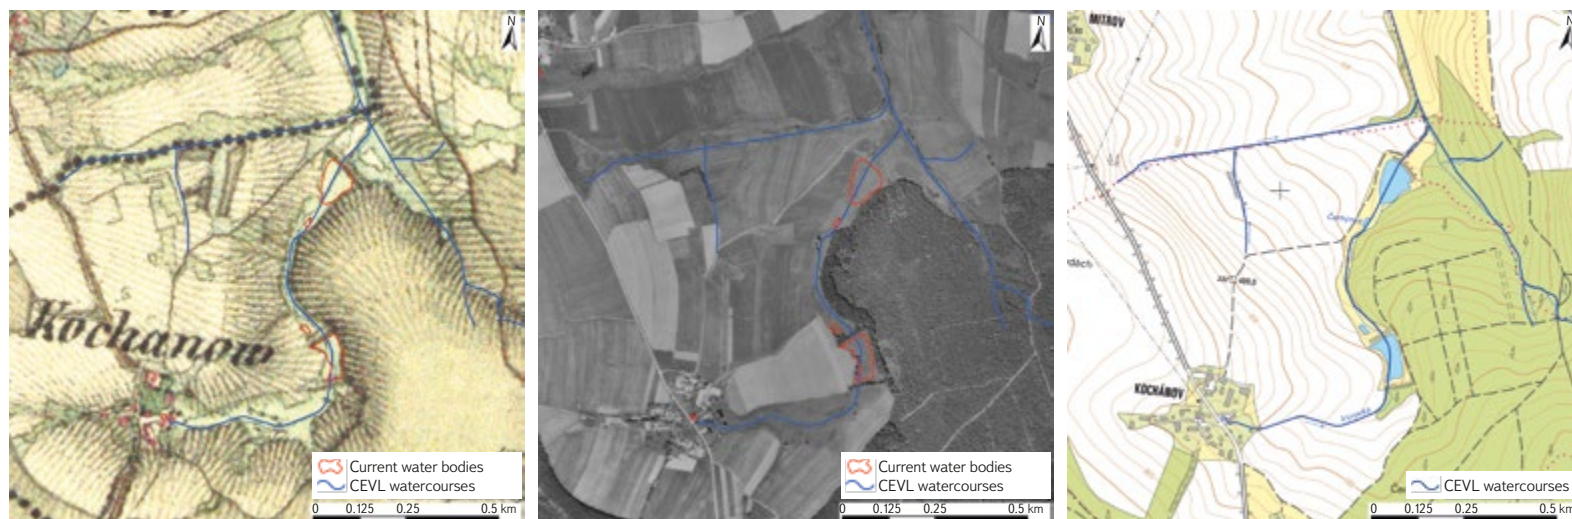
Fig. 4. Landscape changes in the Východní ústí Vávřínský náhon spring area, based on the 2nd Military Mapping (1852), historical orthophotomaps from the 1950s, and BTM 10 (2024)

However, on the map of the 1st Military Mapping, ponds near Kochánov were located in similar places to those today (Figs. 4 and 15), but that time the watercourses meandered and were surrounded by floodplain meadows, and climatic conditions were also different from those today. The situation recorded on the 1st Military Mapping along the Výrovka in the area of Uhlířské Janovice shows more water bodies/ponds than the 2nd Military Mapping (Figs. 3 and 16). Here, near the former Lucký mill (if we can rely on the not entirely accurate depiction of the landscape), it appears that between the two military surveys, the watercourses within the floodplain at the confluence of the Výrovka and Anenský stream were modified (Figs. 9, 10, and 16).

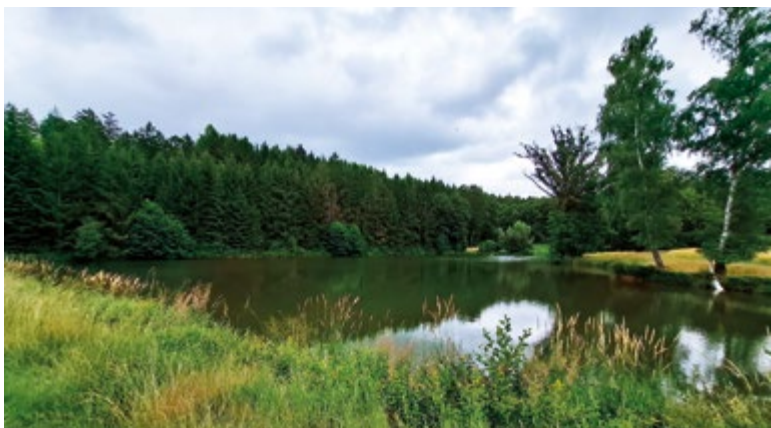
Fig. 6. The first pond on the Výrovka (July 2025)

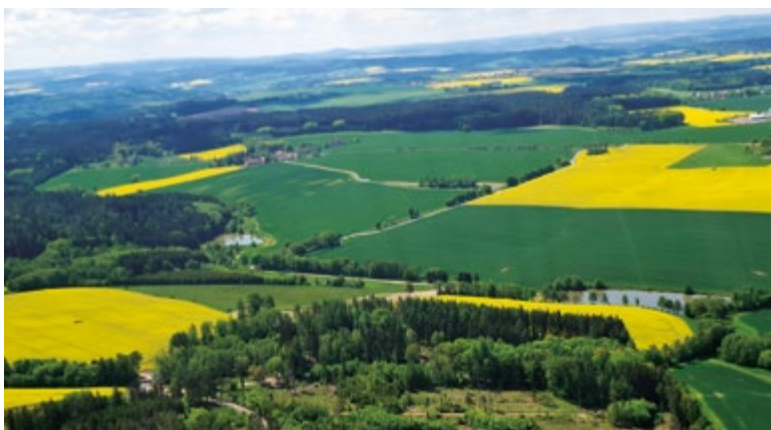
Fig. 7. Landscape in the Výrovka spring area up to Bohr (Beaver) pond (May 2025)

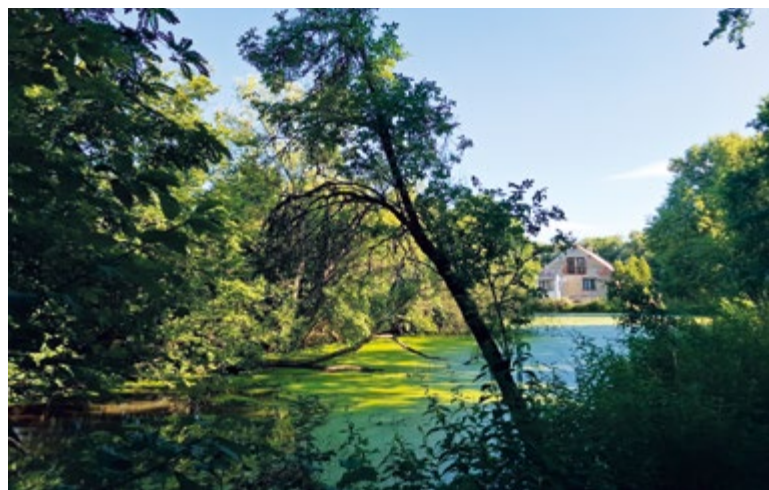
Fig. 8. Pond at the former Lucky mill (July 2025)

Over the next 4 km of the Výrovka, within the territory of Uhlířské Janovice, the following water bodies occur: Nový pond, the bathing pond, Hořejší pond, Holoubek pond, and the pond at the former Lucky mill (Fig. 8). The landscape around the former Lucky mill has undergone considerable changes from a water-management perspective. Extensive drainage of agriculturally used land has taken place, and the watercourses have been altered, including their straightening and deepening. The landscape development in this site from the mid-19th century through the 1950s to the present is shown in Figs. 9 and 10. These sources indicate that significant interventions in the watercourses have occurred: the location of the confluence of the Výrovka and Anenský stream has been changed, floodplain meadows have disappeared, and the landscape mosaic has become generally simplified. It should be emphasised that all these changes have taken place within the first 6 km of the Výrovka, and similar changes have also affected the tributaries of the Výrovka in this intercatchment. Combined with current climatic conditions, the above-mentioned changes in the landscape contribute to the periodic drying of the Výrovka channel and its small tributaries. The drying has a long-lasting character; initially it occurred only during summer, but in recent years it has begun as early as April and continues through September and usually also into October (Fig. 11a, b). In this site, the failure of drainage systems has led to the successional regeneration of a wetland headwater site on what is currently agricultural land (Figs. 12–14). However, this development is not the result of targeted management but rather of the inability to cultivate such waterlogged land using modern agricultural machinery.

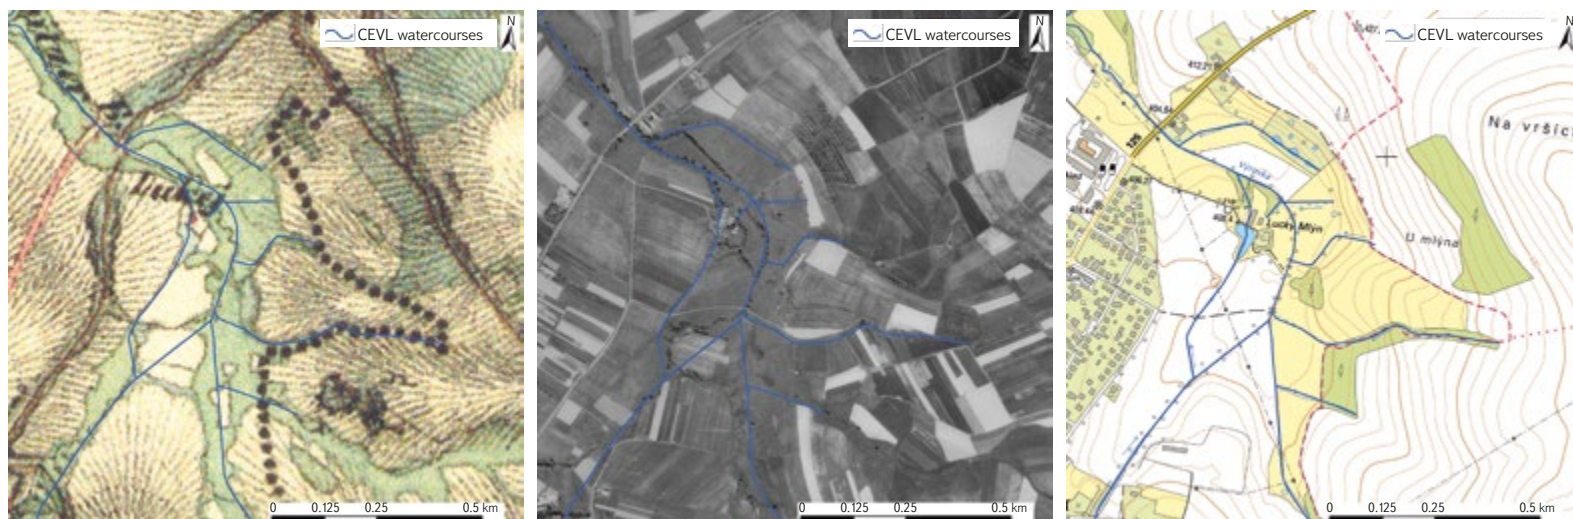
Fig. 9. Landscape changes in the area of the former Lucky mill shown based on the 2nd Military Mapping (1852), historical orthophotomap from the 1950s, and BTM 10 (2024)

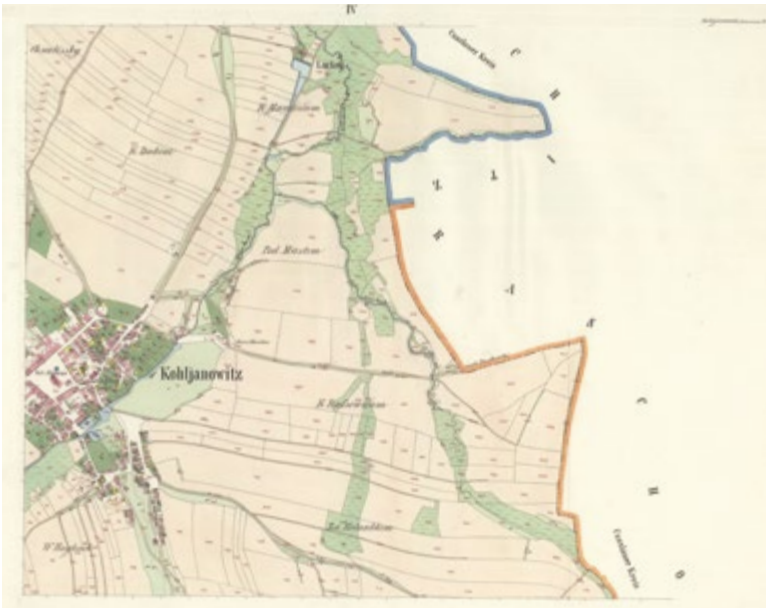
Fig. 10. Landscape in the area of the former Lucky mill on Imperial Imprint of the Stable cadastre (1839)

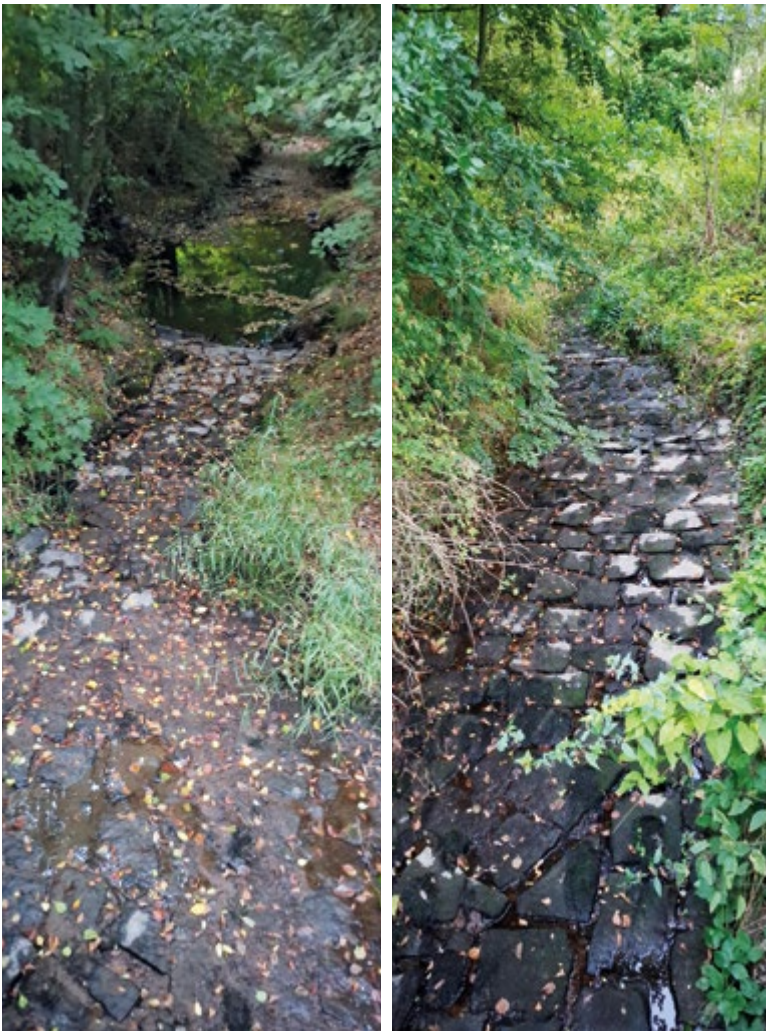
Fig. 11a, b. Dried-up riverbed of the Výrovka at the confluence with Anenský stream (September 2025)

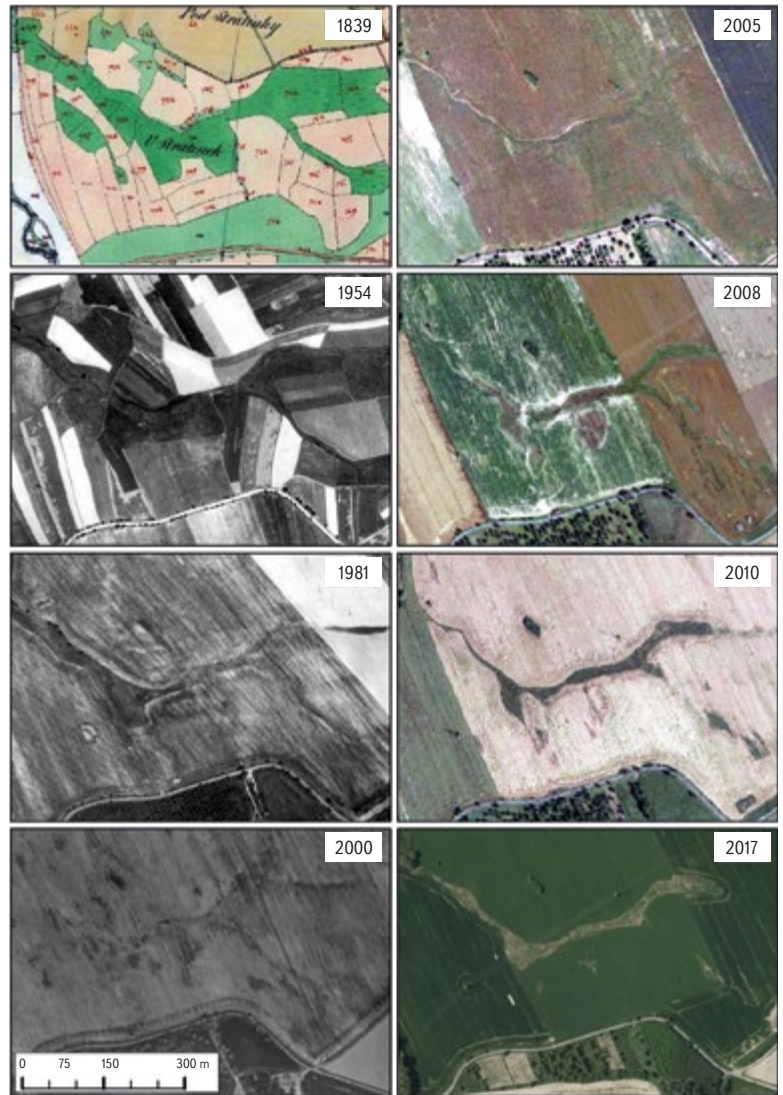
Fig. 12. Succession restoration of the drained site "U Stratinek" shown on the Stable cadastre (1839), historical orthophotomap from the 1950s, and archival orthophotomaps

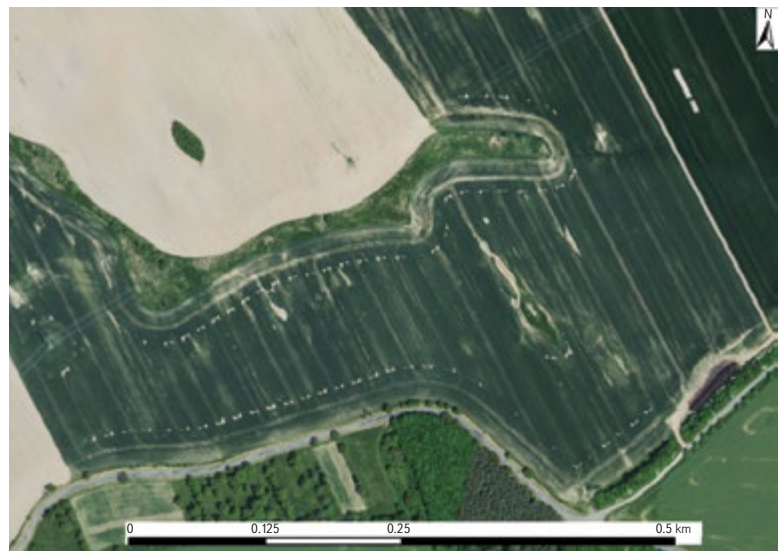
Fig. 13. Site "U Stratinek" on a current orthophotomap (2023)

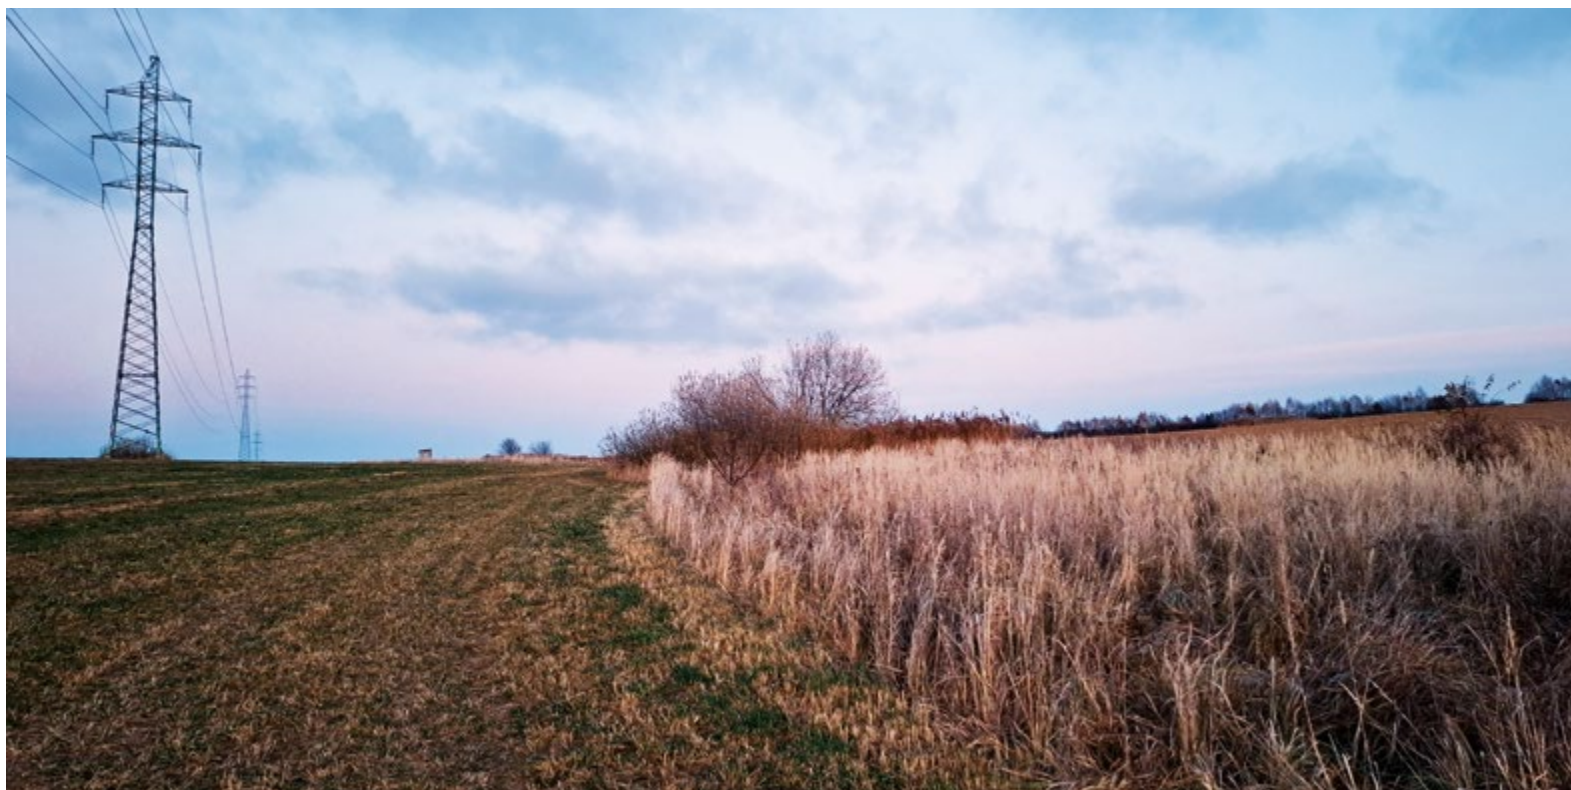
Fig. 14. Current state of the site “U Stratínek” (November 2025)

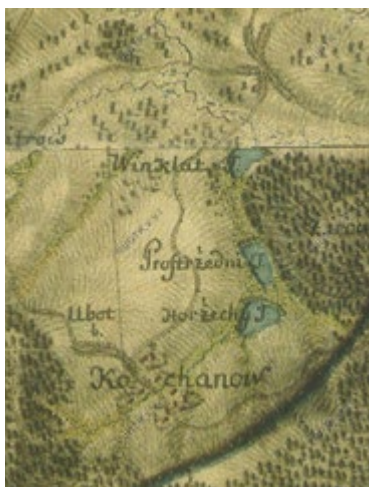
Fig. 15. Landscape in the Výrovka spring area on the 1st Military Mapping

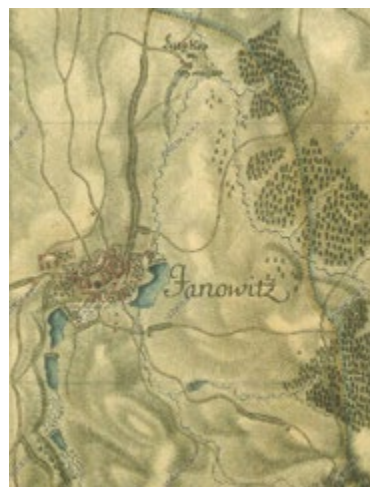
Fig. 16. Landscape in the area of Uhlířské Janovice village, including the former Lucký mill, on the 1st Military Mapping
