Reconstruction of the July 1903 flood in the Opava River basin using GIS and hydrological models

Keywords: Opava – 1903 flood – hydrological models – reconstruction of historical floods

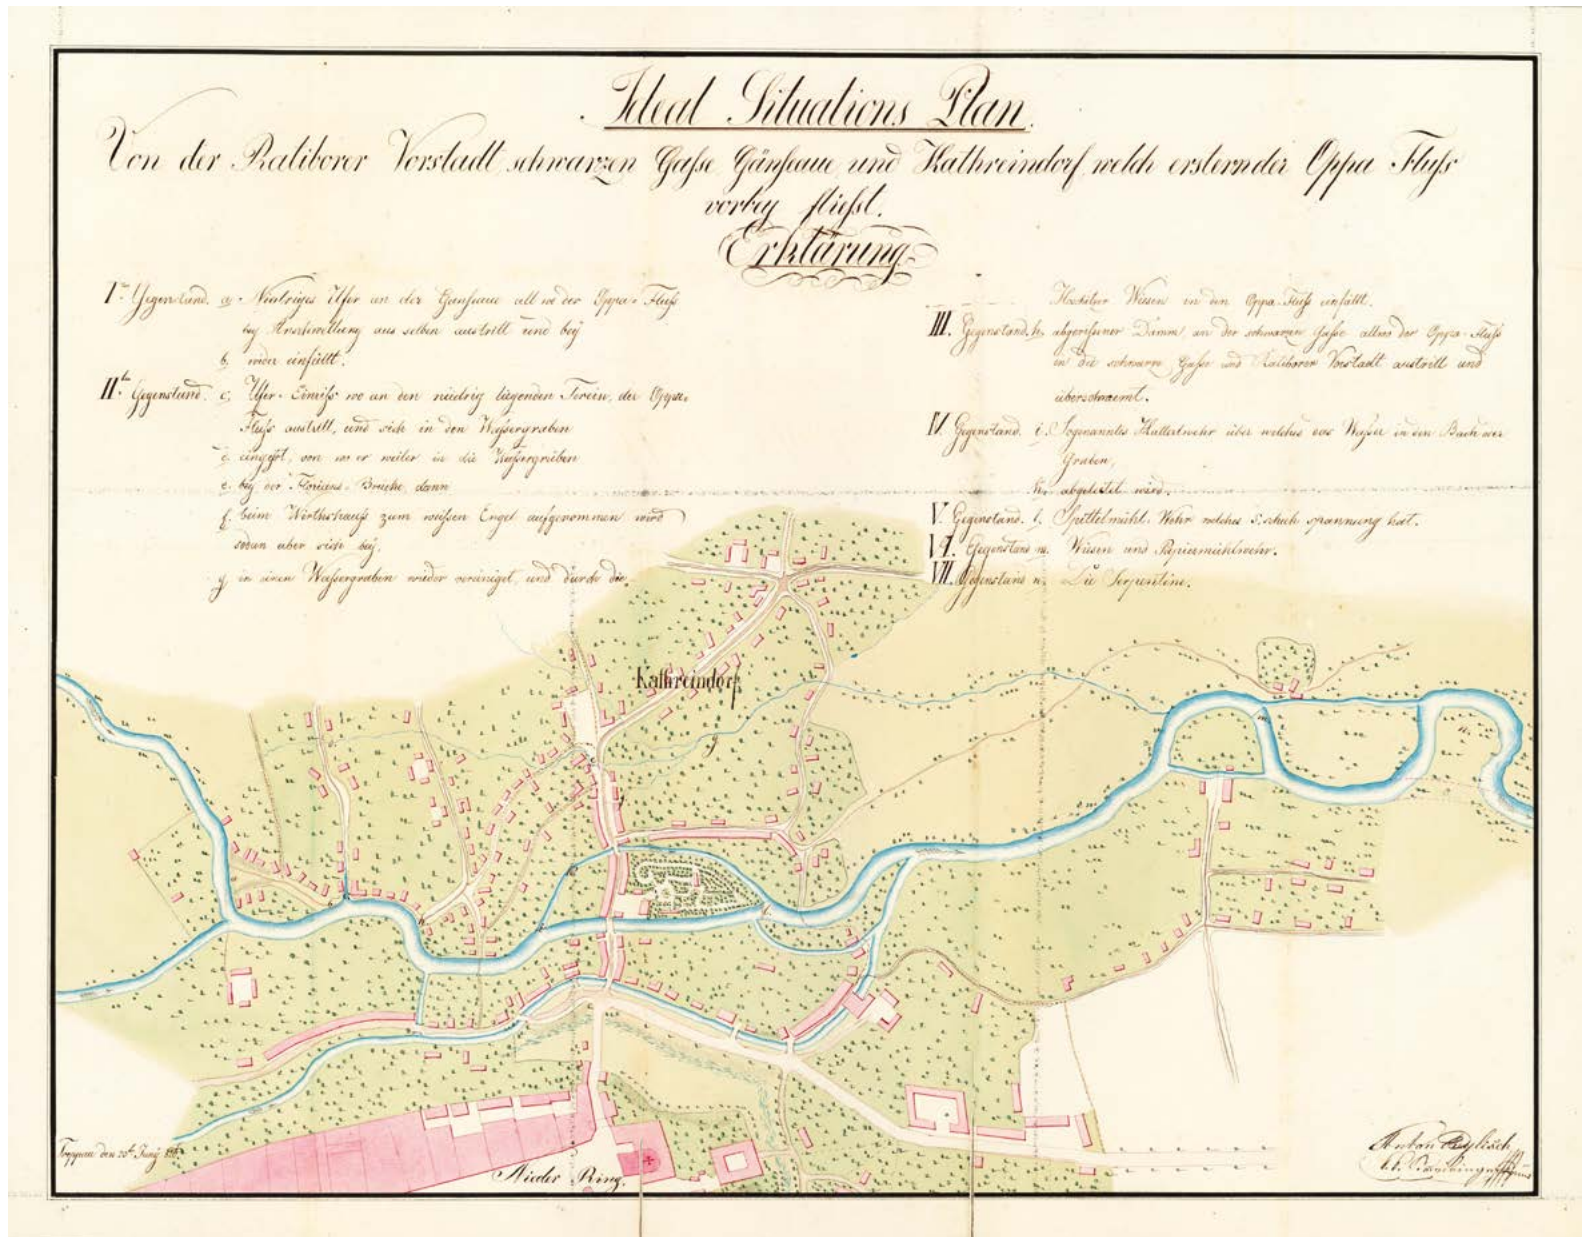
Fig. 3. Site plan of Kateřinky and Racibórz suburb from 1826 (source: Provincial Archives of Opava, archival number 688, inv. No. 50, signature 37/2)

Historical plans, sketches, and maps constitute an important source of information, particularly regarding the topography of the study area. Fig. 3 shows a site plan of part of the town of Opava, focusing on Ratiboř suburb and Kateřinky, dating from 1826 (Provincial Archives in Opava). In comparison with the Imperial Imprints of the Stable Cadastre (Moravia and Silesia were surveyed between 1826 and 1836), differences are apparent in the representation of the built-up area of Kateřinky at that time, see Fig. 4. Differences in the depiction of buildings are also visible in the Second Military Survey (Moravia and Silesia were surveyed between 1836 and 1840). It is also necessary to take into account the fact that Opava was affected by one of the more significant historical floods precisely in 1826, after which one of the historical regulations of the Opava channel was conducted; further floods subsequently occurred in 1829, 1831, and 1838 [1, 2].

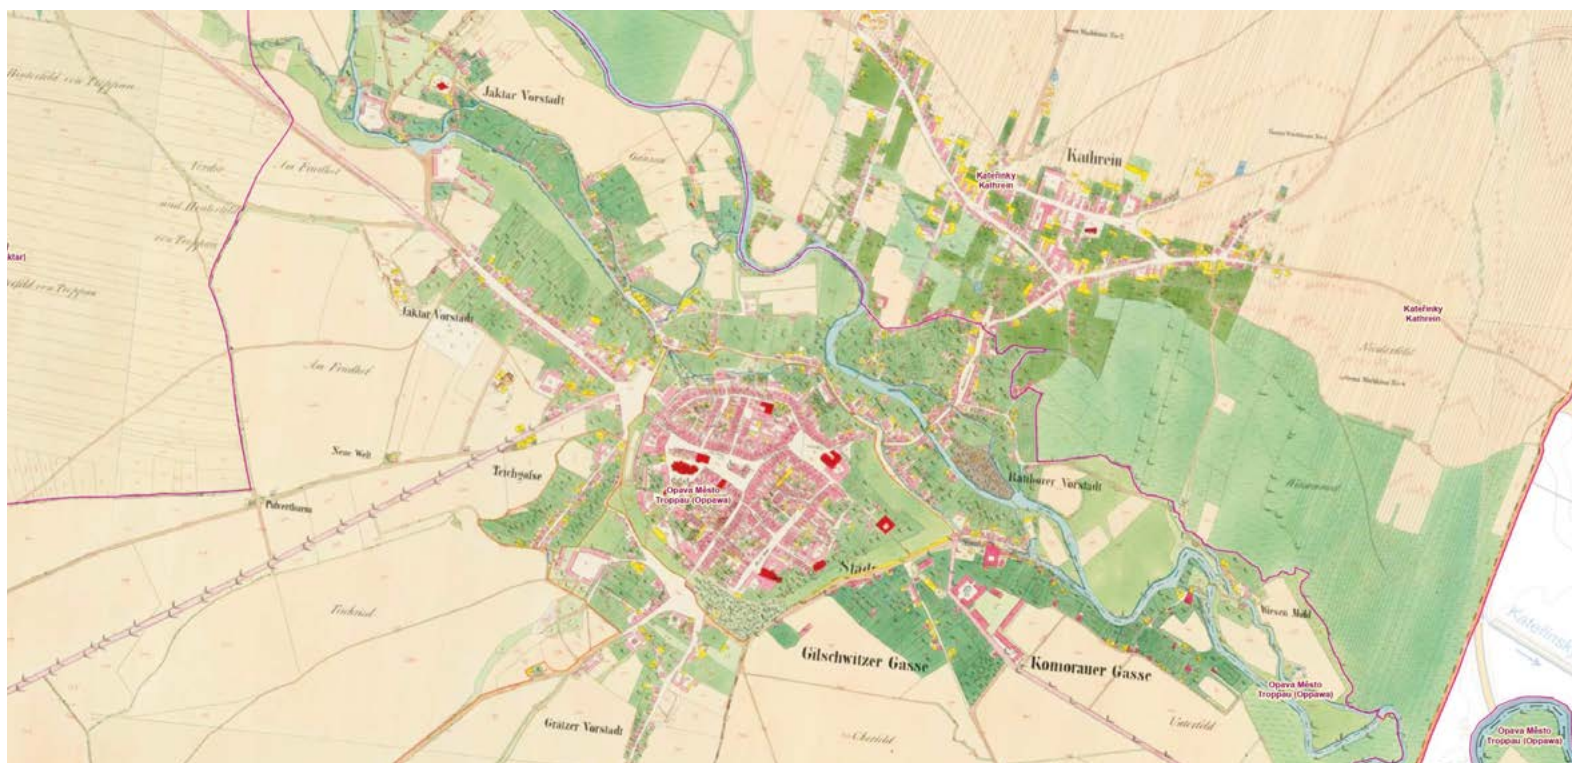
Fig. 4. Extract from the Imperial Imprint of the Stable Cadastre for Kateřinky and Racibórz suburb (source: ČÚZK)

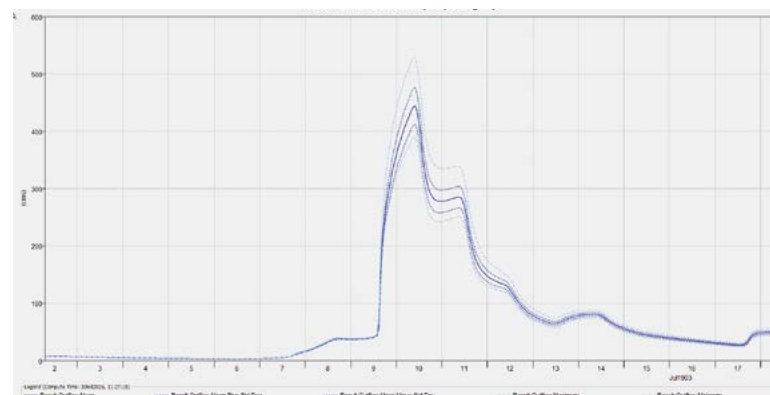
Fig. 5. Comparison of the simulated flood peak of the 1903 flood using the HEC-HMS model for the Opava profile with uncertainty analysis using the Markov chain Monte Carlo method

Sensitivity analysis using the Markov Chain Monte Carlo method was conducted primarily within the HEC-HMS rainfall–runoff model, specifically for the possible ranges of infiltration values, Curve Number (CN) values, and concentration times, which depend both on catchment morphology and land use. In 1903, forest cover in the Opava basin was undoubtedly less extensive than today; therefore, CN values for the individual sub-catchments were set within the range from 65 (forest, HSG A) to 92 (arable land, HSG D), with 250 samples generated for the specified interval range. Because CN values are primarily derived for agricultural soils, values for forest soils in the upper parts of the catchment were derived using nomograms for forested areas; see, for example, Haan et al. [16] and Mishra and Singh [17]. The AMC (Antecedent Moisture Conditions) parameter was not modified because both precipitation totals and the antecedent precipitation index were known. At the same time, conversion equations between the SCS-CN method and the Green–Ampt

The results of the HEC-HMS simulations with Markov Chain Monte Carlo sensitivity analysis are shown in Fig. 5. For the present-day Opava gauging profile, the peak discharge obtained using the SCS-CN method (and similarly for the Green–Ampt method) ranged from $389 \text{ m}^3 \cdot \text{s}^{-1}$ to $529 \text{ m}^3 \cdot \text{s}^{-1}$, with a mean peak discharge of $444 \text{ m}^3 \cdot \text{s}^{-1}$. This value corresponds relatively well to the peak discharge derived from the historical rating curve ($454 \text{ m}^3 \cdot \text{s}^{-1}$).

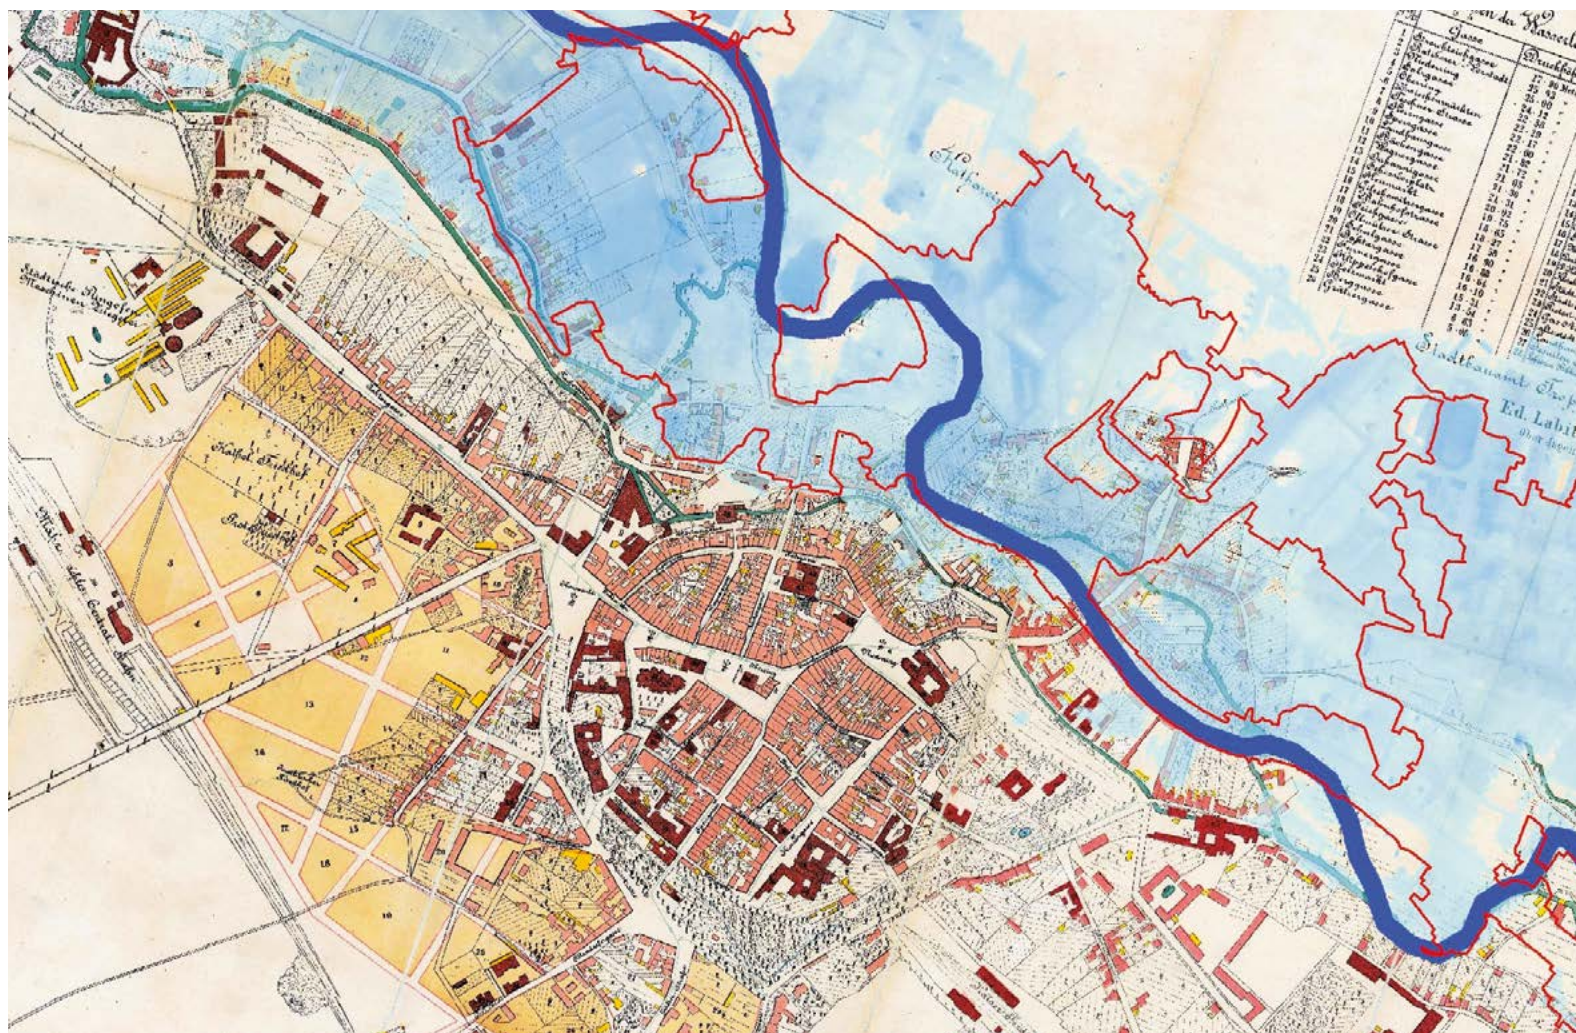
Fig. 6. Simulated water levels and flood extent in 1D and 2D hydraulic models (HEC-RAS and DHI MIKE) for the peak discharge of $438 \text{ m}^3 \cdot \text{s}^{-1}$. The red line is the Q_{100} boundary ($388 \text{ m}^3 \cdot \text{s}^{-1}$) for the present-day riverbed and floodplain. The base map is Labitzky's 1876 plan of Opava

The simulations performed in the HEC-HMS rainfall–runoff model were subsequently followed by simulations in the MIKE and HEC-RAS hydraulic models in both 1D (reconstructed course and condition of the channel according to preserved historical sources and maps) and 2D (state of the floodplain areas based on preserved maps and plans). Flood-mark elevations (Ratibořská street and the industrial area on Sadová street) and the extent of inundated areas in comparison with the Q_{100} flood and the floods of 1997 and 2024 were used for verification (Fig. 6). In terms of the flood-mark elevation on Ratibořská street, the simulated water level corresponding to a discharge of $438 \text{ m}^3 \cdot \text{s}^{-1}$ provided the best agreement (Fig. 7). If historical sources describing the situation in Kravaře and other settlements further downstream are also taken into account, this value may be regarded as realistic, including in comparison with the evaluated peak discharge of $670 \text{ m}^3 \cdot \text{s}^{-1}$ for the September 2024 flood (the difference between the flood-mark elevation and the 09/2024 flood level is 23 cm).

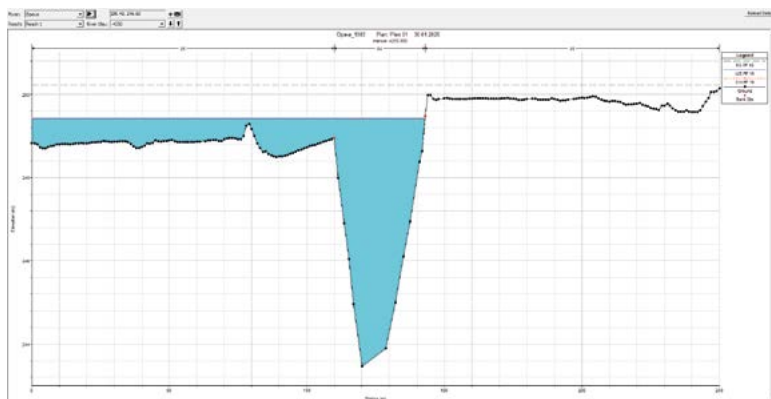
Fig. 7. Simulated water level in the HEC-RAS model for a peak discharge of $438 \text{ m}^3 \cdot \text{s}^{-1}$ in the area of Ratibořská street. The elevation of the flood mark on building No. 43 is 249.45 m above sea level (own geodetic measurements)
