# Changes in spring areas following sudden major disturbances

PAVEL ECKHARDT, KAMILA TICHÁ

**Keywords:** groundwater — springs — water resources — drainage — restoration — forest fire

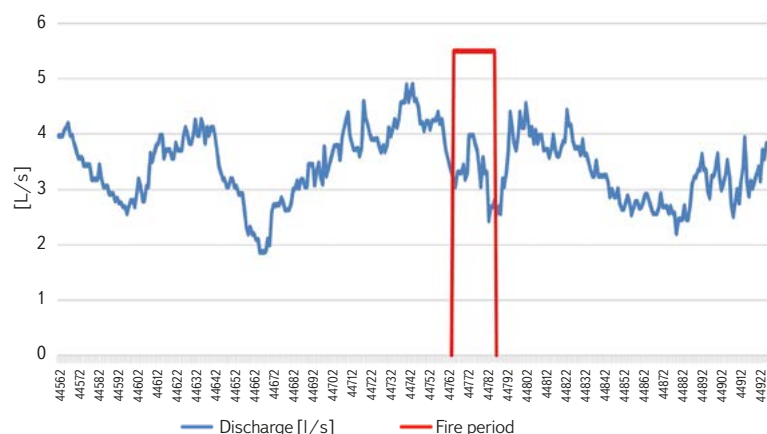
Fig. 3. Fluctuations in the discharge of the Suchá Bělá 3 spring in 2022 (data source: CHMI)

The discharge of Suchá Bělá 3 spring fluctuated slightly around a mean value of 4.3 L/s between 2013 and 2024. During some periods, discharge increased to more than 5 L/s, while at other times it fell to just above 3 L/s. The only period in which discharge fell below 3 L/s was during the study year 2022 (Fig. 3). Marked decreases in discharge had already occurred before the fire, falling to 2.5 L/s in February and subsequently to below 2 L/s, with the annual minimum occurring in mid-April. Discharge then gradually increased to an annual maximum of approximately 4.8 L/s around the end of June and beginning of July, followed by a decrease to around 3 L/s in mid-July. During the fire in late July, spring discharge increased from 3.18 L/s to almost 4 L/s before falling to 2.44 L/s in early August, including a very marked daily decrease of as much as 0.9 L/s. After the fire, discharge increased to the usual level of around 4 L/s in the second half of August, before declining to the second-lowest annual value in November and then returning to usual levels by the end of December. In our opinion, the daily discharge data recorded during the fire should be interpreted with caution, particularly given the possible sensitivity of the automatic measuring equipment to changes such as trees and branches falling into the measuring structure or firefighting activities (e.g. the use of water). Nevertheless, it is apparent that the more pronounced absolute changes in spring discharge in 2022 occurred not during the fire itself, but in the periods before and after it.

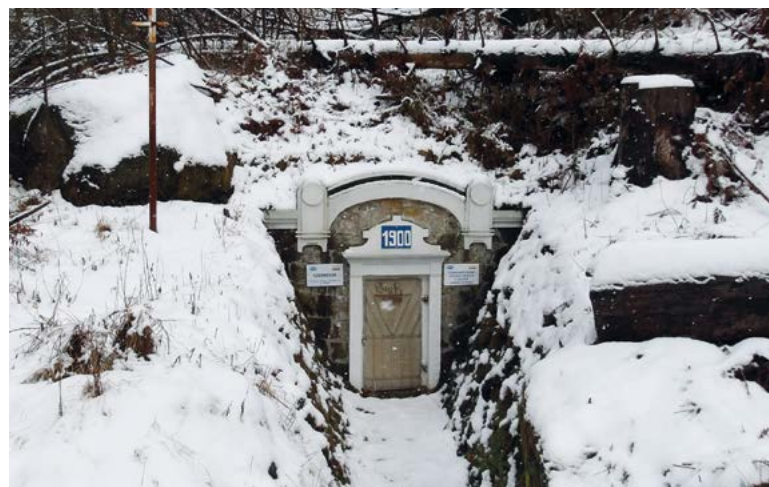
Fig. 4. Historical capture structure at Nad Klepáčem spring near Hřensko; condition in February 2026 (photo: P. Eckhardt)

Panenský spring has disappeared as a result of groundwater abstraction, and no traces of it remain at the site of its former outflow. Nad Klepáčem spring area in Malinový důl is used as a source of drinking water for the town of Hřensko. The main surface outflow from this spring area has disappeared (the spring intake is shown in Fig. 4). Groundwater outflows with substantially lower discharge occur within the spring area, but infiltrate back into the rock environment after several tens of metres. After abstraction, the overflow from the main spring is discharged unused through a pipe into the Dlouhá Bělá stream. Pod Pravčickou bránou spring (Tři prameny) and Pytlův spring are fenced off, covered by chambers and soil, and connected to the public water supply system; consequently, there are no longer any surface groundwater outflows at these sites (Fig. 5). U Cikánského smrku spring still exists in a degraded state (a concrete well ring; see Fig. 6) and has a markedly lower discharge than in the last century. The five high-discharge springs monitored in the Suchá Bělá valley flow freely onto the surface without any significant restrictions. The highest-discharge spring, Suchá Bělá 3, is regularly monitored by CHMI. Groundwater abstraction from the Hřensko abstraction area has decreased compared with the past and is currently around 80 l/s [17]. Even several years after the fire, much of the area remains covered with charred wood debris. Scorched tree trunks rise towards the sky, with vegetation gradually regenerating between them, particularly through self-seeding birch (Figs. 5 and 6).

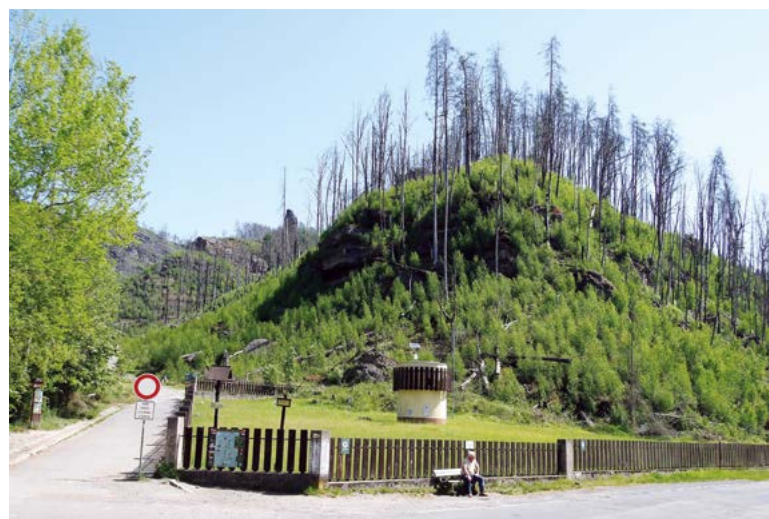
Fig. 5. Pod Pravčickou bránou spring site near Hřensko, currently with no water emerging at the surface, status in May 2026 (photo: P. Eckhardt)

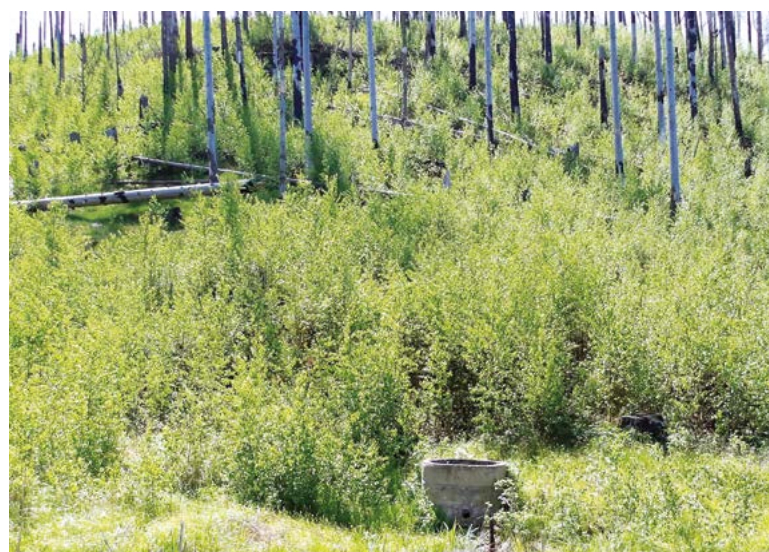
Fig. 6. Concrete well ring at U Cikánského smrku spring in the Hřensko study area, May 2026 (photo: P. Eckhardt)

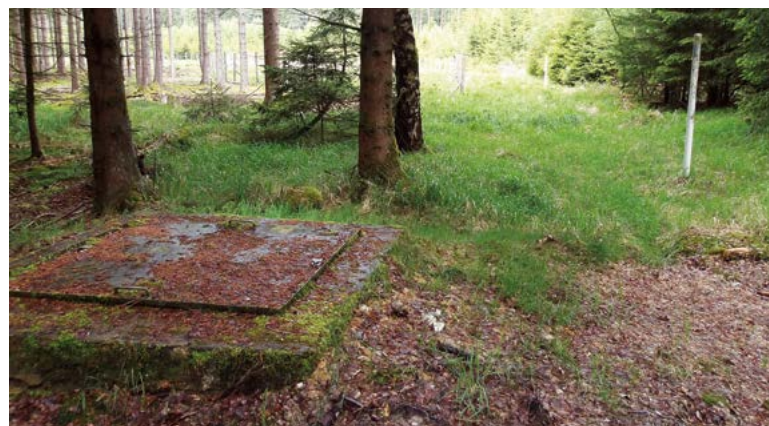
Fig. 7. No water flows at the surface from the captured Pekelský stream spring near Aš, which is enclosed in a chamber (photo: P. Eckhardt)

capture has eliminated surface discharge from the springs, and no water from them now flows into the former border stream.

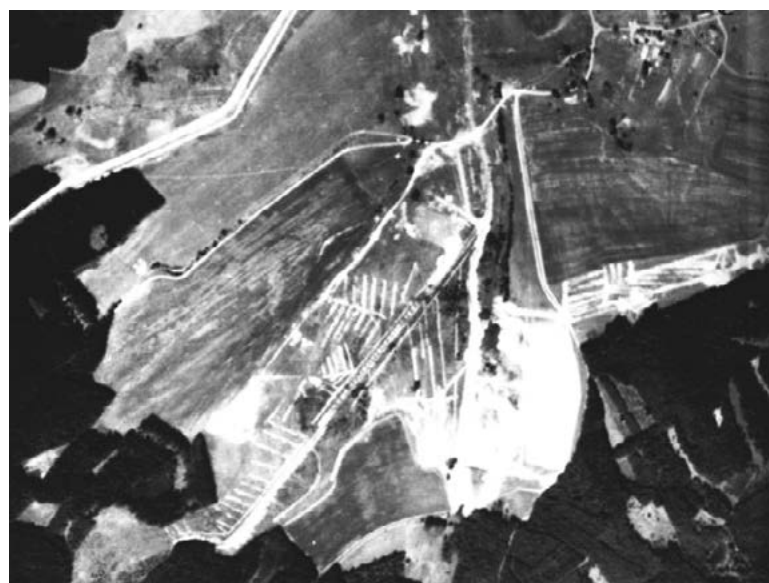
Fig. 8. Historical aerial photograph showing the construction of drainage systems around the village of Pastviny in the Aš area

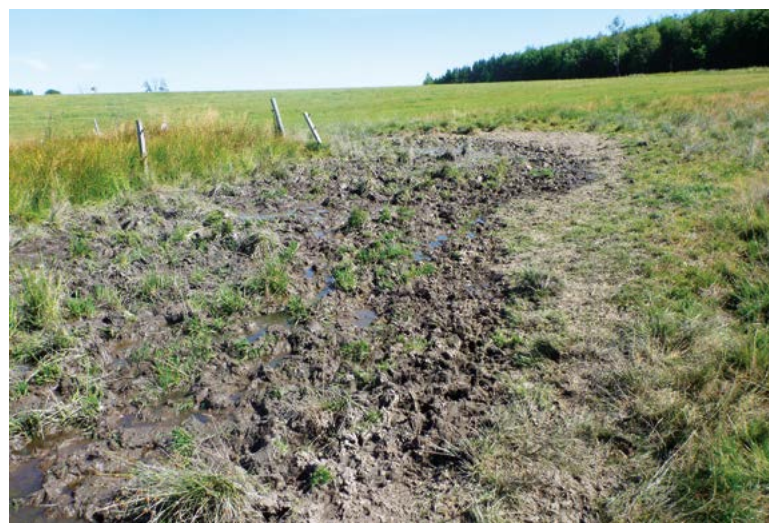
Fig. 9. Luz 67 spring area formed by a drainage-system failure in a pasture; previously fenced off, the secondary spring outlet has since shifted, and the wetland area is now repeatedly damaged by livestock (Aš area)

shift from place to place. This has been observed, for example, at the long-term monitored secondary spring area U stružky (Luz 67) (Fig. 9), where the manager of the Bystřina – Lužní stream National Nature Monument (Slavkovský les Protected Landscape Area) has confirmed that the subsurface drainage system has been blocked for many years. Nevertheless, in spring areas with a disturbed water regime, even these habitats are important components of the heterogeneous landscape structure. They provide refugia for temporary macrozoobenthic species and other animals and increase biodiversity within the study area. Tab. 1 presents basic information on the nine monitored spring areas, including their principal characteristics and relationship to drainage.

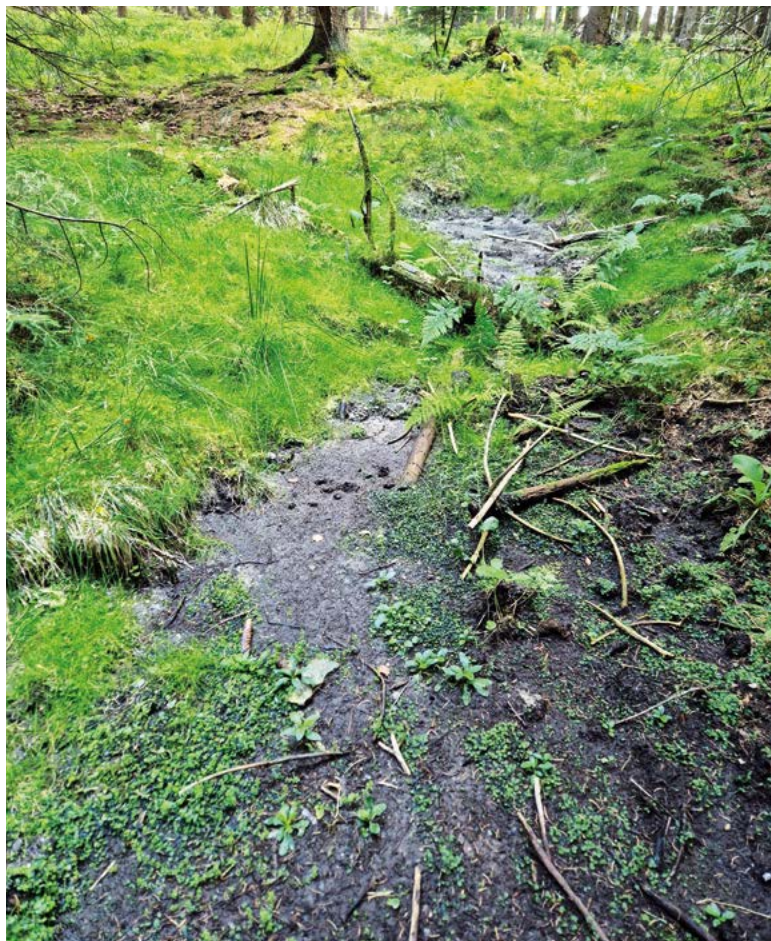
Fig. 10. One of the upper spring outlets of the Lužní stream, dry in 2025; drainage channels located 20–50 m from the outlet convey water towards the Lužní stream, affecting the discharge and overall condition of the spring areas (Aš area)

In the forests of this area, surface drainage channels were constructed in the past to drain some spring areas and other wetlands locally (Fig. 10).

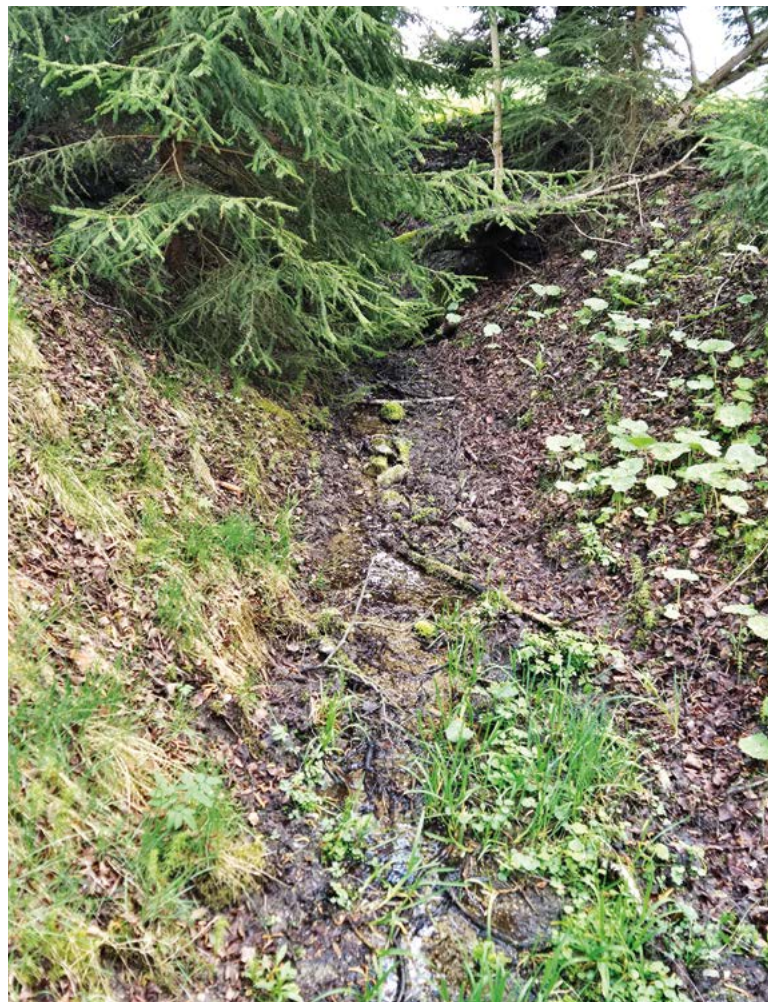
Fig. 11. VMP08 spring area drained by a drainage channel (upper Blanice catchment area)

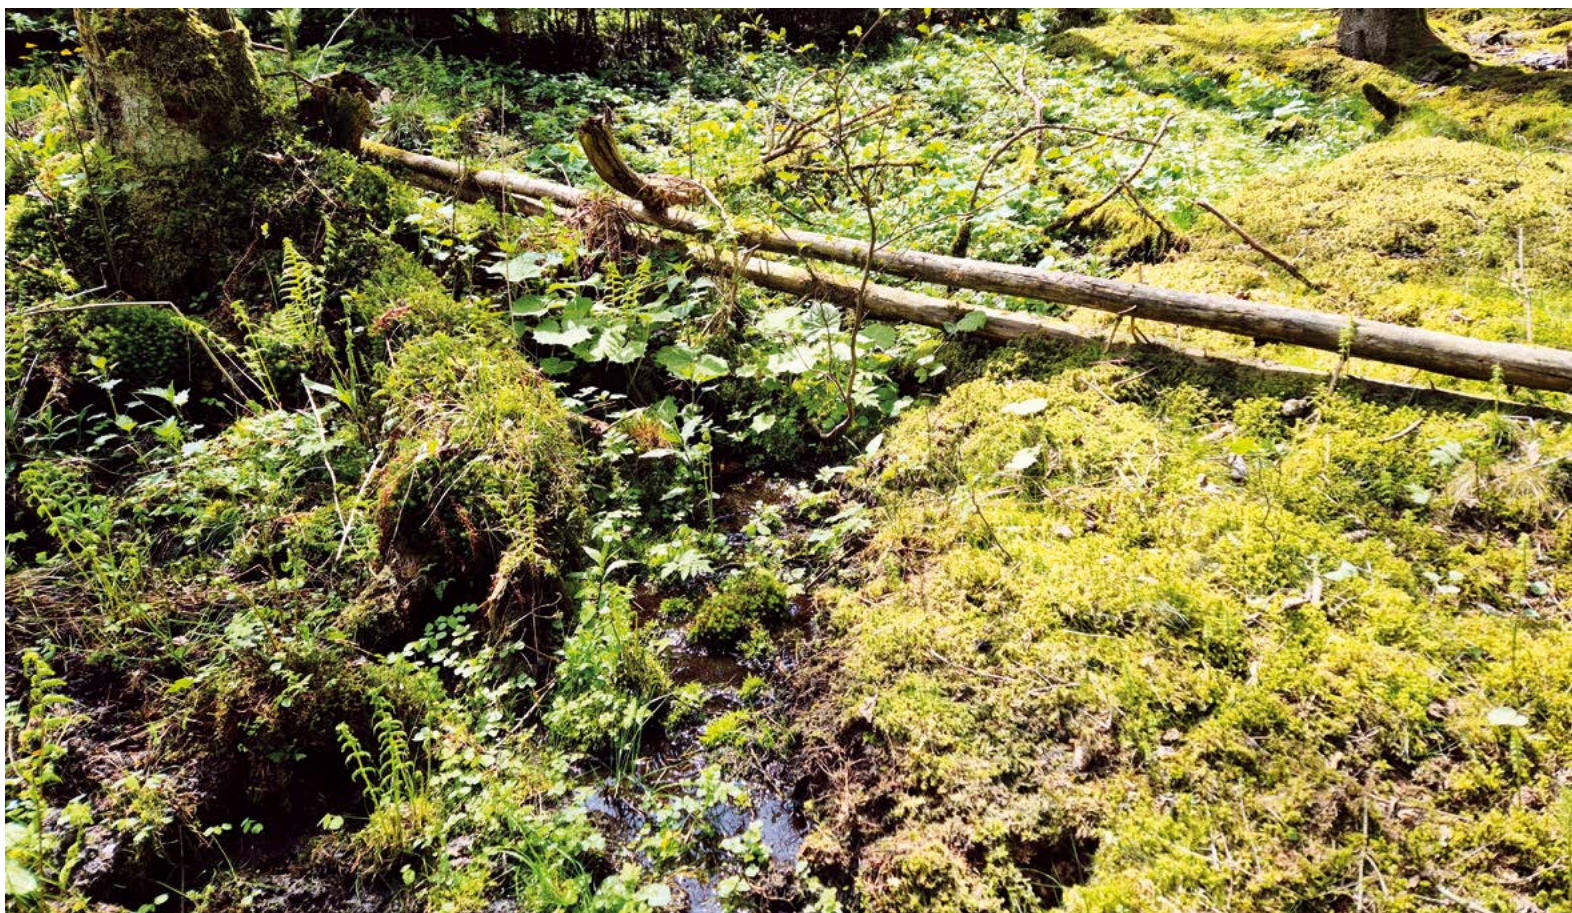
Fig. 12. Natural forest spring area M01A (upper Blanice catchment area)
