Landscape changes in selected locations of the Polabí lowlands with a focus on wetlands

This article presents three typologically different sites from Polabí where large-scale wetland sites were located in the past, including ponds. These sites were chosen in order to present disappeared floodplain meadows, disappeared "field" wetlands, disappeared ponds or pond systems, and, simultaneously, to present sites where wetland habitats have been at least partially restored. The main aim was to present easily accessible archival maps, on the basis of which it is possible to assess the spatio-temporal dynamics of wetland habitats in the places of disappeared wetlands with regard to their possible restoration. The article presents the map of the 2nd military mapping as best suited for primary detection of historic wetlands. This map shows the state of the landscape in the mid-19th century rather accurately. It was, among other things, a landscape of almost unregulated watercourses, including their floodplains, as well as wetlands and springs where there is arable land nowadays. However, even the spatially less accurate map of the 1st military mapping from the second half of the 18th centu

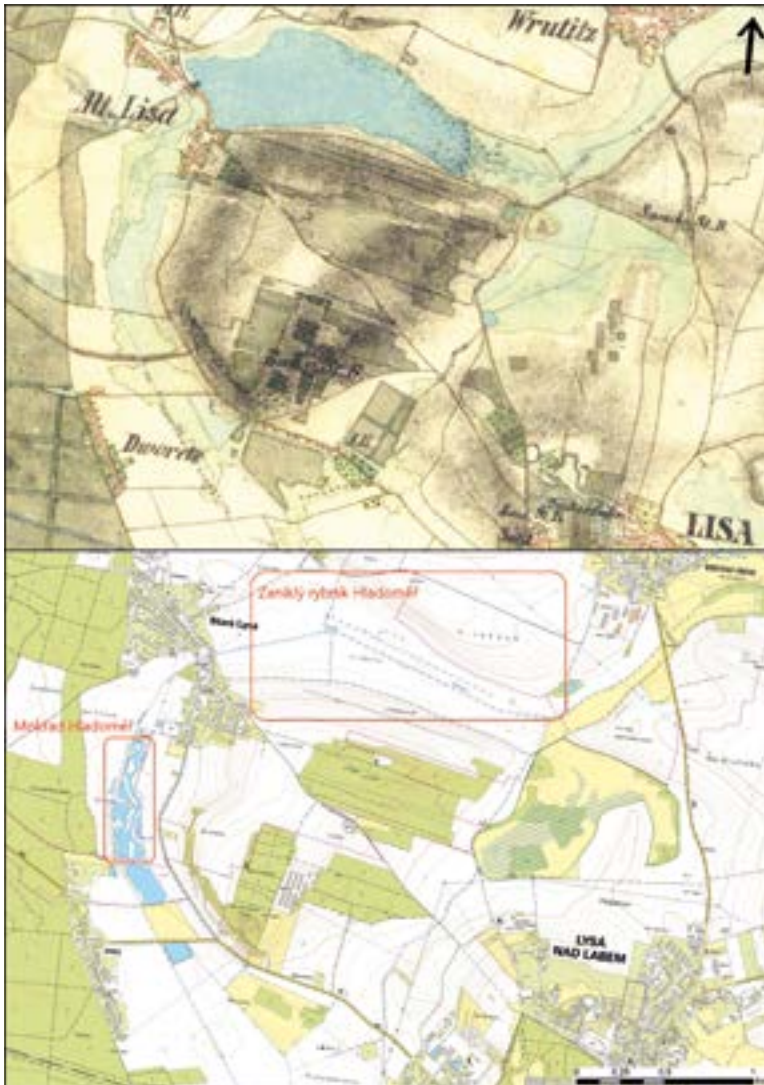
Fig. 1. Mlynařice floodplain and the extinct Hladoměř pond near Stará Lysá on a map of the 2nd military mapping (top) and on BM10 (bottom)

In the past, in the vicinity of Stará Lysá, there was the Hladoměř pond with an area of 64 ha on the Mlynařice stream (marked as Wilkawa Bach on the map of the 2nd military mapping, i.e. Vlkavský stream), which was located in a wide floodplain formed by wet meadows and swamps with marshes. The area of the wetland site from Benátecká Vrutice to Dvorce, including the pond, was almost 150 ha.

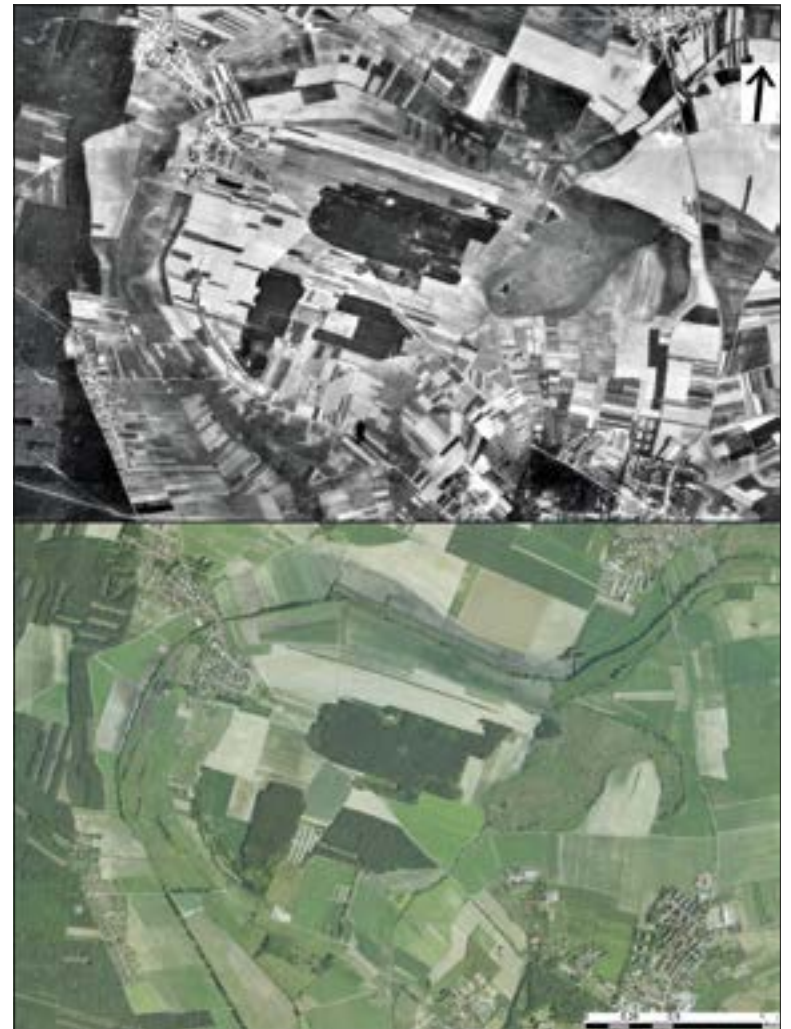
Fig. 2. Mlynařice floodplain and the extinct Hladoměř pond near Stará Lysá on an orthophotomap of Czechoslovakia from the 1950s (top) and on the archival orthophotomap of the Czech Republic from 2004 (bottom)

Currently, the regulated watercourse of Mlynařice flows through land made up of arable land, and at Benátecká Vrutice, it also flows through meadows. The Hladoměř pond was land-filled (Fig. 1). Between Stará Lysá and Dvorce, between 2009 and 2011, a system of several pools and a riverbed named Mokřad Hladoměř (Hladoměř Wetland) was created on the site of historical swamps and marshes. It is 700 m long and covers an area of about 10 ha. There is a sluice at the edge of the pool system, which can be used to regulate the water level. The site should attract back birds, fish and amphibians. It should be a relaxation zone for nature-watching. It cost around 20 million crowns; Stará Lysá received 18 million from EU subsidies within OPE in priority axis 6 – Improving the state of nature and landscape [20–22]. According to the entry in the land registry, this site is still on arable land, however, proceedings are being conducted here due to the discrepancy between the type of land and the actual condition. Beneath this site (behind the road to Dvorce in the Lysá nad Labem cadastral area), there is a water reservoir, which is registered as permanent grassland in the cadastre; proceedings due to discrepancy in the type of land are not conducted here. None of these sites is registered in LPIS.

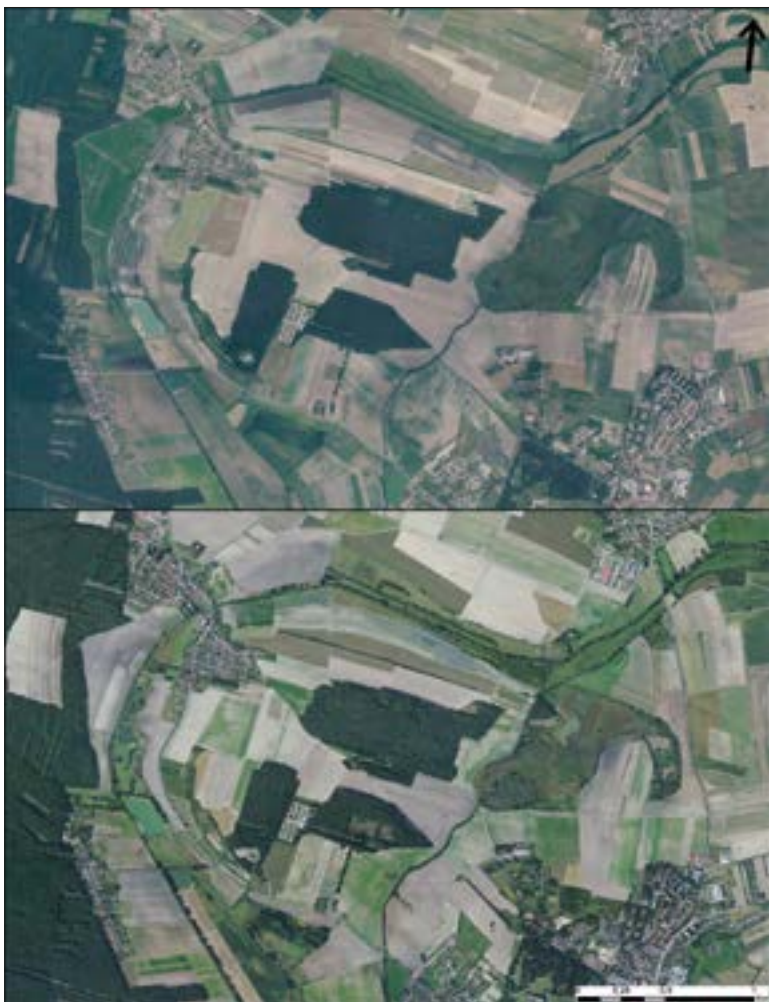
Fig. 3. Mlynařice floodplain and the extinct Hladoměř pond near Stará Lysá on the archival orthophotomap of the Czech Republic from 2010 (top) and on the current orthophotomap of the Czech Republic (bottom)

When clarifying the historical development of this site, it was found that on the map of the 3rd military mapping, the Hladoměř pond is already land-filled. In 1954, there was arable land with a classic mosaic of small plots

in the Mlynařice floodplain and at the site of the Hladoměř pond. Only at the site of the Hladoměř Wetland, there was a site with wet meadows. In 2004, both sites showed signs of waterlogging (Fig. 2). In 2010, there is the Hladoměř Wetland under construction, the water reservoir under it is already built. On the current orthophoto map, waterlogged sites can be seen at the site of the disappeared pond and, to a much lesser extent, in the vicinity of the wetland (Fig. 3).

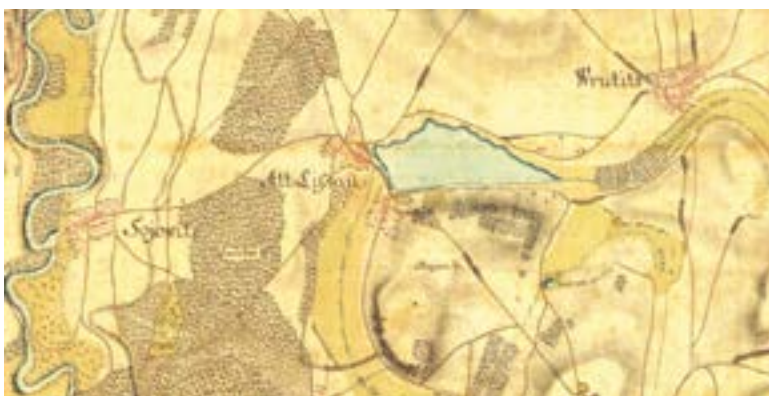
Fig. 4. Mlynařice floodplain and the extinct Hladoměř pond near Stará Lysá on the map of the 1st military mapping

The Hladoměř pond was already recorded on the maps of the 1st military mapping (Fig. 4) and on Müller's map of Bohemia, where, however, the Mlynařice stream is apparently incorrectly recorded (Fig. 5).

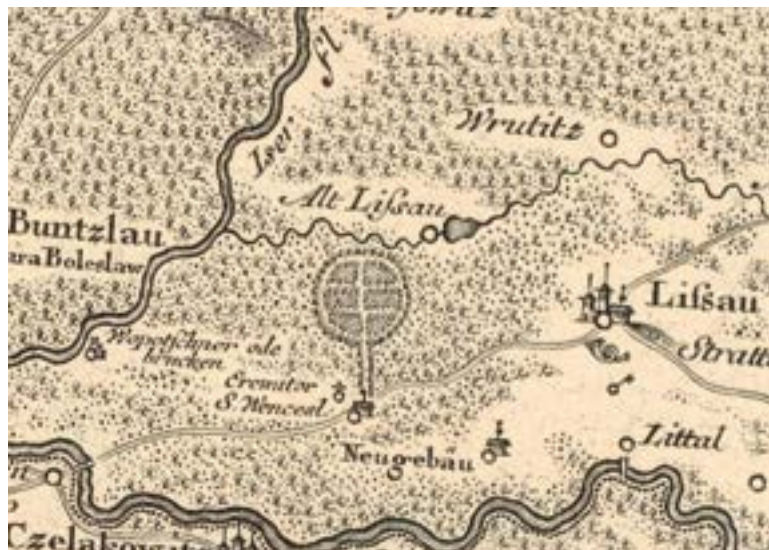
Fig. 5. Mlynařice floodplain and the extinct Hladoměř pond near Stará Lysá on Müller's map of Bohemia

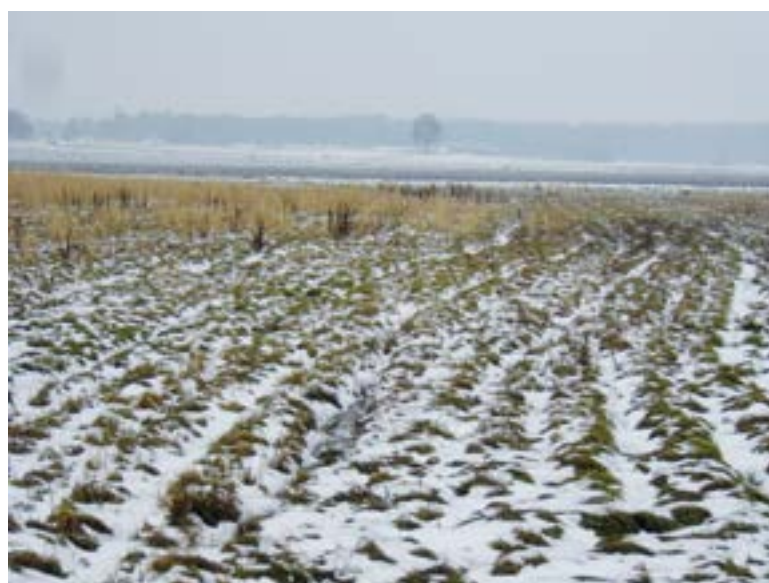
Fig. 6. Current landscape in Mlynařice floodplain at the site of the extinct Hladoměř pond near Stará Lysá, view from Benátecká Vrutice (December 2022)

Fig. 6 and 7 show the current state of the landscape at the site of the Hladoměř pond, and Fig. 8 shows a view of the Hladoměř Wetland with already stratified bank vegetation.

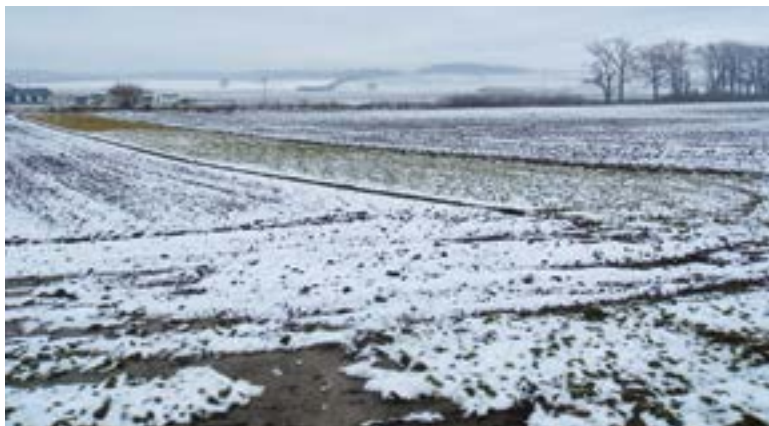
Fig. 7. Current landscape at the site of the extinct Hladoměř pond near Stará Lysá, view from Stará Lysá (December 2022)

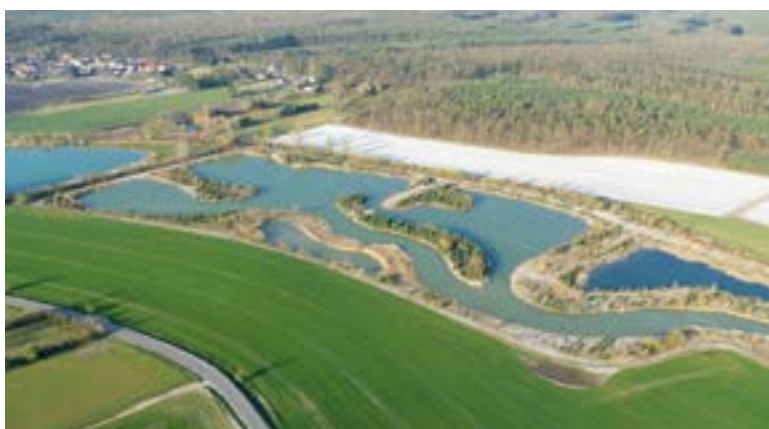
Fig. 8. Bird's-eye view of Hladoměř Wetland (April 2020; Photo: J. Kolomazník) [22]

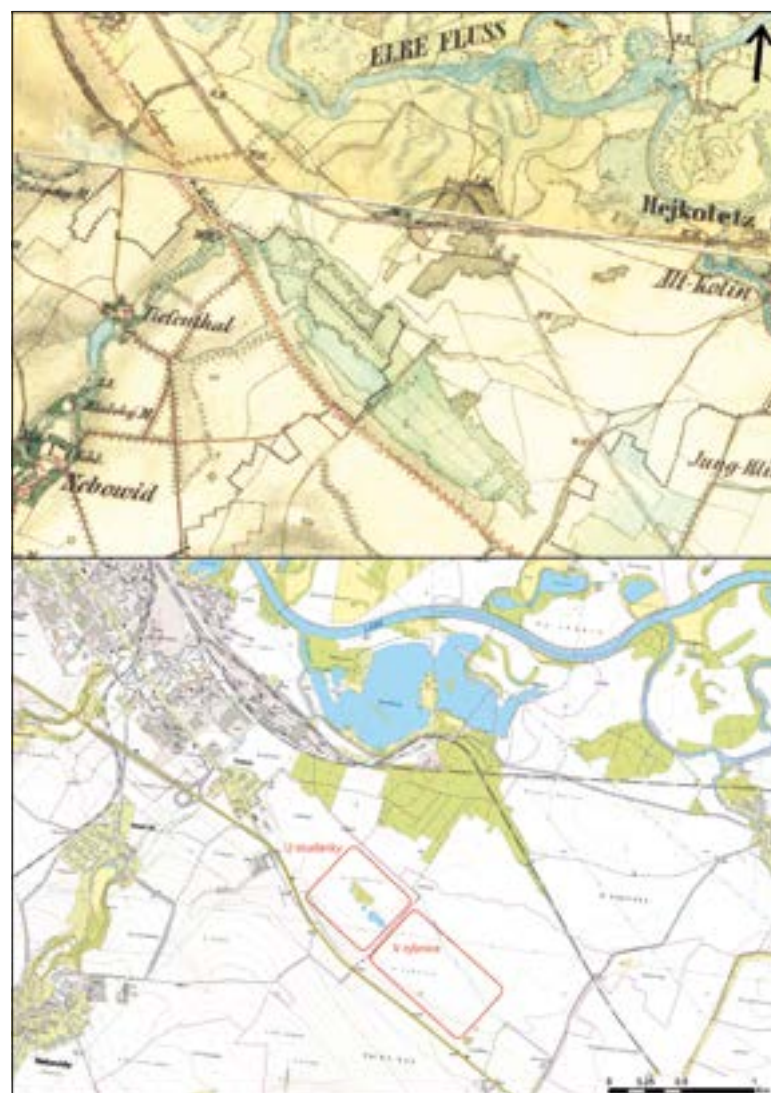
Fig. 9. The extinct wetland near Libenice on a map of the 2nd military mapping (top) and on BM10 (bottom)

Between Štářalka and Libenice, along the road to Kolín, there used to be a large site consisting of wet meadows with an area of almost 100 ha. It reached almost to the railway line to Kolín, beyond which there was a wide waterlogged floodplain of the Elbe. Currently, there is mainly arable land here. The bed of the Elbe was straightened due to its navigation and several water bodies were created in its floodplain. In the part of the "U Studánky" site, restoration of the area was started in 2014 named "Anti-erosion measures in the Nebovidy cadastral area – building object SO 03 – "U studánky" site, co-financed by the EU from the European Agricultural Fund for Rural Development as part of sub-measure I.1.4. Land improvements. At the time of project approval, a subsidy of approximately 15,250,000 CZK was allocated. A system of three pools, a perimeter ditch, and vegetating the "Wetland forest" by planting trees, shrubs and grass was implemented according to the approved proposal for comprehensive land management in the Nebovidy cadastral area. The site has an area of 8.3 ha [23, 24]. It is not registered in LPIS. In the cadastre, it is registered as the land type of "other area with the greenery of use".

Opposite this site, located in the Libenice cadastral area, is the site "V rybníce", where there is currently uncultivated agricultural land, an actual wetland site (Fig. 9). In LPIS, it is registered as fallow land, i.e., a temporarily intentionally uncultivated field. The site has an area of 7.5 ha. In the cadastre, the land type is arable land.

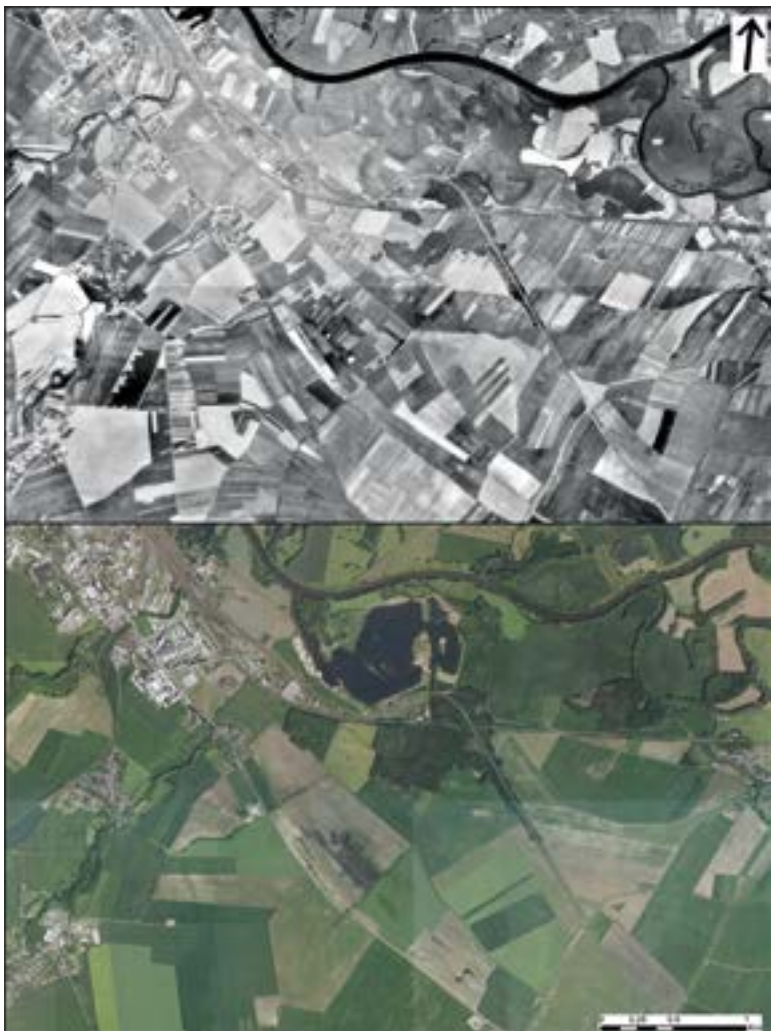
Fig. 10. The extinct wetland near Libenice on an orthophotomap of Czechoslovakia from the 1950s (top) and on the archival orthophotomap of the Czech Republic from 2004 (bottom)

When clarifying the historical development of this site, it was found that in 1954 there was arable land on the site of the wetland site with a classic mosaic of plots smaller than at present. In 2004, there were signs of waterlogging at both sites; at the site of the future implementation of the anti-erosion project "U studánky" it is more pronounced (Fig. 10). In 2015, we can see the newly implemented anti-erosion project "U studánky" and waterlogging with successional vegetation in part of the disappeared wetland in the site "V rybníce" in the Libenice cadastral area. The current orthophoto map shows the full stratification of the newly planted vegetation in the "U studánky" site and the wetland site, registered as fallow land in the Libenice cadastral area (Fig. 11).

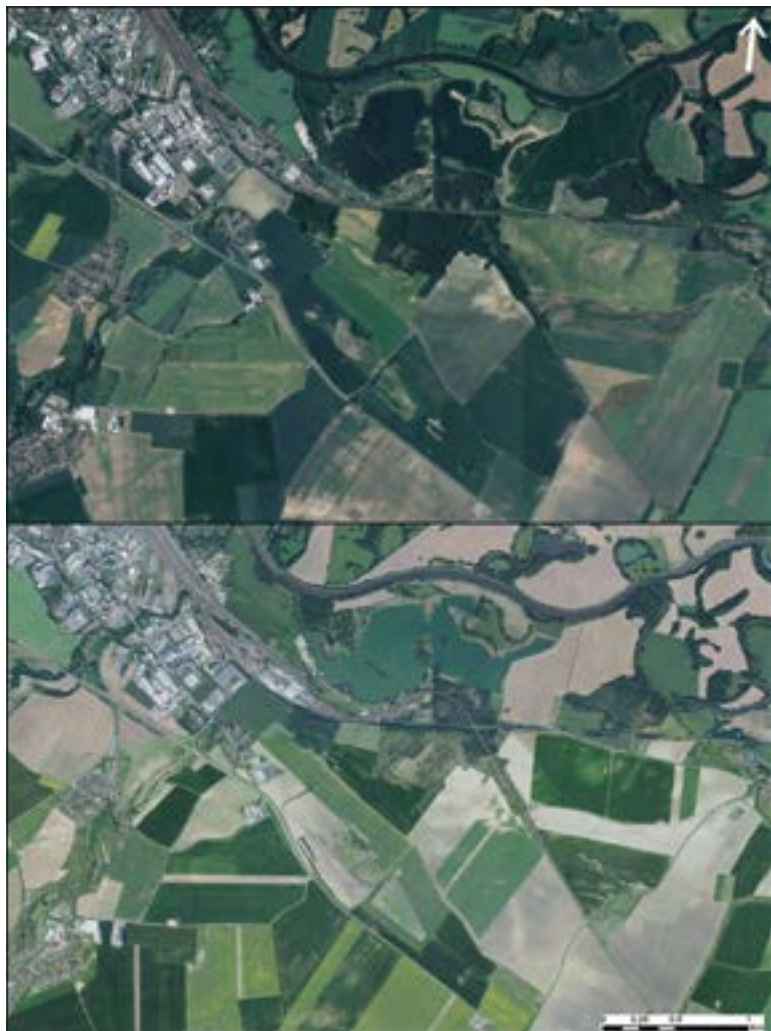
Fig. 11. The extinct wetland near Libenice on the archival orthophotomap of the Czech Republic from 2015 (top) and on the current orthophotomap of the Czech Republic from 2022 (bottom)

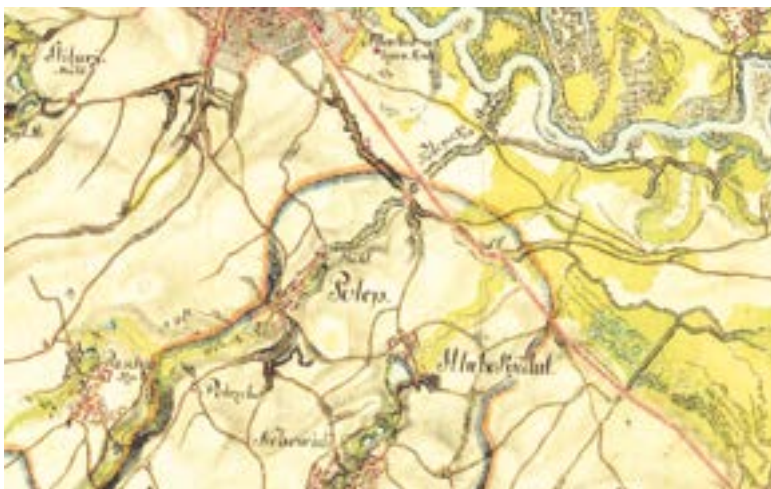
Fig. 12. The extinct wetland near Libenice on the map of the 1st military mapping

On the map of the 1st military mapping, this site is recorded as a meadow (wet meadow) with a spring, and partly with trees. No water body is recorded here (Fig. 12). The same situation at this site can be found also on the map of the 3rd military mapping and on Müller's map of Bohemia.

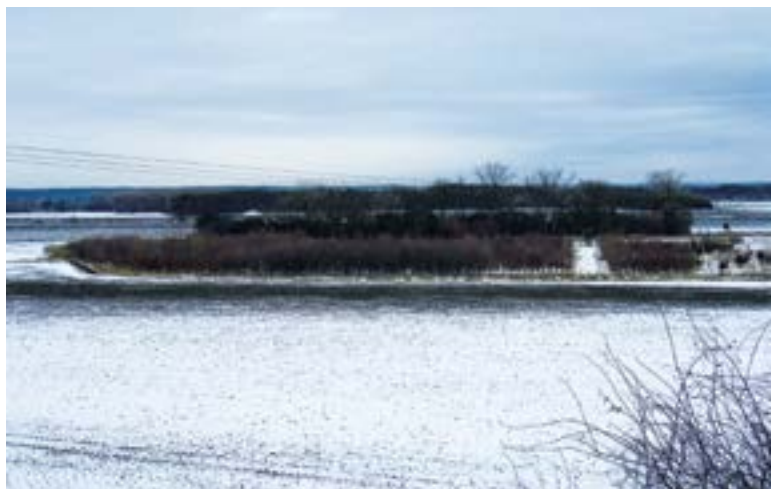
Fig. 13. Site "U Studánky" (December 2022)

Fig. 13 shows the current status of the implementation of the anti-erosion project in the "U studánky" site, and Fig. 14 shows the view of the "V rybníce" wetland site, registered in LPIS as fallow land.

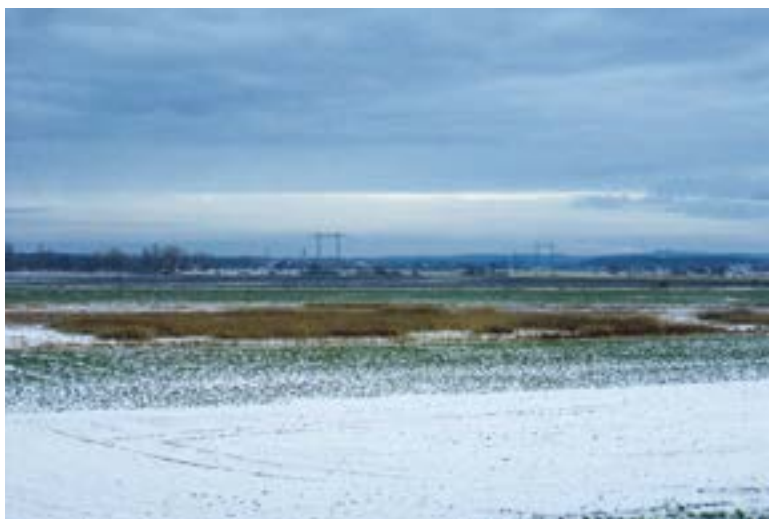
Fig. 14. Site "V rybnice" (December 2022)

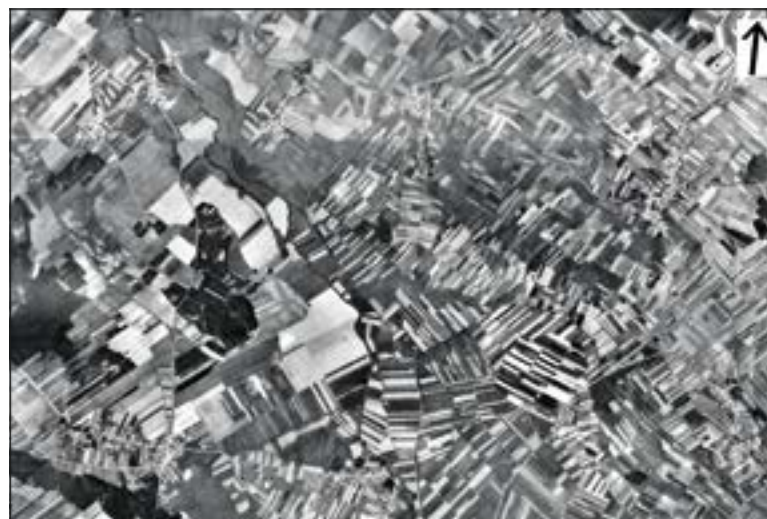
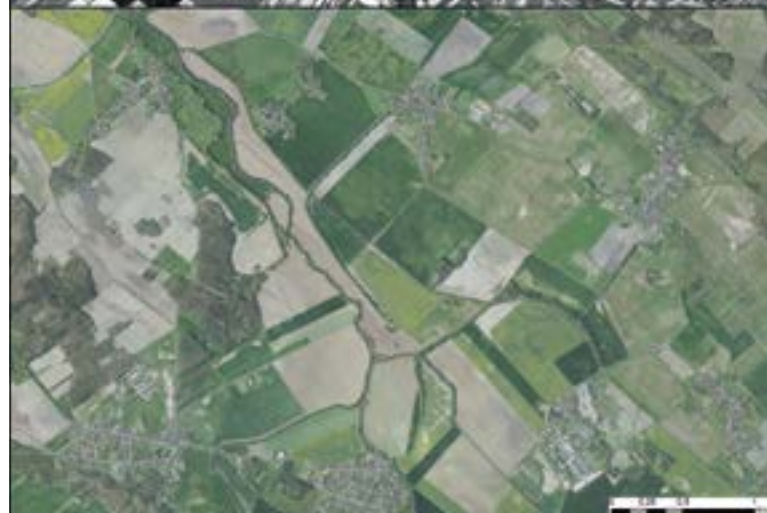
Fig. 16. Doubrava floodplain and the extinct Kmotrov pond near Sulovice on an orthophotomap of Czechoslovakia from the 1950s (top) and on the current orthophotomap of the Czech Republic (bottom)

When clarifying the historical development of this site, it was found that on the map of the 3rd military mapping that the Kmotrov pond is already land-filled. In 1954, arable land with a classic mosaic of small plots of land was located on the site of the pond, and the Doubrava floodplain was already used as arable land. The current orthophoto map shows a change in the landscape mosaic as well as several small waterlogged areas at the site of the disappeared Kmotrov pond (Fig. 16).

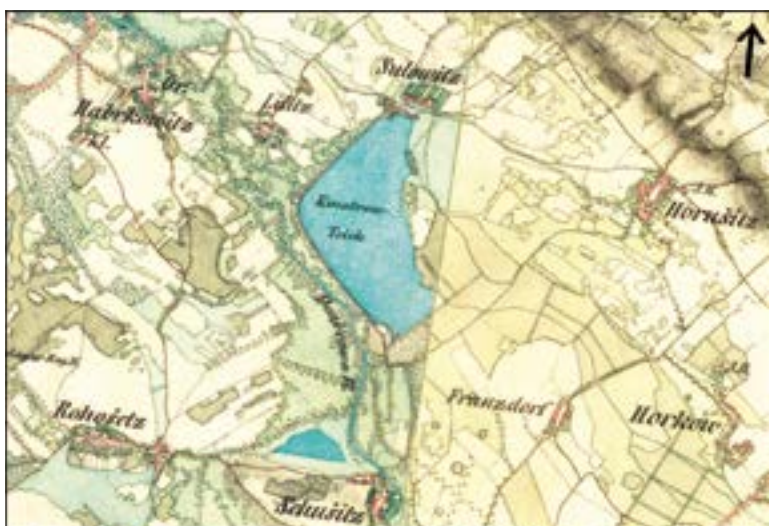
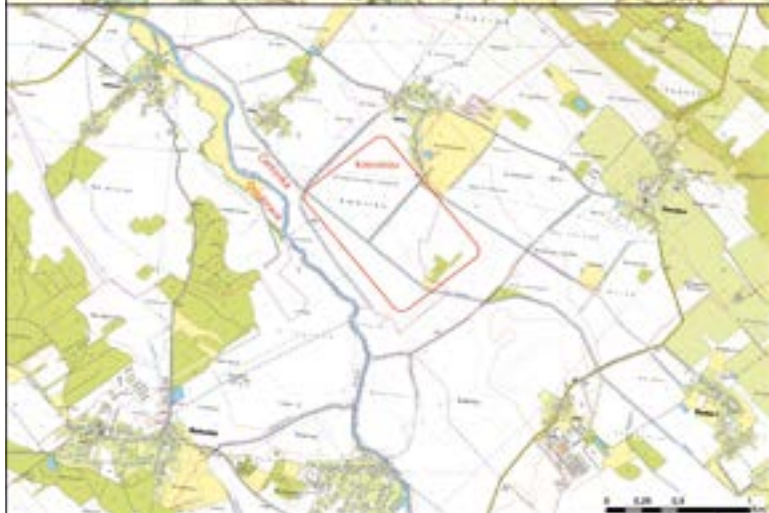
Fig. 15. Doubrava floodplain and the extinct Kmotrov pond near Sulovice on a map of the 2nd military mapping (top) and on BM10 (bottom)

Near the village of Sulovice, there used to be the Kmotrov pond with an area of 87 ha in the immediate vicinity of the Doubrava river, which was located in a wide floodplain formed by wet meadows with woody plants. Between Žehušice and Habrkovice in the neighborhood of the Kmotrov pond, wet meadows with woody plants spread over an area of over 160 ha. Currently, there is arable land, which is also in the immediate vicinity of the Doubrava river, which is bordered only by a narrow strip of riparian vegetation. Similarly to the wet meadows with woody plants in the Doubrava floodplain, the Kmotrov pond also disappeared (Fig. 15).

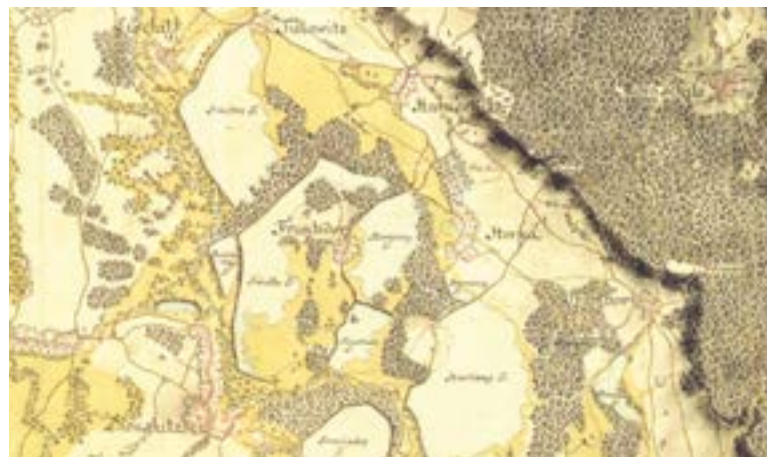
Fig. 17. Doubrava floodplain and the extinct Kmotrov pond near Sulovice on a map of the 1st military mapping

In addition to the Kmotrov pond and a smaller pond near Žehušice (similarly to the 2nd military mapping), another 4 ponds are shown on the map of the 1st military mapping (Fig. 17). The same situation at this site can be found also on Müller's map of Bohemia, although the Kmotrov pond is drawn further from Sulovice (Fig. 18).

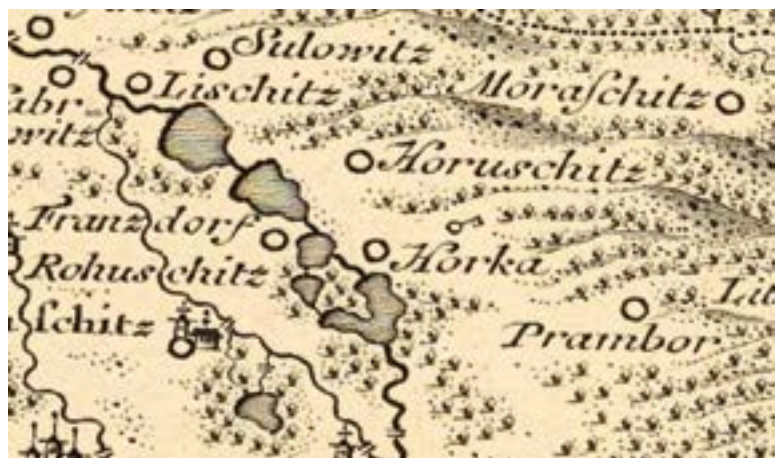
Fig. 18. Doubrava floodplain and the extinct Kmotrov pond near Sulovice on Müller's map of Bohemia

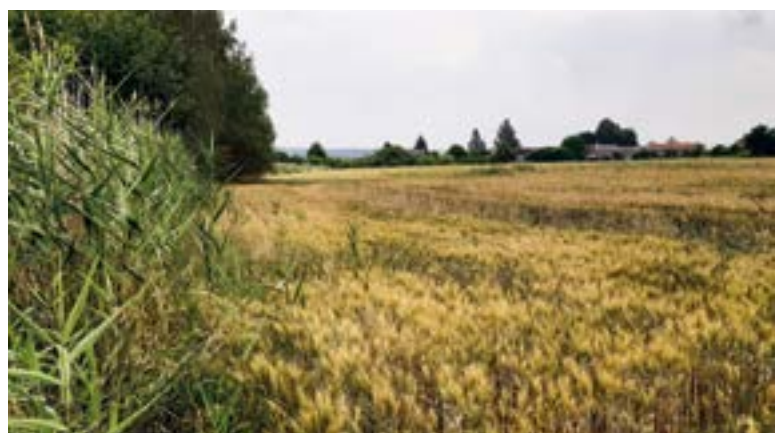
Fig. 19. The current landscape at the site of the extinct Kmotrov pond near Sulovice (July 2022)
